Future Fisheries Improvement Program Monitoring

2016

Livingston Fisheries Office

Montana Fish, Wildlife & Parks

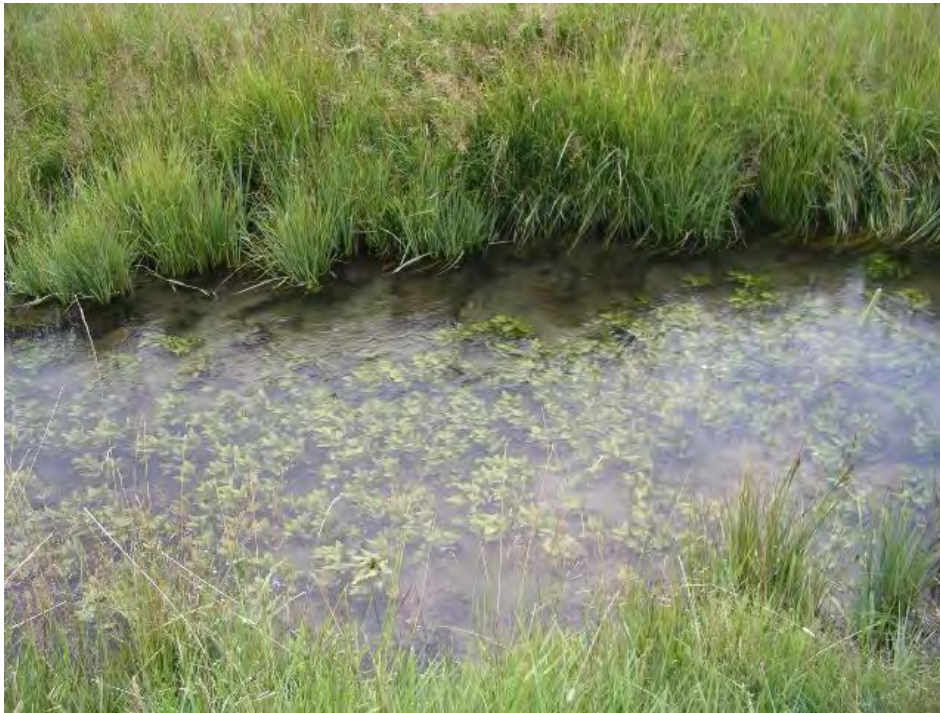
Before project implementation, channel morphology and gradient varied along the length of Kickabuck Spring Creek. In its upper half, the stream had low gradient, a relatively wide and shallow channel, and a mud streambed (Figure 2-55). In the lower half of the stream, the channel became deeper and narrower (Figure 2-56). The higher gradient exposed gravel suitable for spawning (Figure 2-57).

Figure 2-55. Typical channel morphology in the upper half of Kickabuck Spring Creek before enhancement.

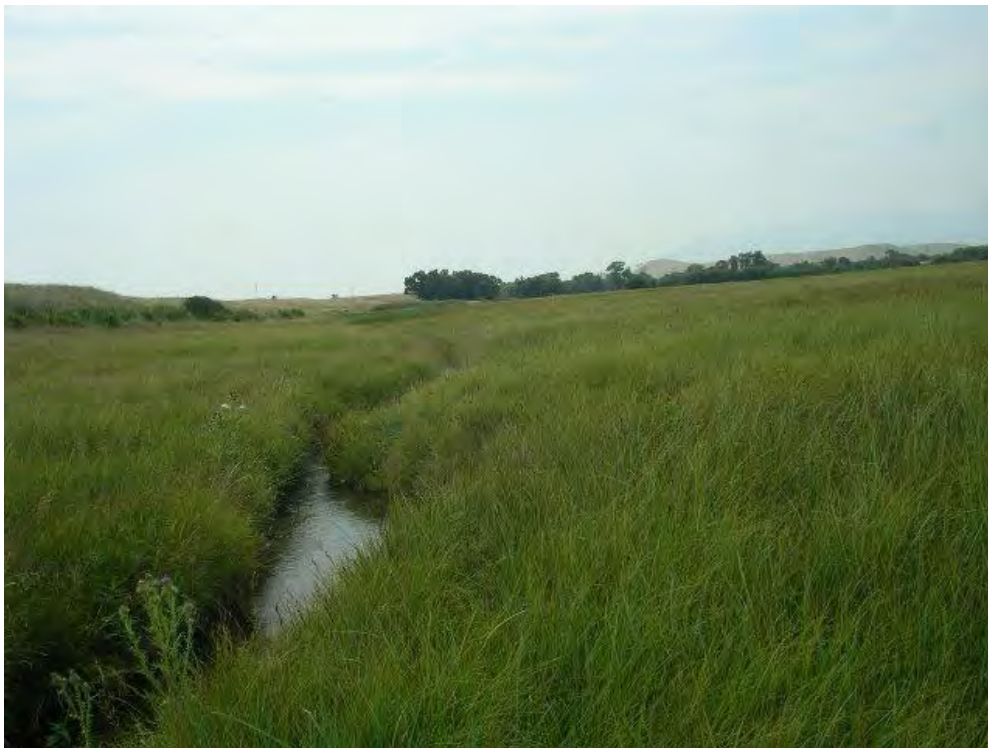
Figure 2-56. Typical channel morphology in lower half of Kickabuck Spring Creek.

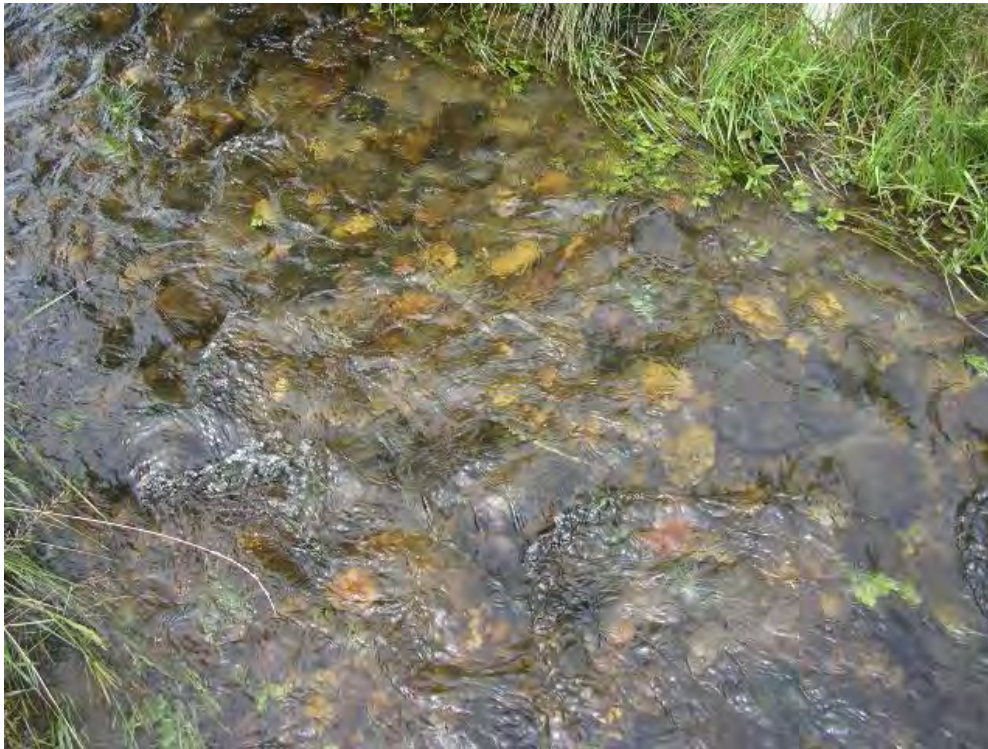
Figure 2-57. Streambed in the lower half of Kickabuck Spring Creek.

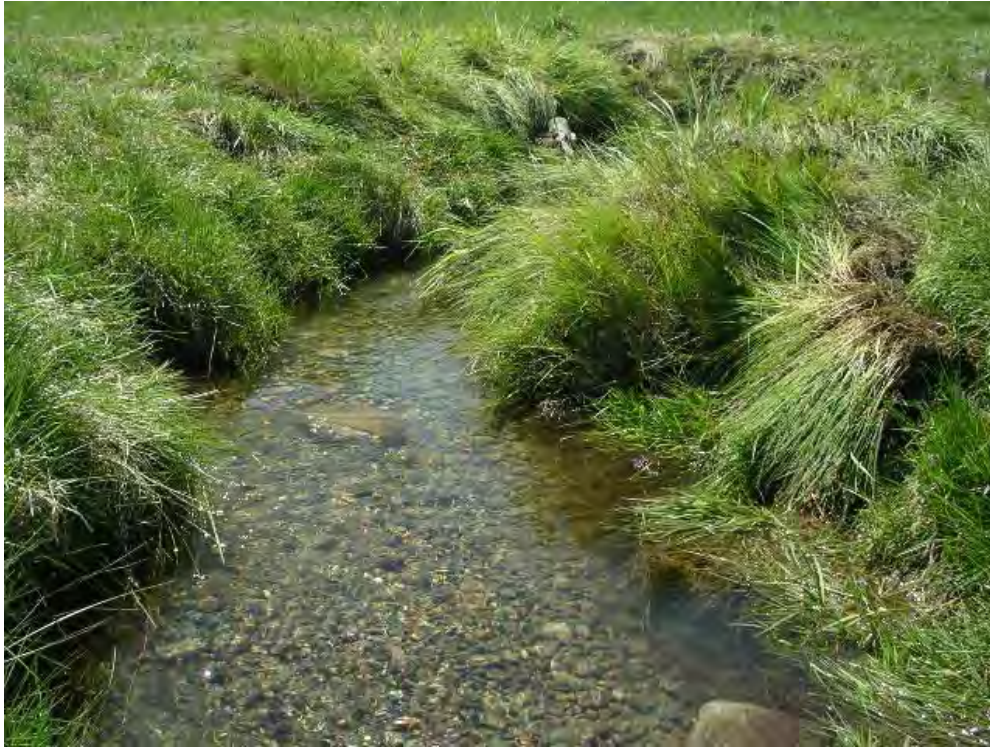
Kickabuck Spring Creek has been visited several times since construction. For several years, the channel cross-sectional dimensions (Figure 2-58) and plan form (Figure 2-59) remained unchanged, and spawning gravel was exposed and clean. In late fall of 2009, the stream teemed with juvenile mountain whitefish, which was atypical, as whitefish typically seek larger water to overwinter. Subsequent visits during the Yellowstone cutthroat trout spawning season did not yield observations of fluvial fish or redds.

Figure 2-58. Reconstructed channel and imported spawning gravel.

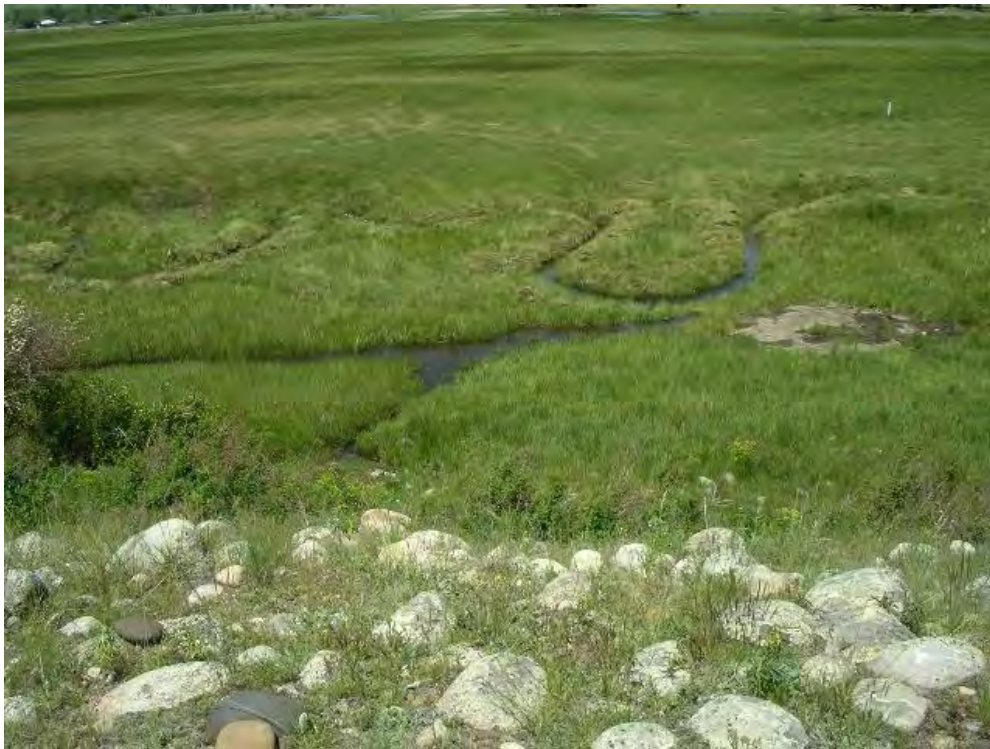
Figure 2-59. View of the reconstructed plan form on Kickabuck Spring Creek.

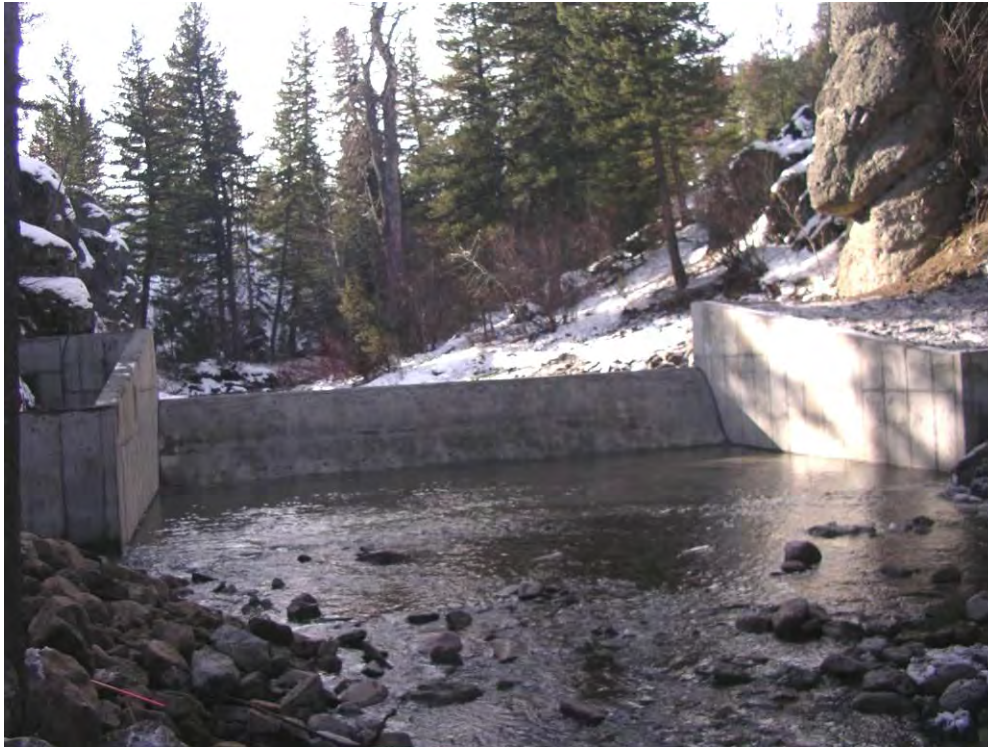
Figure 2-60. Newly constructed barrier on Lower Deer Creek.

The barrier was constructed in November 2010. In spring of 2011, high snowpack and spring rains resulted in peak flows approaching a 500 year flood. Examination of the barrier after this event found the pool upstream of the barrier had filled in entirely with cobbles, which was desirable, as flow and debris

will not exert pressure on the wall in future floods. Conversely, cobbles had accumulated on the downstream apron, which caused concerns for backwatering or providing roughness that would allow nonnatives to breach the barrier. An old wheelbarrow became jammed against the upstream wall of the barrier, and bed load transported over the wheelbarrow scoured a hole in the concrete of the apron. This scour hole was repaired the following summer.

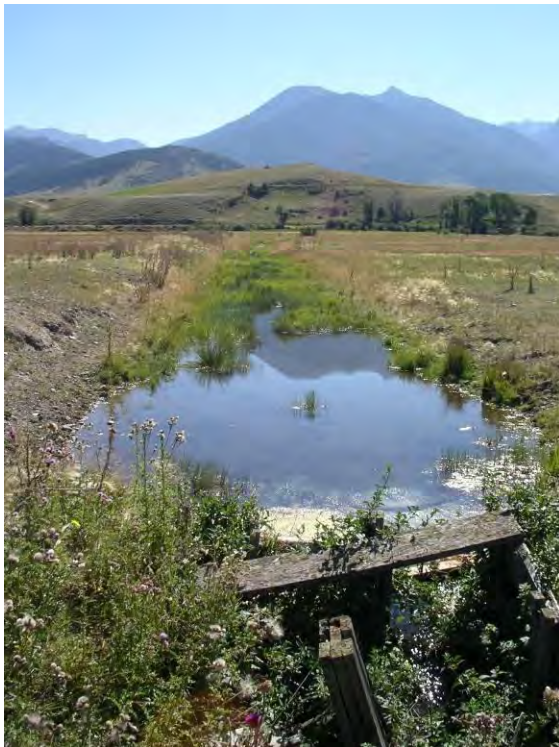
Figure 2-61. Pre-project photo of an excavated channel feeding the Nelson/Dana Spring Creek.

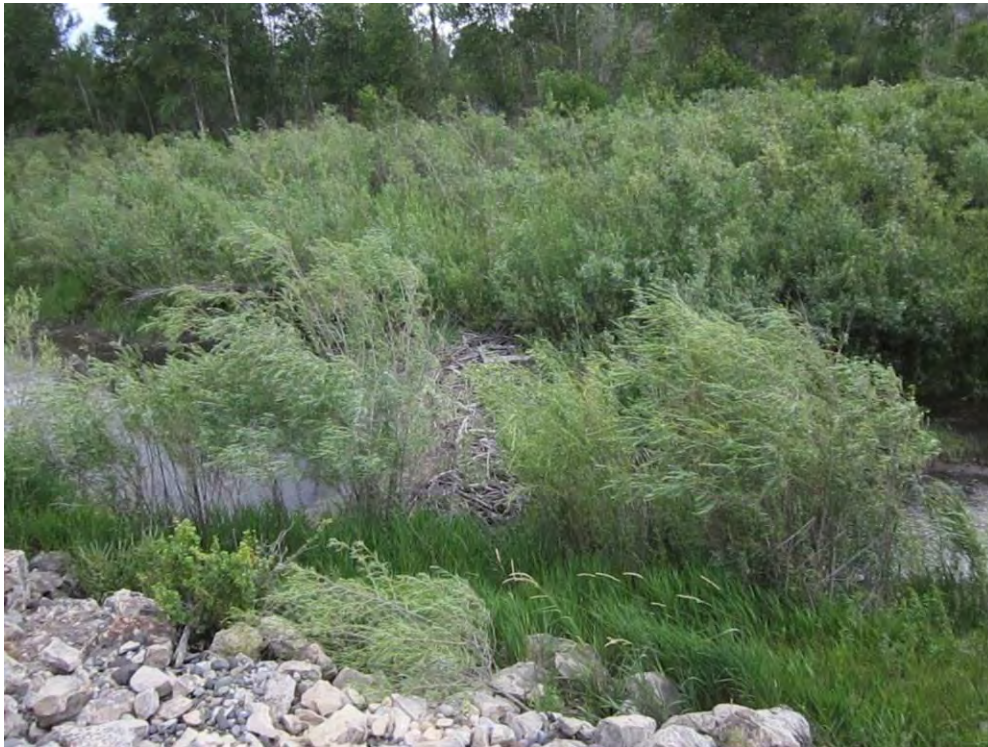
On July 5, 2016, Shannon Bockmon visited the Nelson/Dana Spring Creek project, accompanied by the landowner. A beaver dam near the mouth was the first feature noted (Figure 2-63). According to the landowner, high flows in the Yellowstone River remove beaver dams near the mouth in most years; however, low peak flows did not flush out the dam. He also reported seeing Yellowstone cutthroat trout ascending the spring creek in most years.

Figure 2-63. Beaver dam on Nelson/Dana Spring Creek

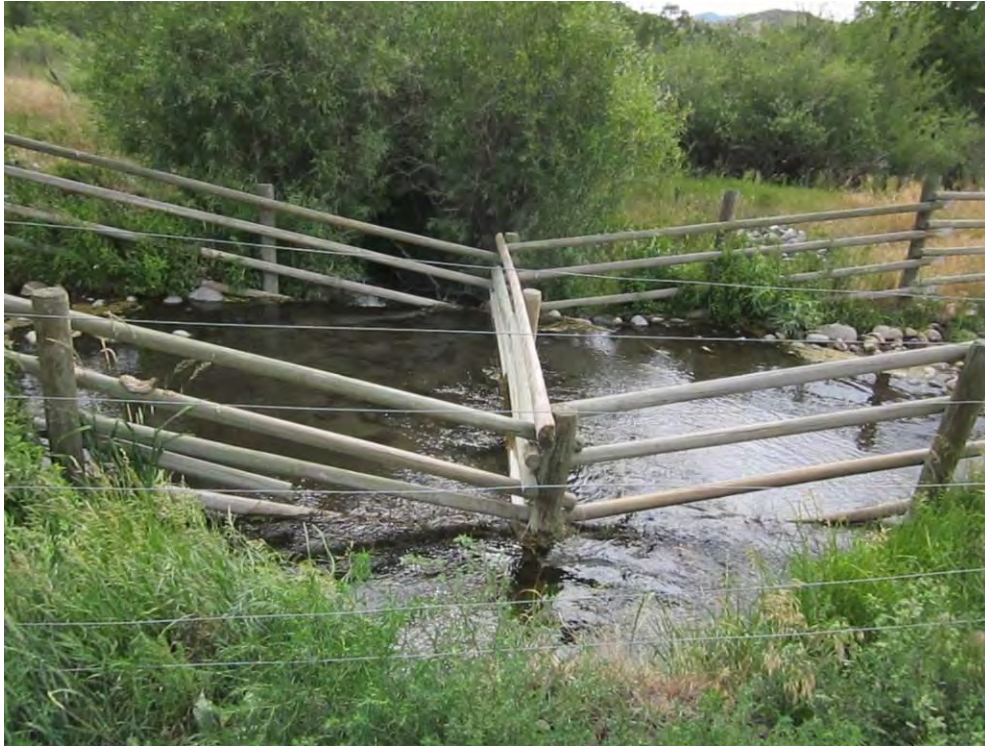
Installation of a hardened water gap was a component of the project that allowed livestock access to water, while protecting the riparian area and stream banks (Figure 2-64). Outside this small area of livestock access, the riparian area was thriving. A mature, thick stand of willows provided considerable benefit to the stream and fisheries by shading the stream, providing overhead cover, and maintaining channel stability.

Figure 2-64. Water gap for watering livestock on Nelson/Dana Spring Creek.

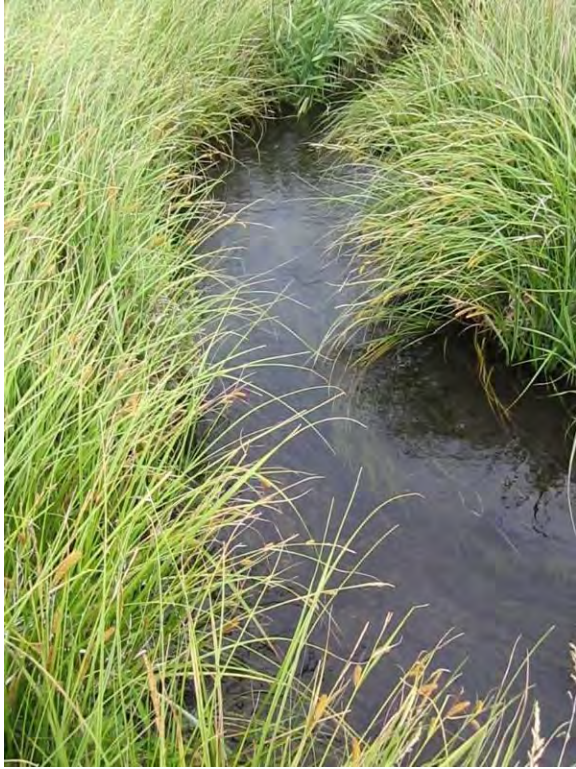
The constructed and enhanced stream channel had maintained its narrow and deep cross-sectional morphology for the stream's entire length (Figure 2-65). The sedge banks provided considerable undercut bank habitat. Aquatic macrophytes, which are typical of spring creeks, were dense in places; however, sufficient flow existed to limit their cover, and areas of spawning gravel remained exposed.

Figure 2-65. Typical view of the constructed and enhanced channel on Nelson/Dana Spring Creek.

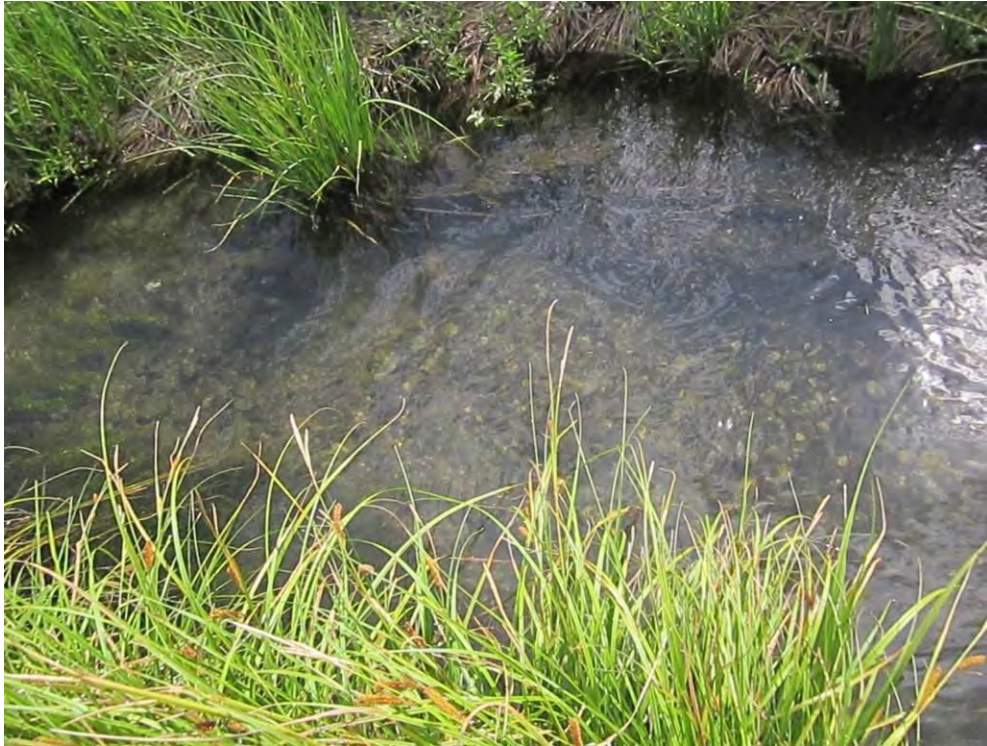
Figure 2-66. Spawning gravel in Nelson/Dana Spring Creek.

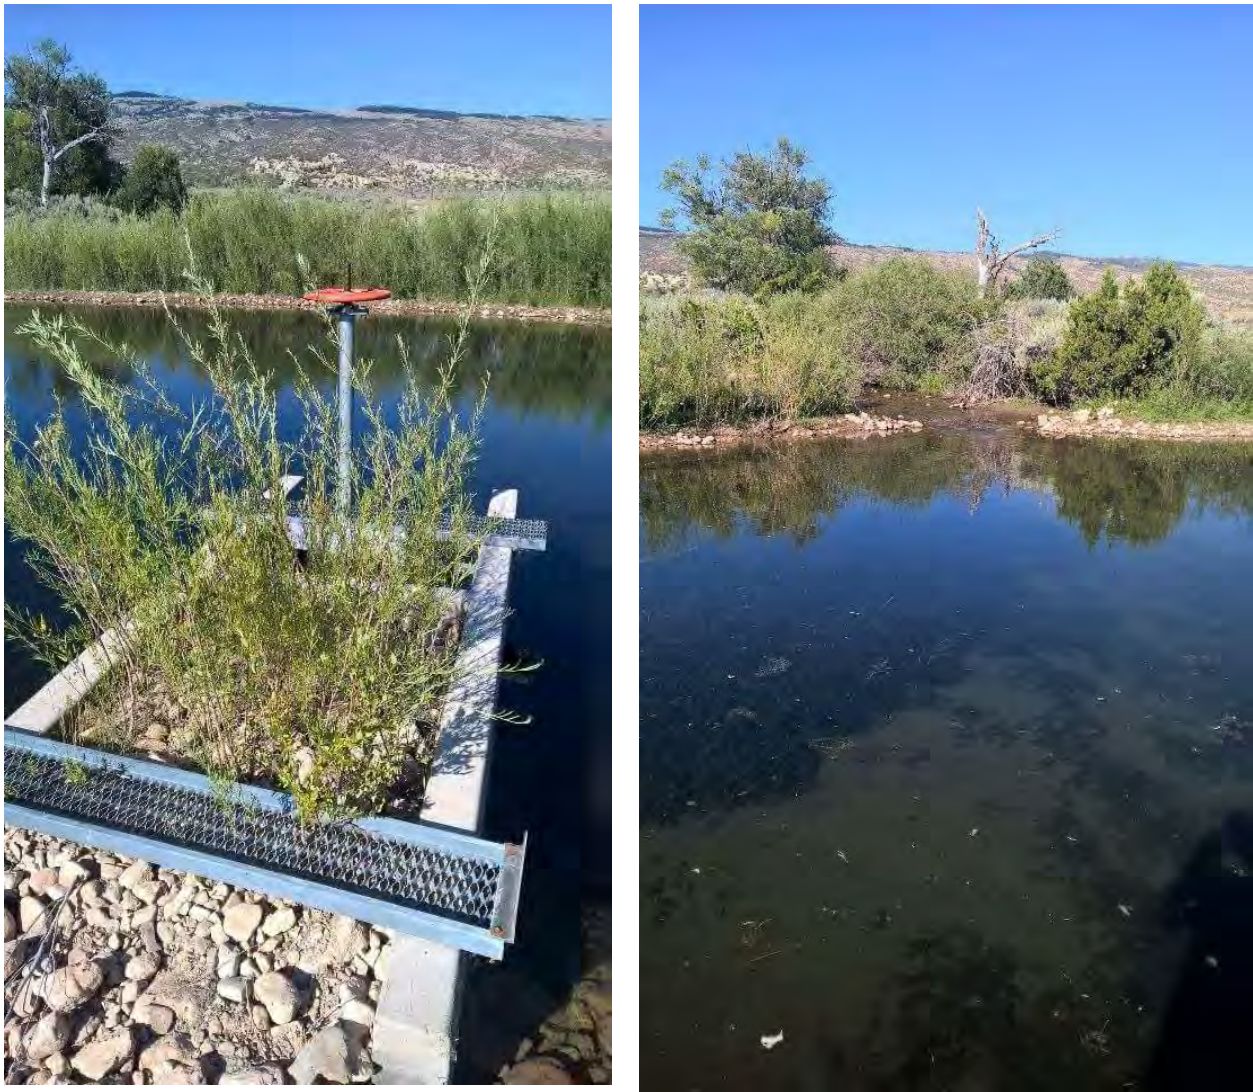
The pond was full and delivering water to the canal through the gated stand pipes (Figure 2-71).

Numerous, relatively large Yellowstone cutthroat trout were visible in the pond. Willows had colonized the perimeter of the pond. This type of aquatic feature is rare to absent in this arid landscape, and provides a patch of habitat diversity.

Figure 2-71. Stand pipe diversion, and inlet of Piney Creek into the storage pond.

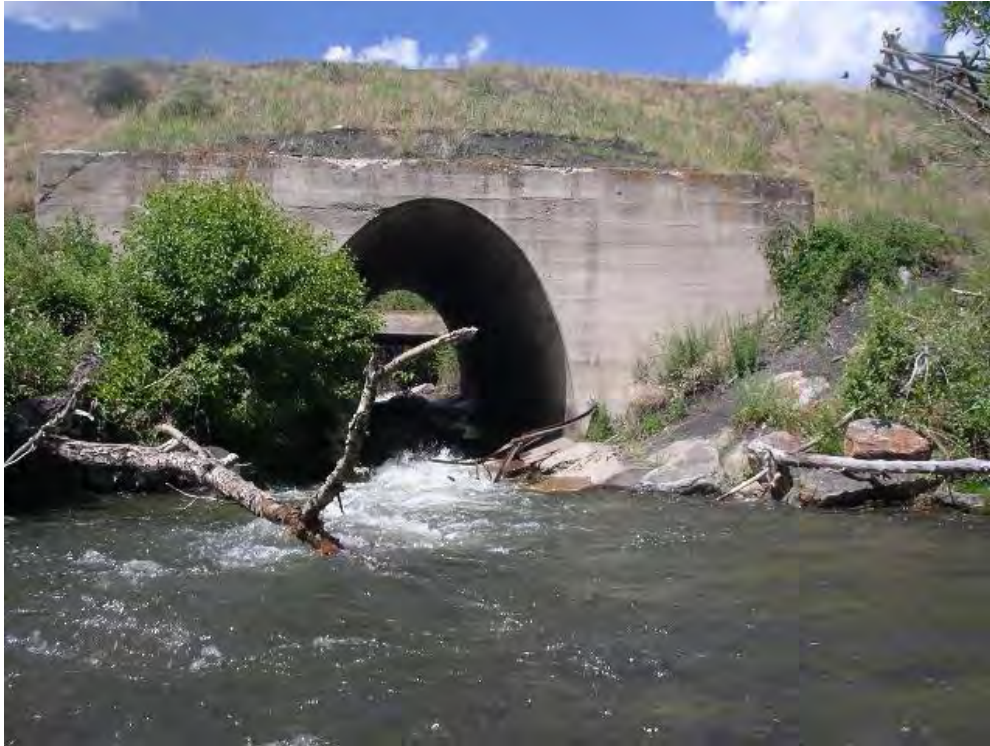
Rock Creek is a tributary of the Yellowstone River, and is located downstream of Corwin Springs, in upper Paradise Valley. In the early 1900s, the Northern Pacific Railroad Company constructed a concrete culvert that funneled Rock Creek under the rail line that ran from Livingston to Gardiner. This culvert was 70 feet long and had a slope of 7.5%. The combined length and velocity of water flowing through this structure made it a barrier to upstream movement, and fluvial Yellowstone cutthroat trout were excluded from spawning in Rock Creek. In the late 1970s, a fish ladder was installed, and connectivity was restored for several years, and substantial numbers of Yellowstone cutthroat trout fry were documented outmigrating from Rock Creek. This ladder failed in the early 1980s. As the culvert floor scoured, and debris clogged the culvert, some Yellowstone cutthroat trout were likely able to swim through the culvert, owing to the increased complexity and roughness. Nevertheless, these would need to be especially strong swimmers. Fry monitoring in 2009 found no fry upstream of the culvert.

Figure 2-72. Railroad culvert on Rock Creek.

The solution to provide passage into Rock Creek was to remove the culvert, and construct a series of step-pools through the former footprint of the steep culvert (Figure 2-73). Design considerations included ensuring rock was large enough to remain in place, and placed so that current refugia existed at the channel margins at high flows.

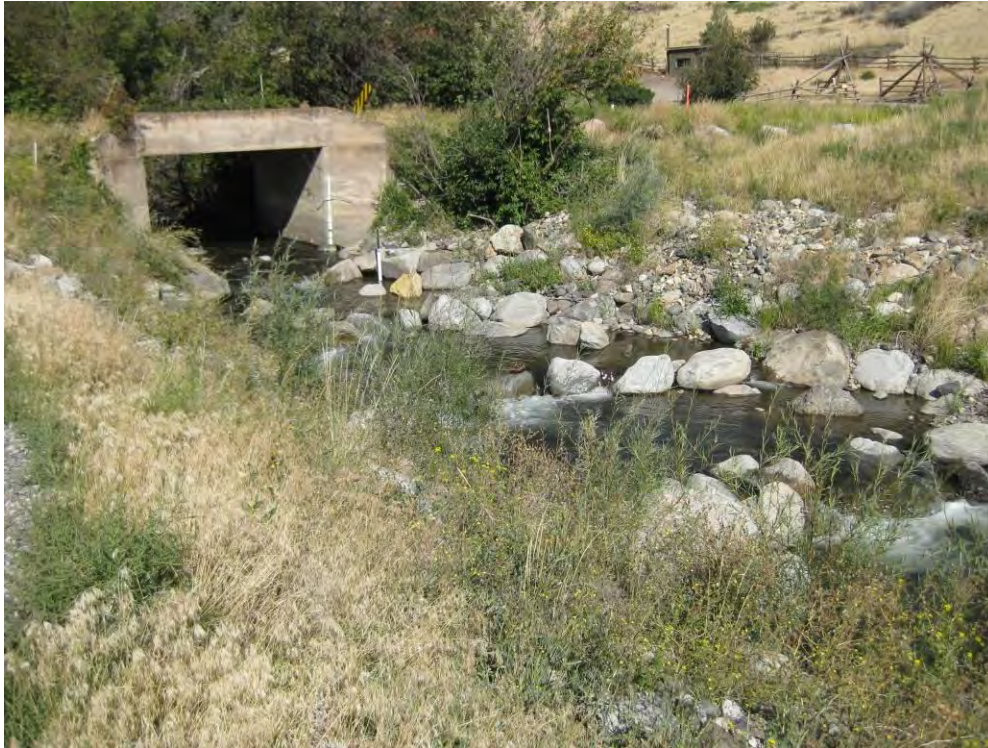
In 2014, Michelle McGree, Jim Darling, and Carol Endicott evaluated the step-pool and the recovery of vegetation planted on the surrounding railroad berm. The boulders remained in place, and the feature appeared passable. Willows were beginning to recruit along the stream margin, and upland plantings on the re-sloped sides of the berm were doing well.

Figure 2-74. Step-pool sequence constructed to provide fish passage into Rock Creek.

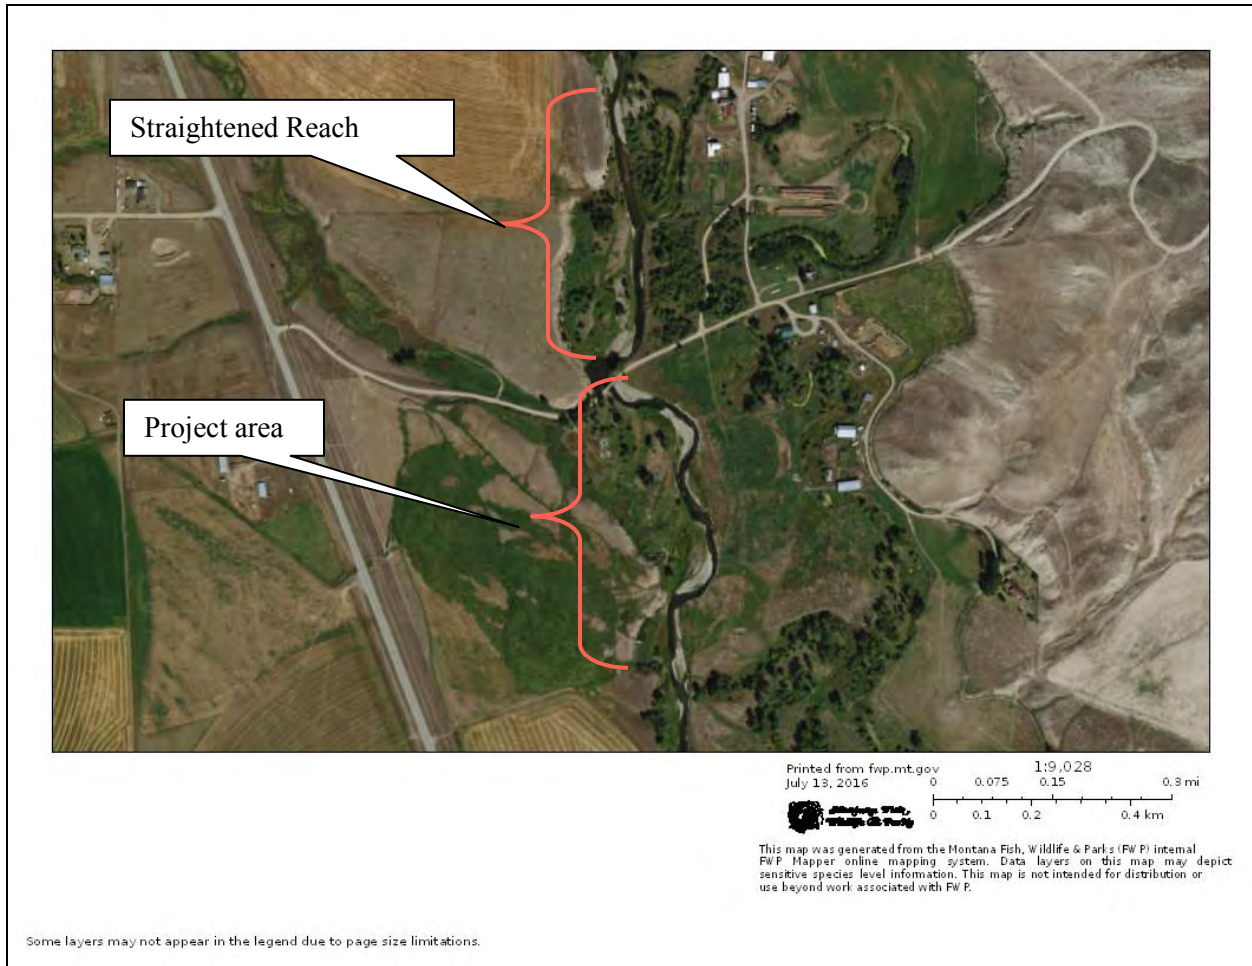
Evaluation of aerial photos upstream of the project area, and within the project area, provides insight into the cause of the lateral movements of stream banks. Approximately 1/3 of a mile of stream channel was likely straightened in the relatively distant past (Figure 2-78). Closer view of the channelized reach shows old meander scars, which support the assumption that the stream occupied more of its floodplain, and humans had altered the channel (Figure 2-79).

Figure 2-78. Aerial photo of project area and the straightened reach located upstream.

Straight channels have greater stream power during high flows, as they lack meanders to dissipate flow velocities. As a result, bed load movement of gravel and cobbles is substantial, and these particles do not accumulate on point bars within the straightened channel. When the flows hit the more sinuous reach, the water slows down, and the gravel and cobble settle out to form large point bars. (Figure 2-78). These point bars divert high flows into the opposite bank, which results in greater erosive pressure than the banks can handle.

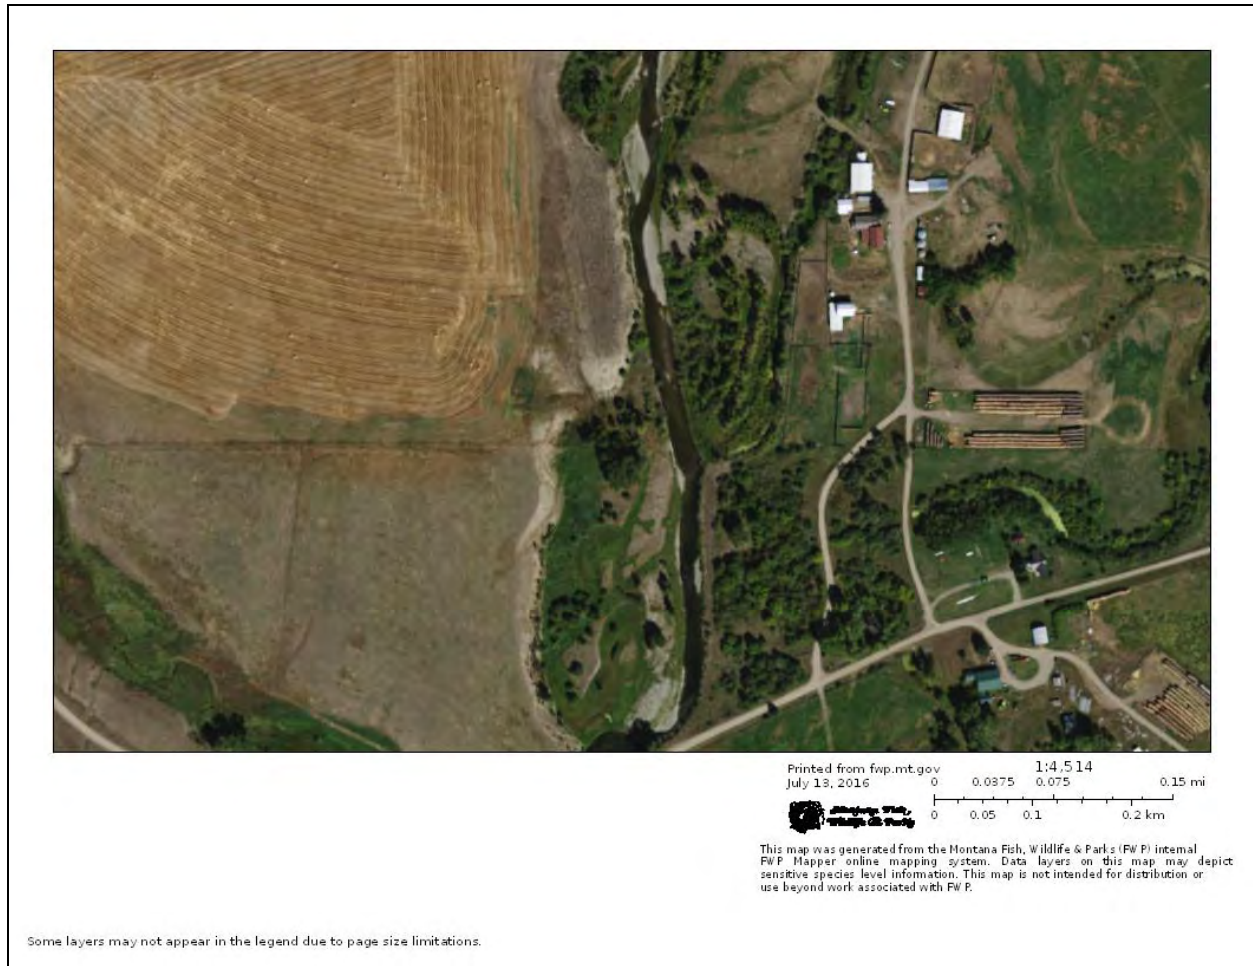
Figure 2-79. Close-up of channelized reach upstream of the project area.

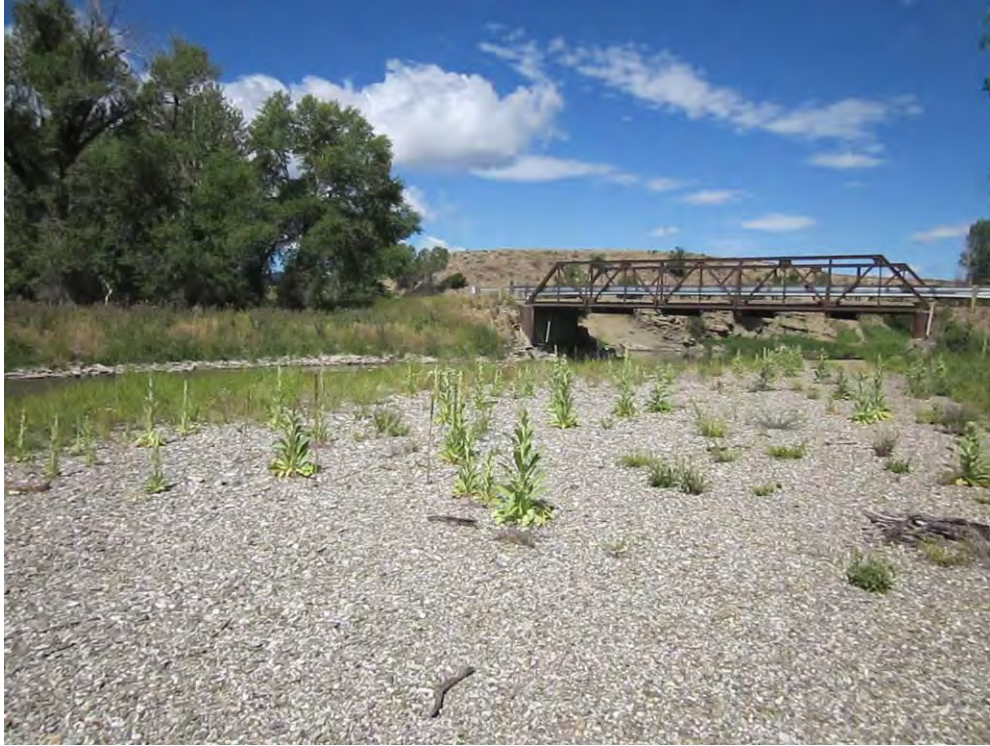
Within the restored reach, point bar development indicated an imbalance in transport and deposition of bed load (Figure 2-81 and Figure 2-78), and growth of point bars put more pressure on the opposing banks, which were the subject of restoration efforts. Bank armoring, although not desirable from fisheries or river form and function perspectives, was successful in protecting land. Nonetheless armoring did extend the area of disturbance by exerting pressure on banks downstream of the project area, contributing to a small area of bank erosion.

Figure 2-81. Example of large point bar within project area.

With the exception of the large point bars, the livestock grazing management component of the project continued to be successful in promoting a healthy, functional riparian area, with recruitment of woody vegetation. In contrast, the amount of bed load deposited on the large point bars, and their elevation above the water table makes recruitment of woody vegetation difficult. Young willows and cottonwoods are buried by deposited rock. In addition, as seedlings, these species need to keep their tap roots in contact with groundwater as the flows subside in the summer. Water levels drop relatively quickly in these elevated and porous point bars, and the young plants die of desiccation, despite being within the active channel.

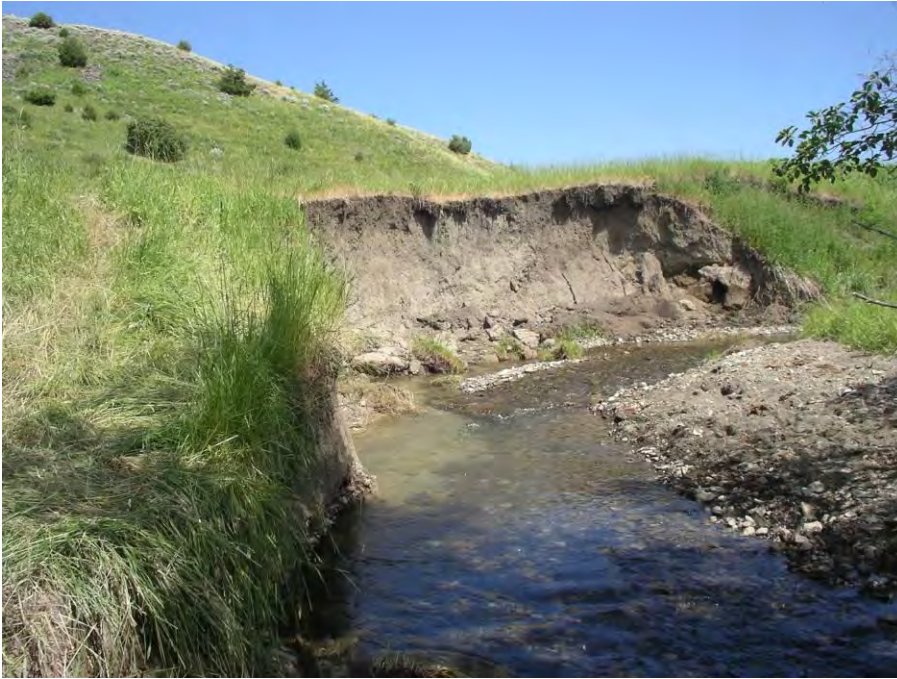
The Middle Fork Horse Creek project addressed sediment delivered from where the stream abutted a vertical, eroding terrace, and a lack of willows within the project area (Figure 2-82). This pasture was likely used during calving by previous owners, and cattle had removed much of the riparian vegetation. The landowners at the time did not plan to use this pasture for grazing, so it had several years of rest. Nonetheless, willows had not recovered, and weeds infested most of the floodplain.

Figure 2-82. Middle Fork Horse Creek project area before project implementation.

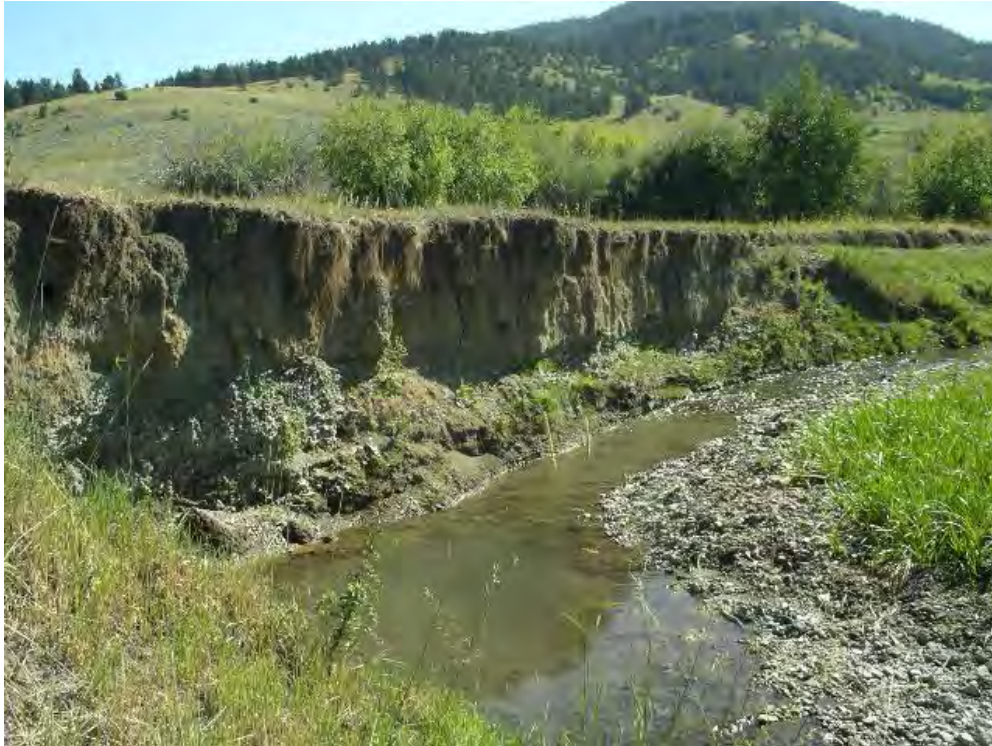
Similar to Middle Fork Horse Creek, South Fork Horse had several reaches where the stream exerted considerable force on vertical, eroding terraces (Figure 2-83). In addition, current grazing practices were damaging stream banks, and impairing the health and function of the riparian area. Cattle accessed the stream at numerous locations, resulting in hoof shear, and exposed dirt (Figure 2-84). Riparian shrubs were absent from a considerable portion of the stream, and many banks were actively eroding (Figure 2-85). The suspended sediment load was substantial, as the stream was turbid, even during low flows.

Figure 2-83. Example of stream abutting an eroding terrace on South Fork Horse Creek.

On both streams, the strategy to reduce erosion from high vertical terraces entailed construction of a floodplain bench between the stream and the terrace (Figure 2-86). The benches removed the shear stress at the toe of the terrace, and provided a floodplain with roughness that dissipates the erosive force of flood flows. The banks were built from wetland sod mats that were harvested from within the project area.

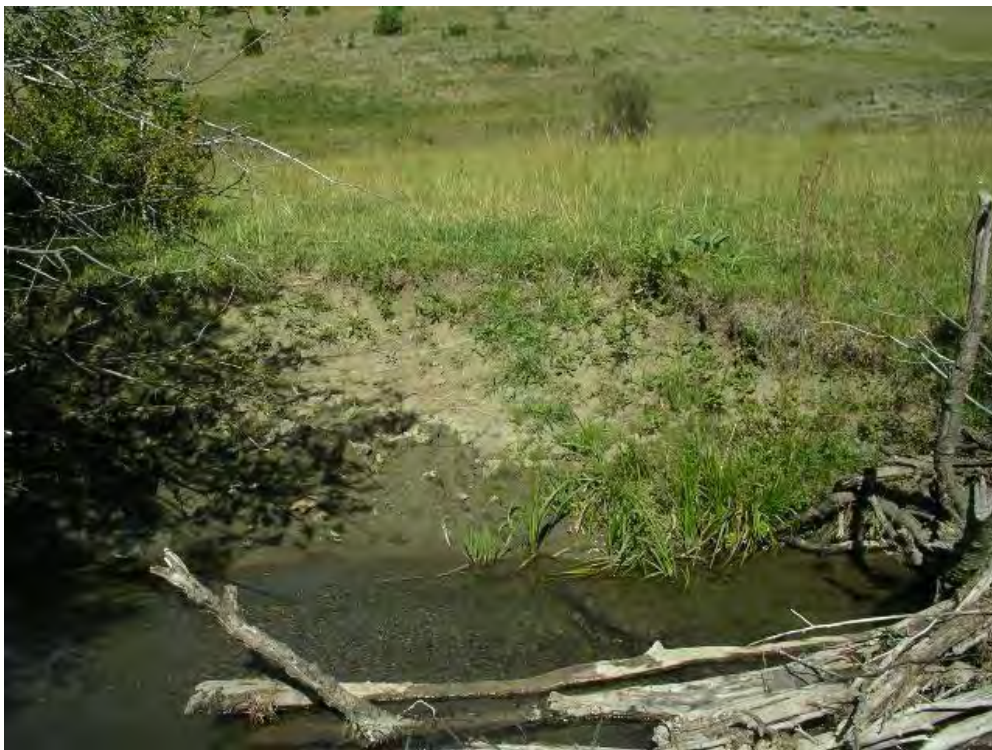
Figure 2-84. Example of cattle access point.

A separate component of this project addressed livestock management on the ranch. The landowner chose to exclude cattle in the project area of the Middle Fork Horse Creek, so livestock would not alter riparian vegetation, or access the stream banks. Actions on South Fork Horse Creek included installation of a fence to control the ability of cattle to access the riparian area and stream, development of a ranch-wide grazing management plan, and installation of off-stream stock water. The landowner worked with the Natural Resources and Conservation Service on these activities.

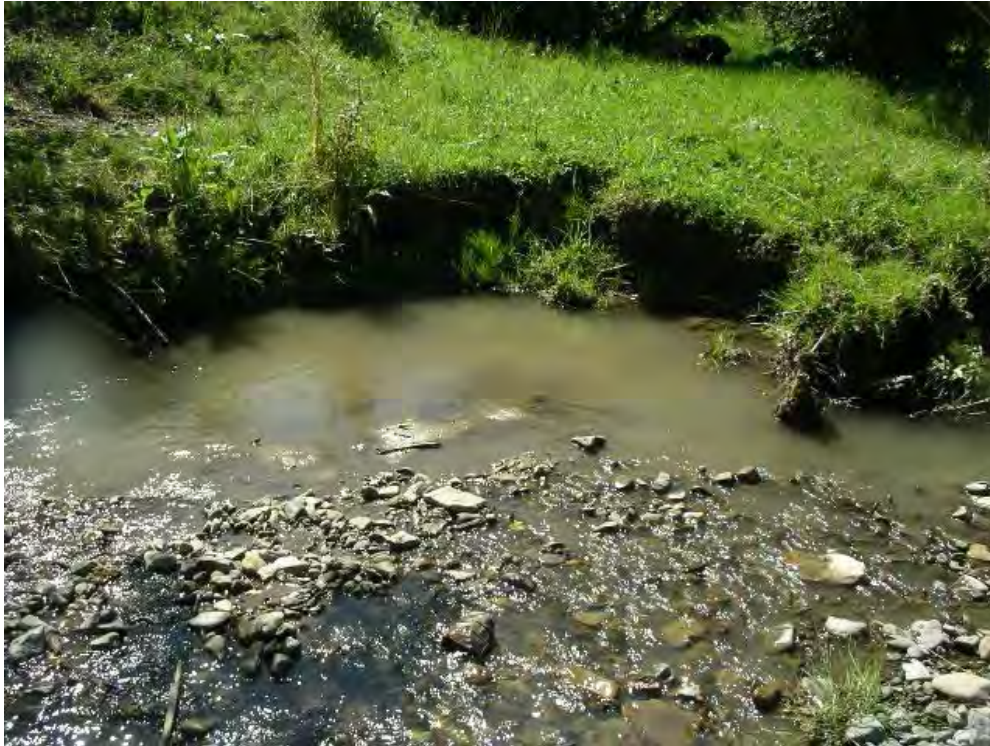
Figure 2-85. Example of lack of riparian shrubs and eroding banks on South Fork Horse Creek.

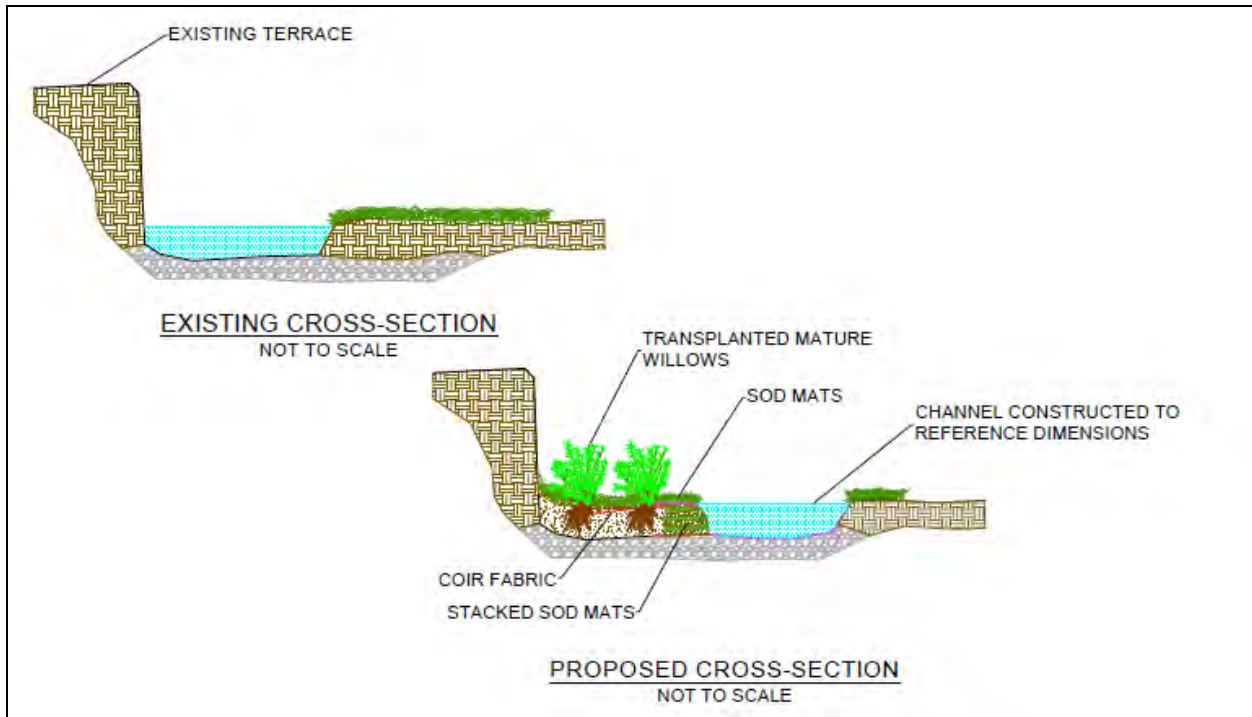
Figure 2-86. Conceptual plan for construction of floodplain bench.

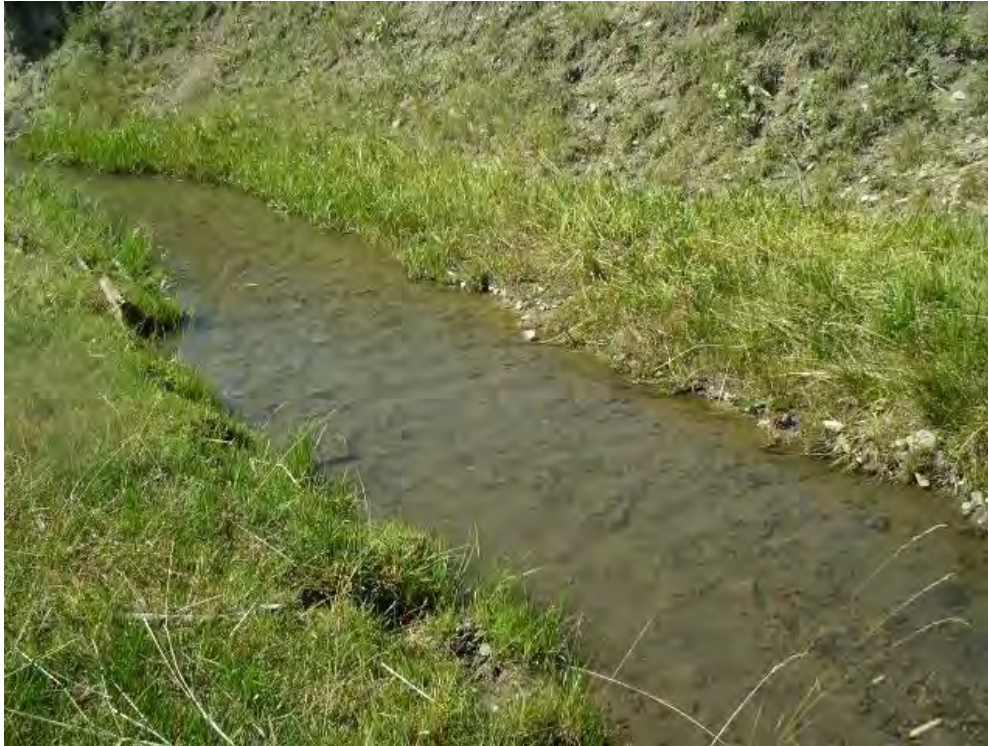
Deposition of fine sediment occurred along most of the channel (Figure 2-87). This siltation reduces the suitability of the gravel for spawning, and limits invertebrate production, as the spaces among gravel particles are clogged with sediment. Even relatively high gradient, narrow and deep portions of channel had substantial amounts of fine sediment.

Figure 2-87. Sedimentation of streambed in a relatively high gradient portion of South Fork Horse Creek.

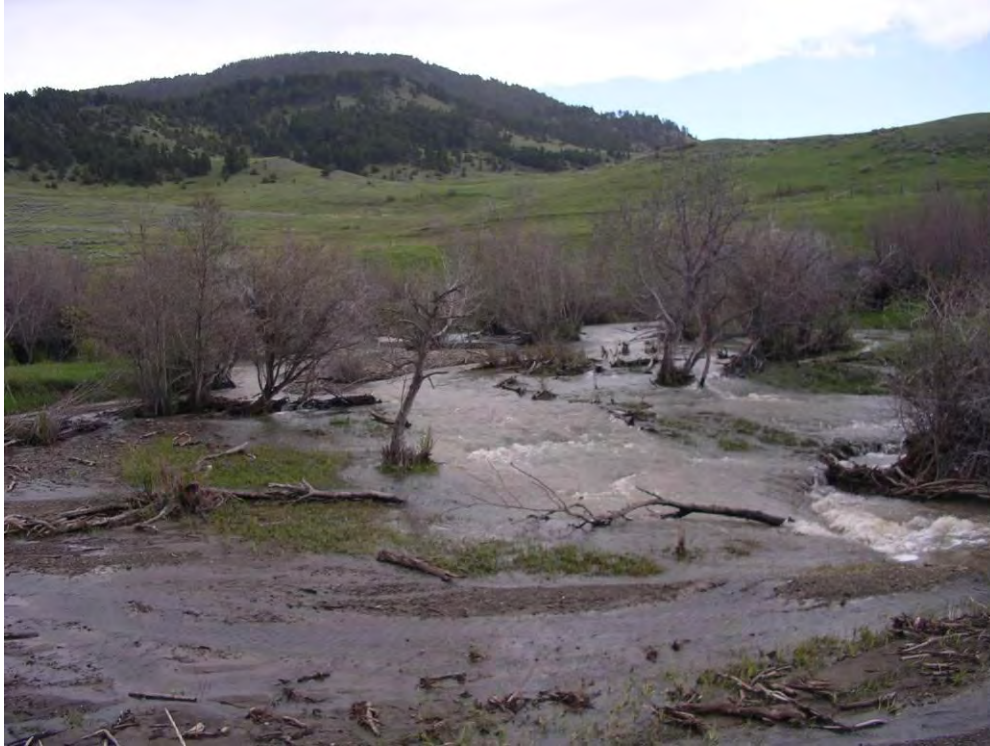
Disturbance is common in streams, and the South Fork Horse Creek flooded the spring after construction (Figure 2-88), resulting in considerable shear stress on the newly constructed benches. These flows also resulted in abandonment of existing channels, formation of multiple channels, and a substantial head cut, where the stream bed made a dramatic drop in elevation (Figure 2-89).

Figure 2-88. Declining limb of flood, spring 2012.

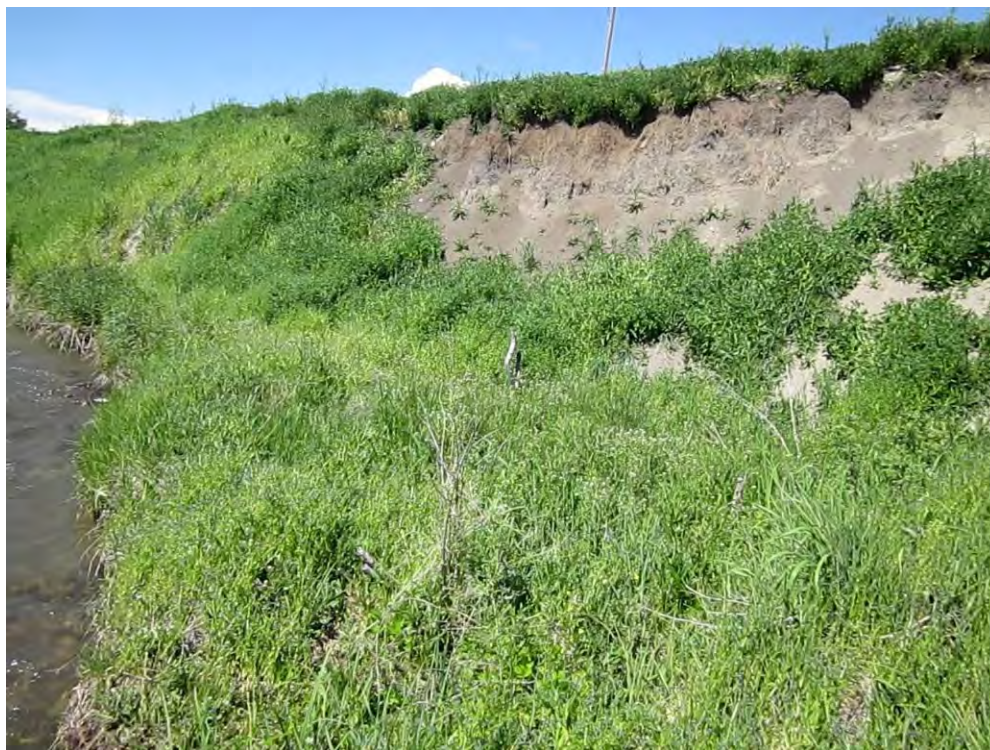
The Middle Fork Horse Creek floodplain bench is serving its purpose of reducing sediment delivery to streams, and the adjacent channel is considerably more narrow and deeper than the pre-project channel (Figure 2-90). Keeping erosive forces off the toe of the vertical terrace has allowed the upper portion of the terrace to settle into an angle of repose. Furthermore, this formerly vertical wall is growing vegetation, albeit weeds, but the plants will continue to stabilize the bare soil. Willows are recruiting on the bench, and the transplanted sedge mats are indistinguishable from a natural bank.

Figure 2-90. Floodplain bench 5 years after construction.
