Future Fisheries Improvement Program Monitoring

2016

Livingston Fisheries Office

Montana Fish, Wildlife & Parks

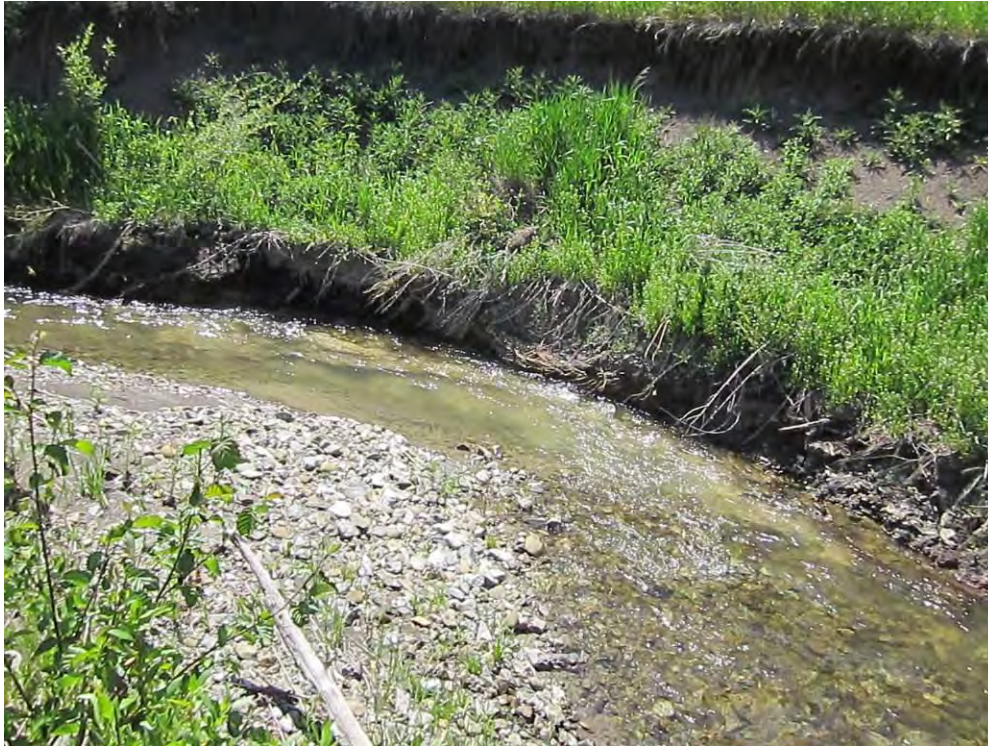
Marked improvements were also present on the South Fork Horse Creek. Similar to the middle fork, construction of floodplain benches had eliminated the erosive force on the toes of the eroding terrace, and these benches are vegetated with sedges and willows (Figure 2-91). Moreover, the vertical walls were settling, and becoming vegetated.

Figure 2-91. Constructed floodplain bench on South fork Horse Creek.

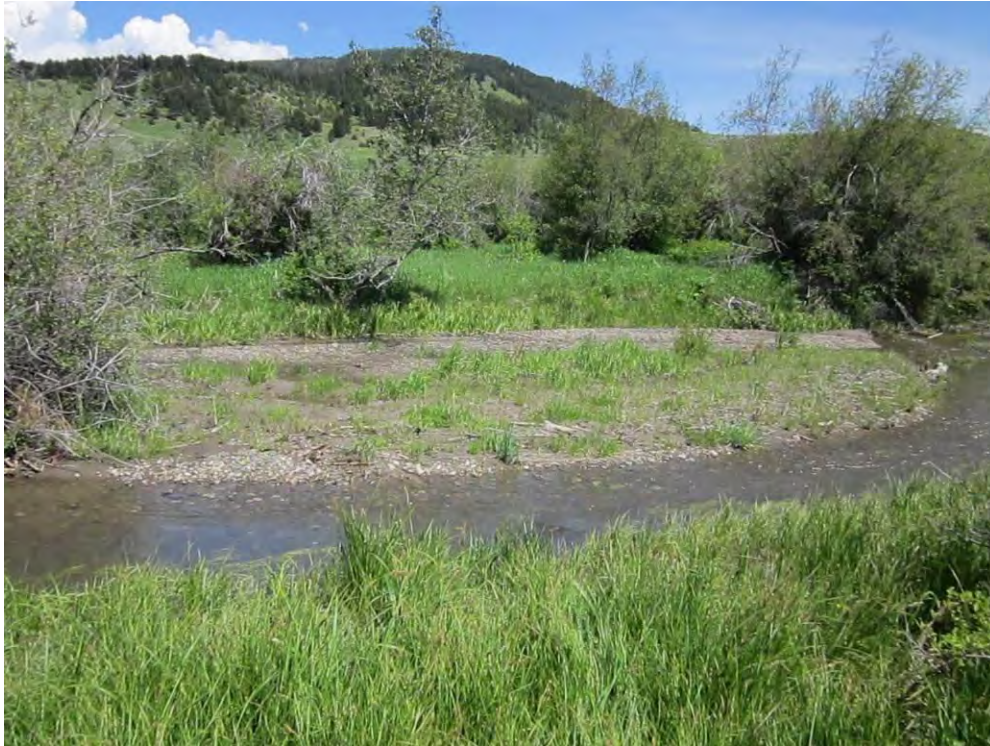
Resting this reach of stream from livestock grazing has resulted in profound improvements in riparian health and function (Figure 2-92). A decrease in deposition of fine sediment was also striking condition, compared to pre-project sedimentation (Figure 2-93). Cleaner substrate should increase spawning success and the forage base for fish.

Figure 2-92. Healthy riparian vegetation and recolonization on gravel bars.

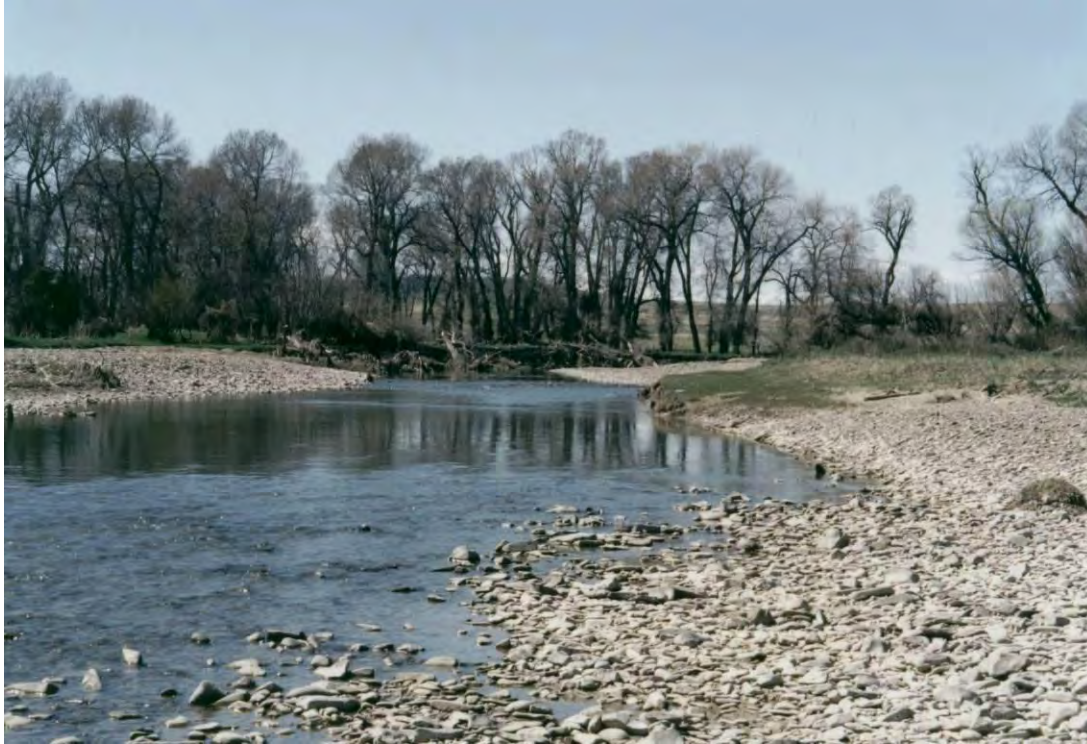
The project was implemented in 1998, and within 4 years, the riparian area and stream channel recovered markedly (Figure 2-94 and Figure 2-95). In its pre-project condition, the banks mostly were exposed cobble, and the channel was overly wide and inefficient in transporting bed load or sediment. With rest from livestock grazing, plants become established on the bare banks. These plants created roughness that trapped sediment during high flows, which is the mechanism through which stream banks are built. With deposition of soil building banks, the channel became narrower. Narrower channels have greater capacity to transport sediment, and the stream carved a deeper channel within the new bank full margin. The consequences of the narrower, deeper channel are improved habitat for fish, and likely slowed warming of water temperatures, with a decrease in the stream's surface water exposed to sunlight. This rate at which the stream recovered is typical of how quickly streams repair themselves when released from continued disturbance.

Figure 2-94. Pre-project photo of the Sweet Grass Creek project area (1998).

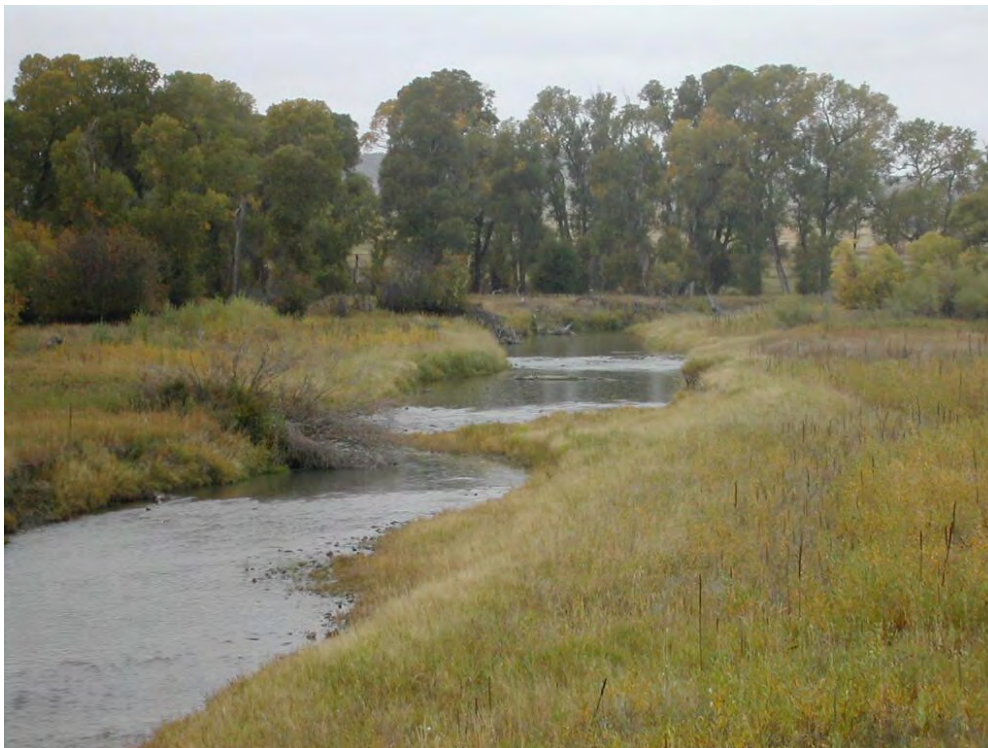
Figure 2-95. Post-project photo of the Sweet Grass Creek project area (2002)

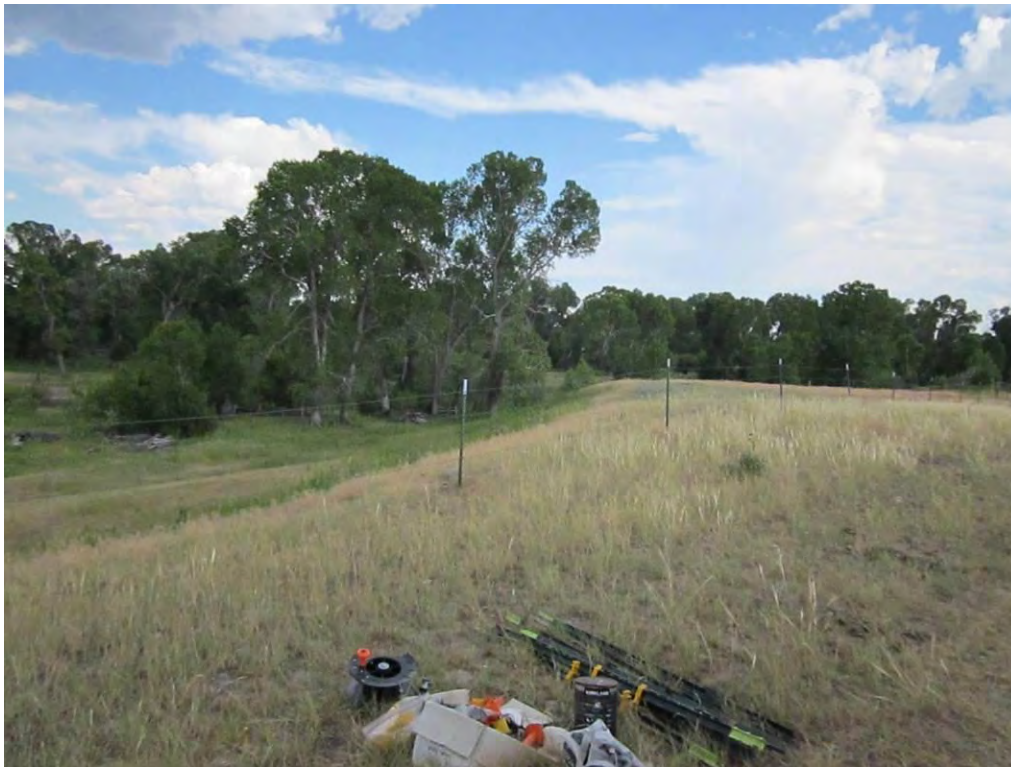
On July 2, 2016, Shannon Bockmon and the landowner evaluated the status of the project. Fencing to control cattle access to the stream was still in place (Figure 2-96), and the landowner reported grazing occurred within the riparian enclosure for short duration each year. An overview of the stream channel from the uplands indicated livestock management continued to maintain stream channel morphology and riparian vegetation (Figure 2-96), and recovery was continuing. Evidence of livestock near the stream was minimal, with isolated hoof shear near banks.

Figure 2-96. Riparian fencing on Sweet Grass Creek.

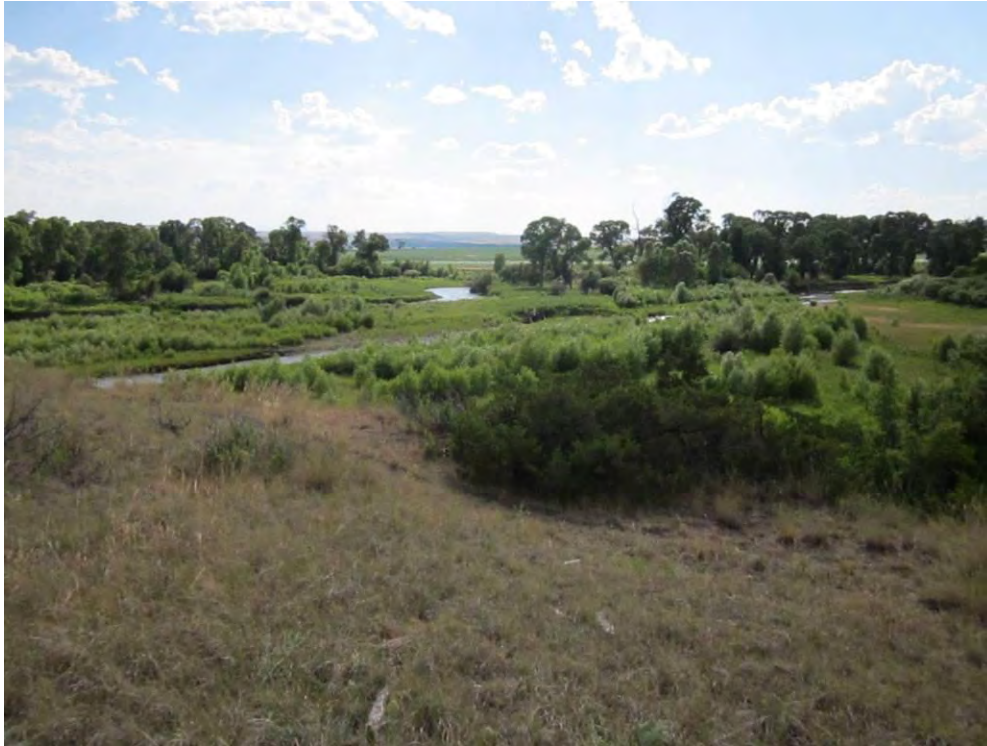
Figure 2-97. Overview of the middle portion of the project.

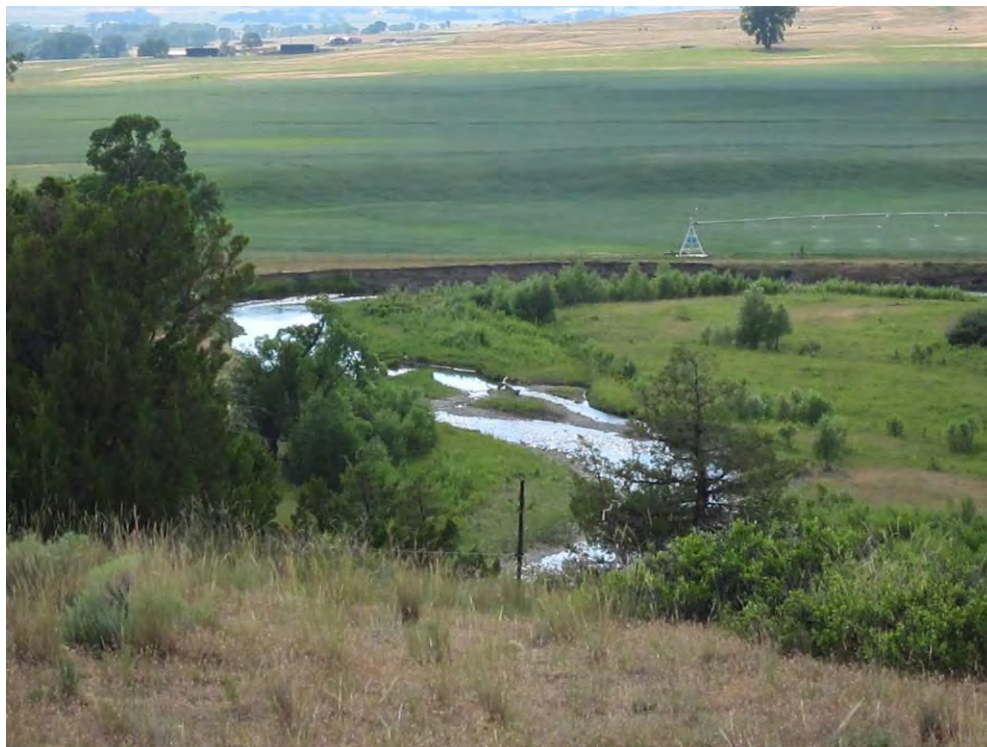
A substantial area of bank erosion was present associated with cultivation of irrigated hay adjacent to the channel (Figure 2-98); however, the landowner was unconcerned with the amount of bank erosion. Should erosion along this bank accelerate, construction of a floodplain bank adjacent to the eroding bank may be appropriate to take pressure off the eroding bank, and provide more floodplain area for dissipation of the erosive force of floods.

Figure 2-98. Area of bank erosion adjacent to hay pasture.

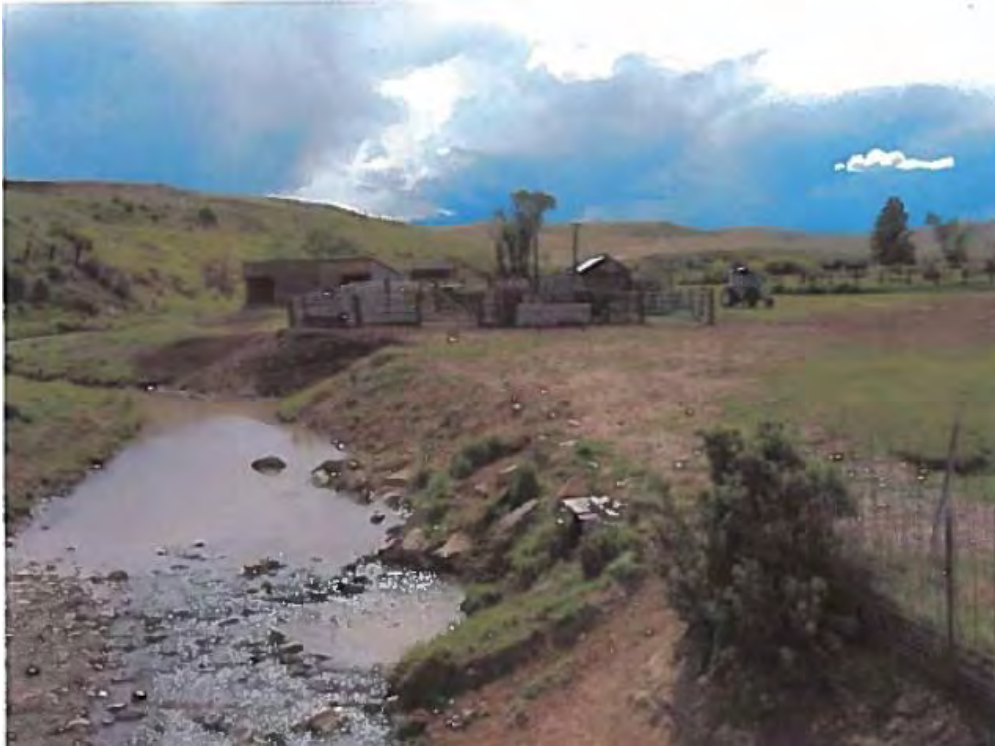
Figure 2-99. On-stream corrals on Volney Creek.

The project entailed moving corrals off Volney Creek, and developing wells to replace Volney Creek as a source of stock water. The goal of this project included improving water quality and fisheries values in Volney Creek, but the expected outcomes extended into Red Lodge Creek and Cooney Reservoir. Red Lodge Creek supports an important brown trout fishery. Cooney Reservoir supports a popular recreational fishery for trout and pan fish, such as black crappie. Nutrient loading into Cooney Reservoir results in periodic algal blooms, which can impair fishing and aesthetics, or result in periods of low dissolved oxygen when the algae decomposes. Concentrating cattle within the corrals had resulted in a severely degraded riparian area, and an overly wide channel that did not provide habitat suitable for a healthy fishery. The corrals were a source of nutrients, and eliminating these inputs would have far reaching advantages, extending from the project site into Cooney Reservoir.

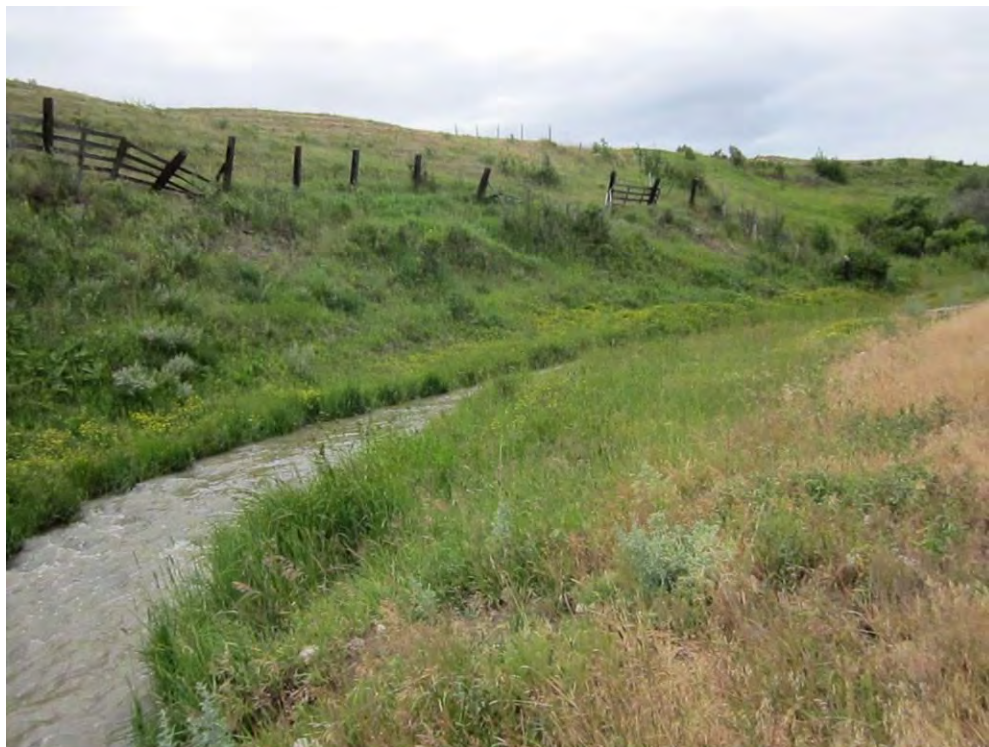
On July 11, 2016, Shannon Bockmon evaluated conditions within the Volney Creek corral relocation project area. All components of the project had been implemented. In the 10 years since project implementation, a narrowing and deepening of the channel was the most apparent sign of recovery (Figure 2-100). Recovery of the shrub community has lagged, although a source for seeds or eventual vegetative recruitment is nearby. As is common in areas with long-term disturbance, noxious weeds continue to infest the project area. The landowner sprays herbicide where she can, and hand pulls weeds close to the stream.

Figure 2-100. Narrow channel and vegetated banks within the former corrals on Volney Creek.
