4 Appendix: Completed Field Forms and Associated Photos

4.1 Bad Canyon Creek barrier repair (003-2005)

FFIP 2016 Field Monitoring Appendix
Field Forms and Geo-referenced Photos
Yellowstone River Watershed

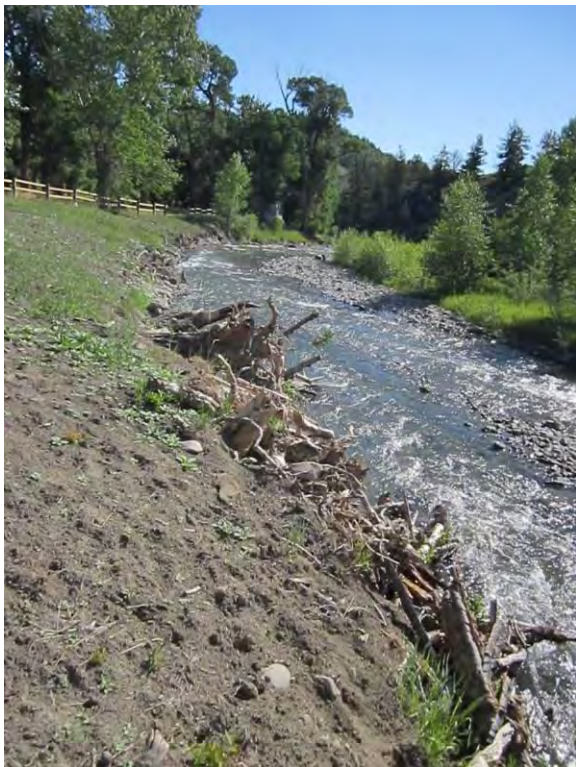
Photo 5. Root wad and log revetment installed in April 2016.

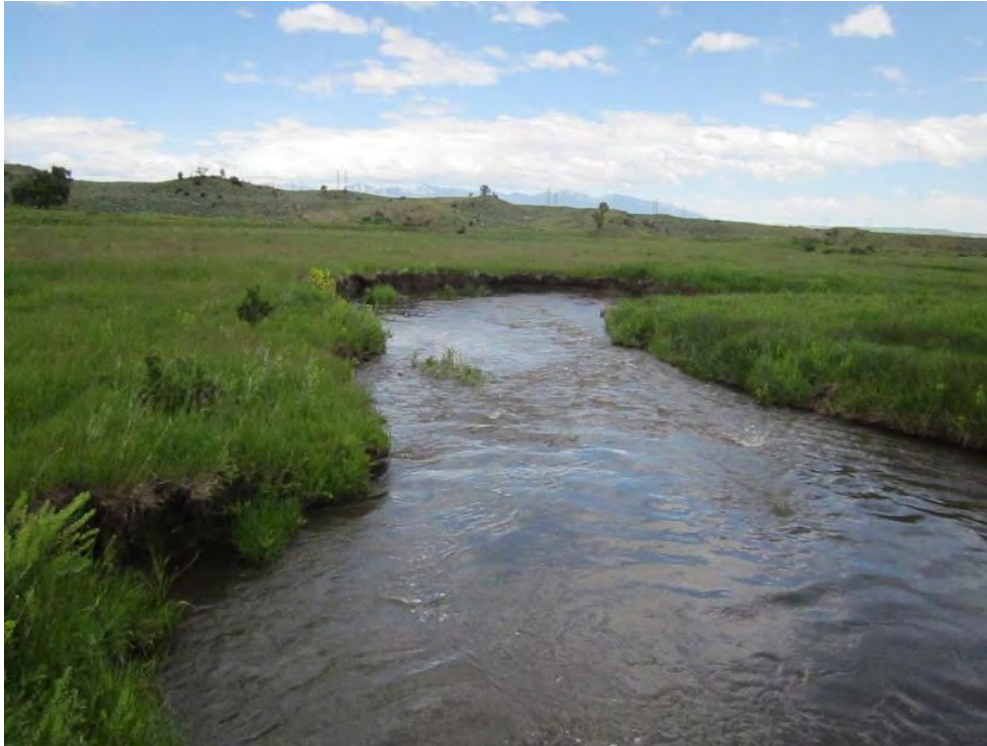
Photo 6. More bank erosion

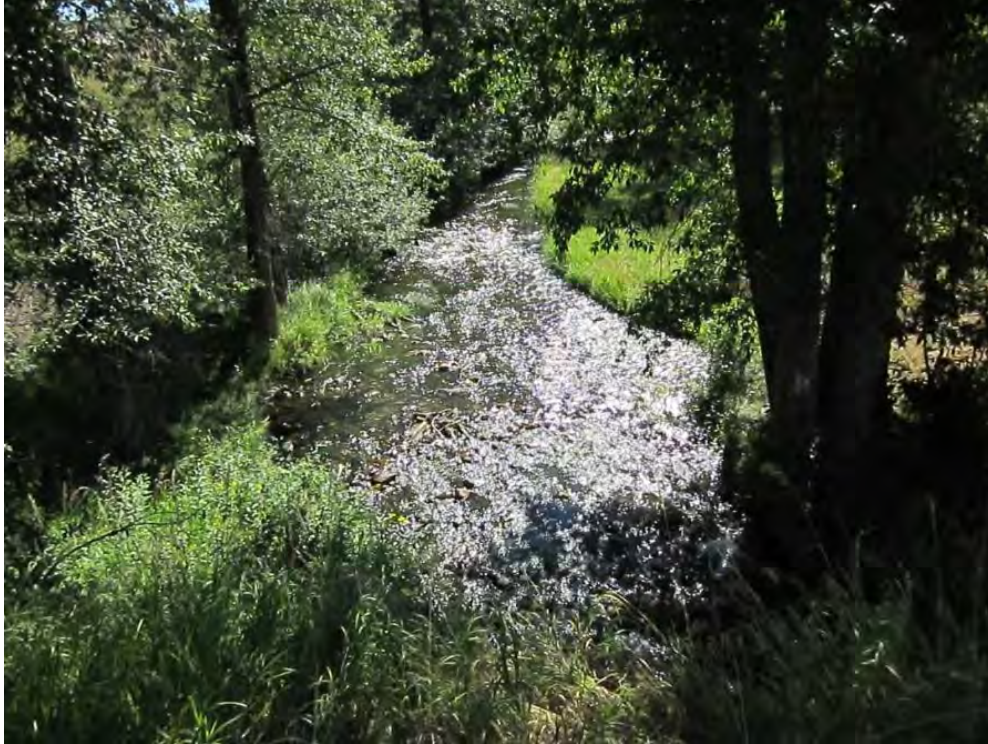
Photo 2. Upstream of culvert and project area.

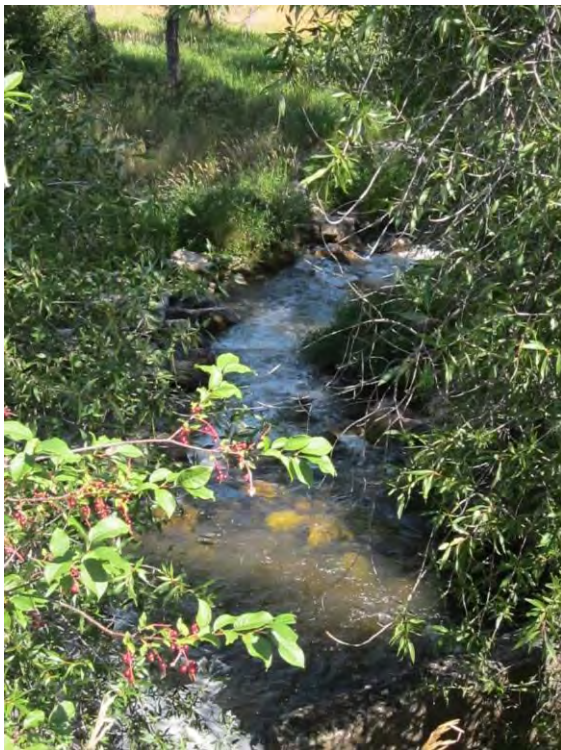
Photo 3. Photo area showing constructed step-pools.

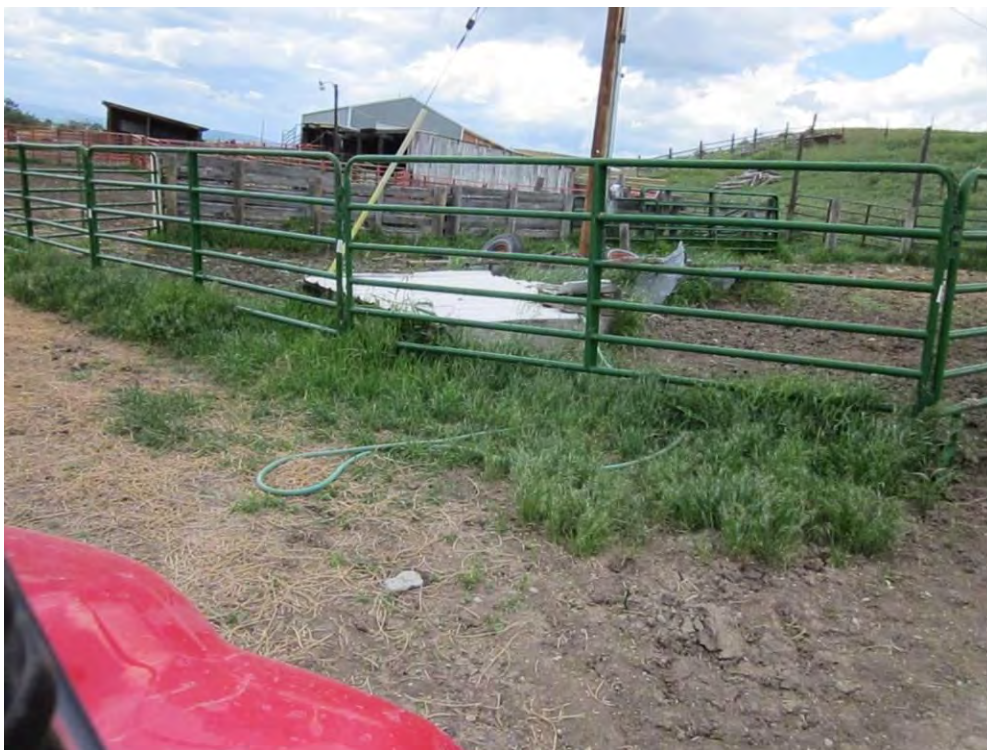
Photo3. Off-channel watering well and pump.

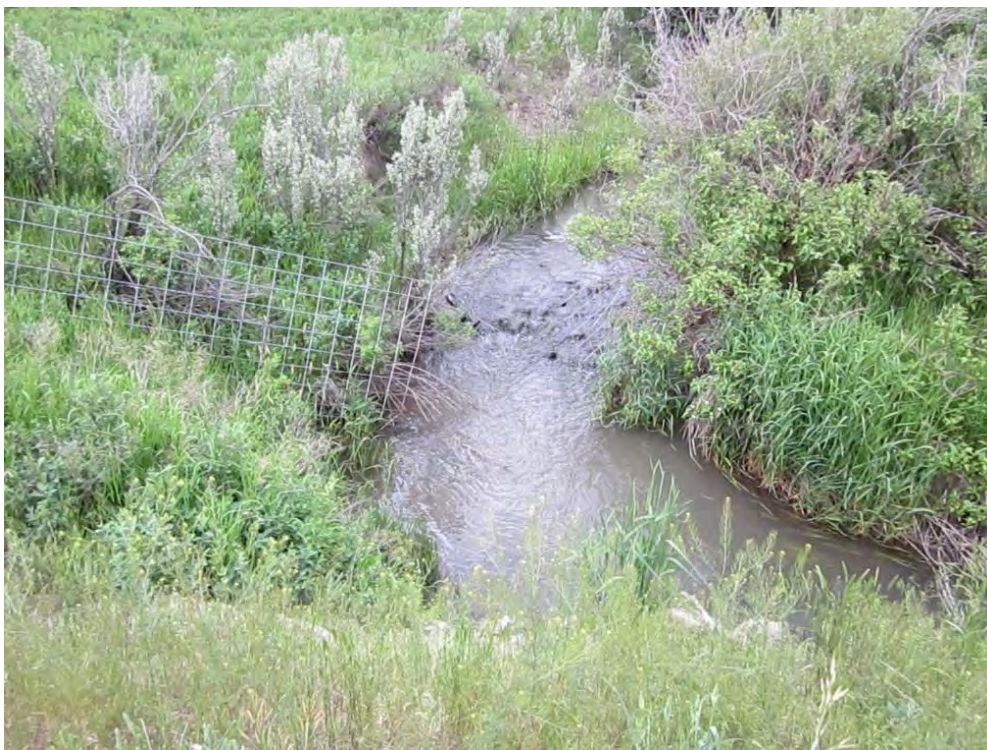
Photo 13. View from road of end of project assessment

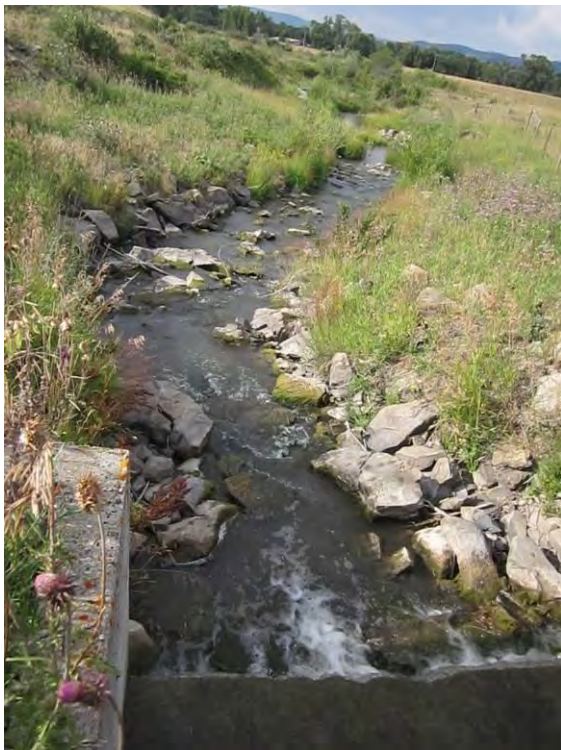
Photo 3: start of project. (head gate on Elk Creek)

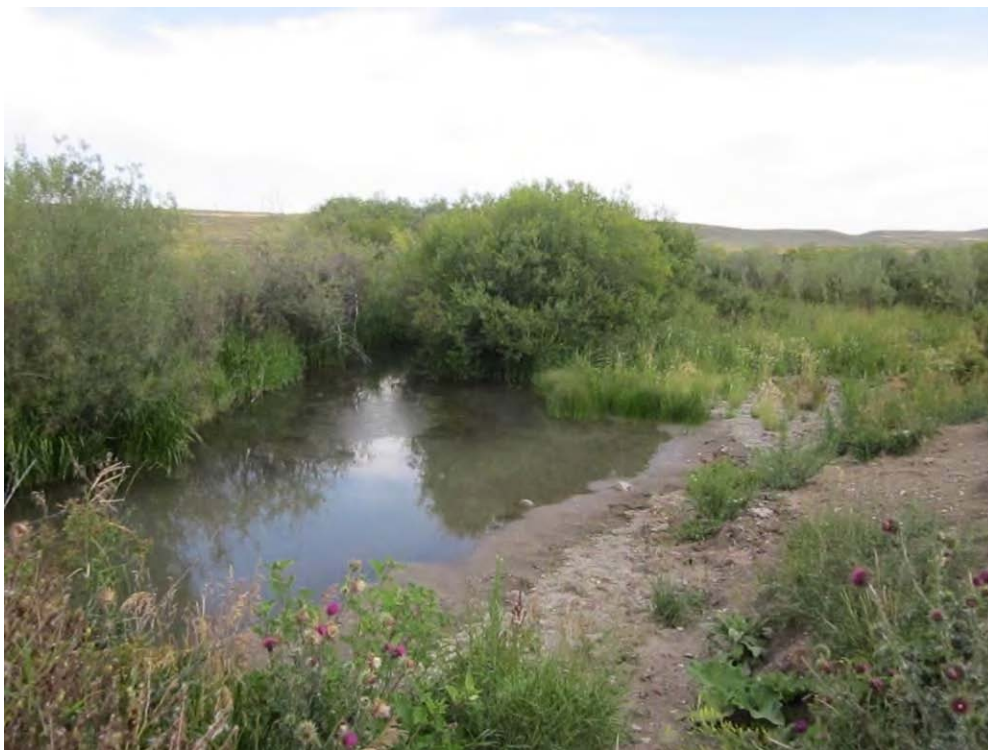
Photo 4: Above head gate

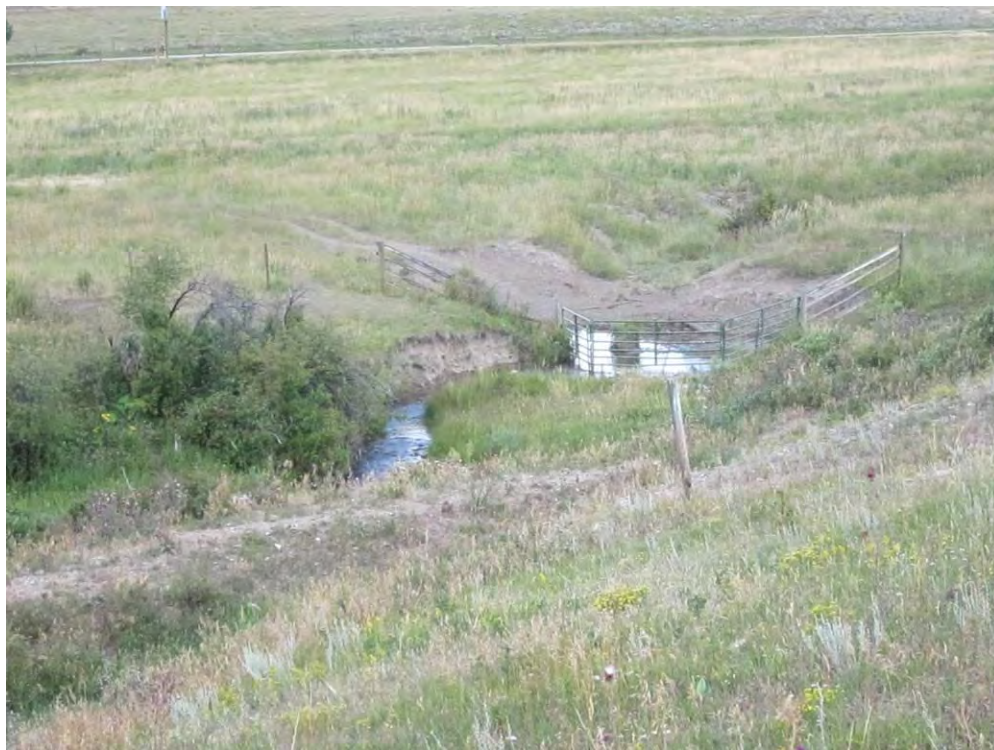
Photo 5: Emergency stock water.

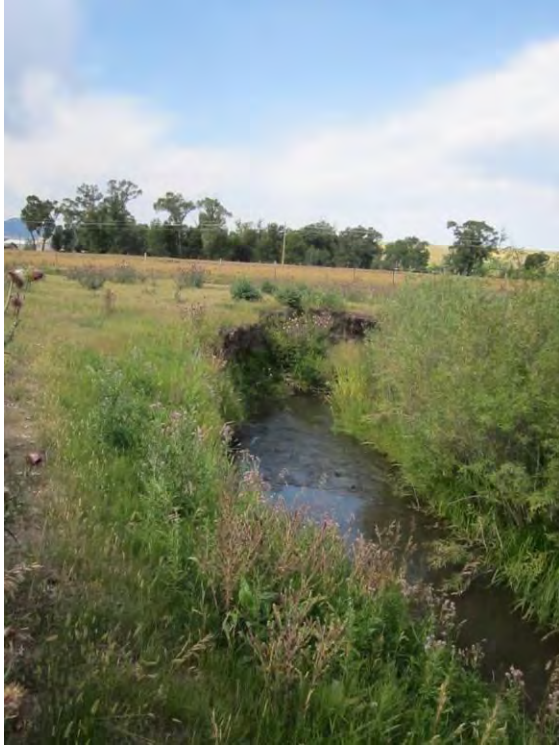
Photo 8: Vertical banks. (no lateral shifting according to landowner)

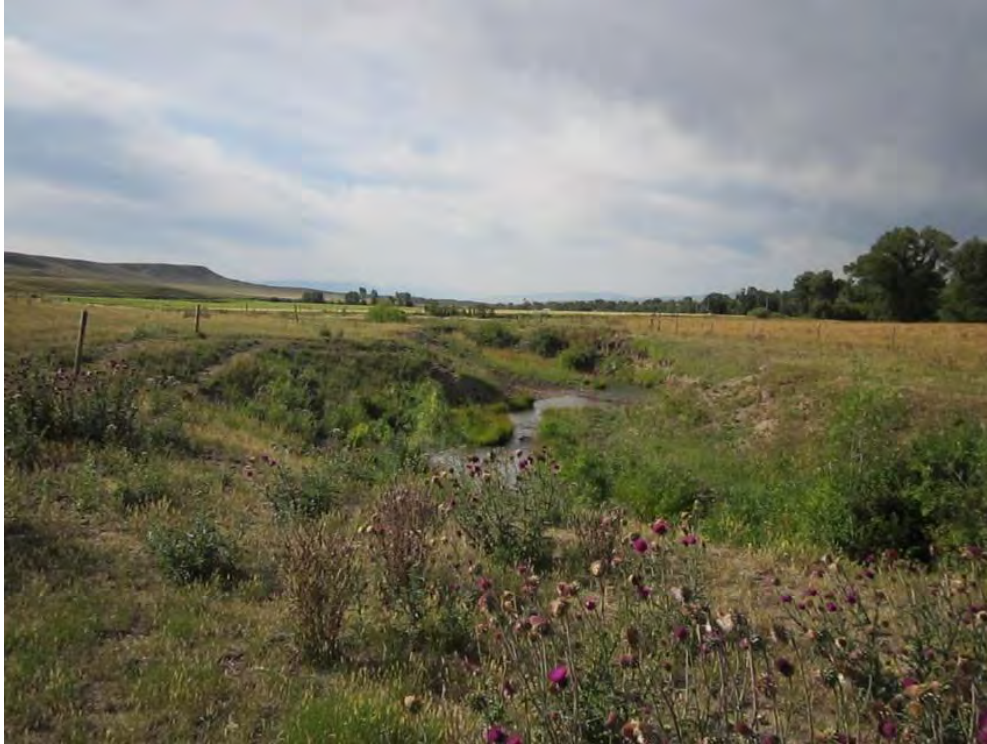
Photo 12: Over view of lower end of project.

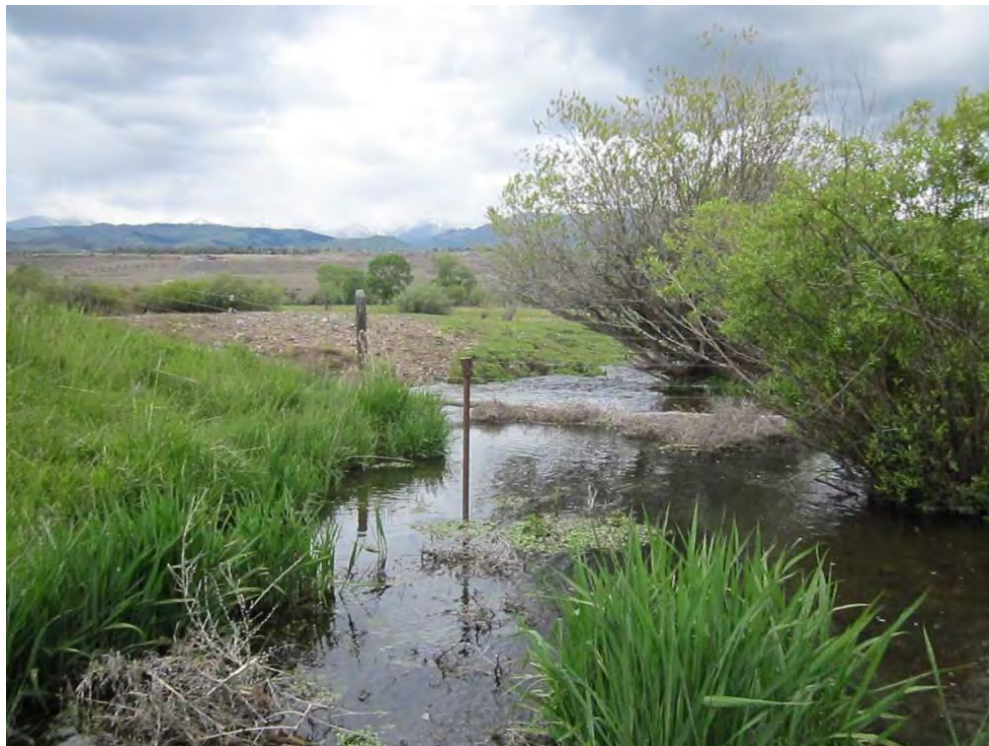
Photo 1: Lower end of exclusion.

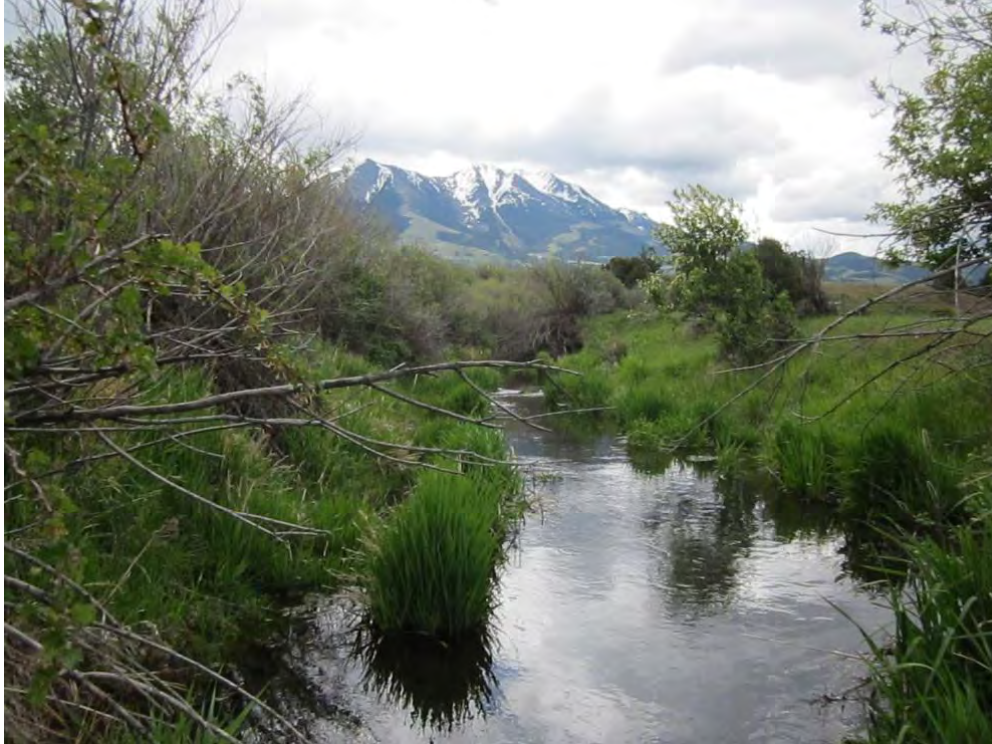
Photo 2: Upstream view of lower end of project.

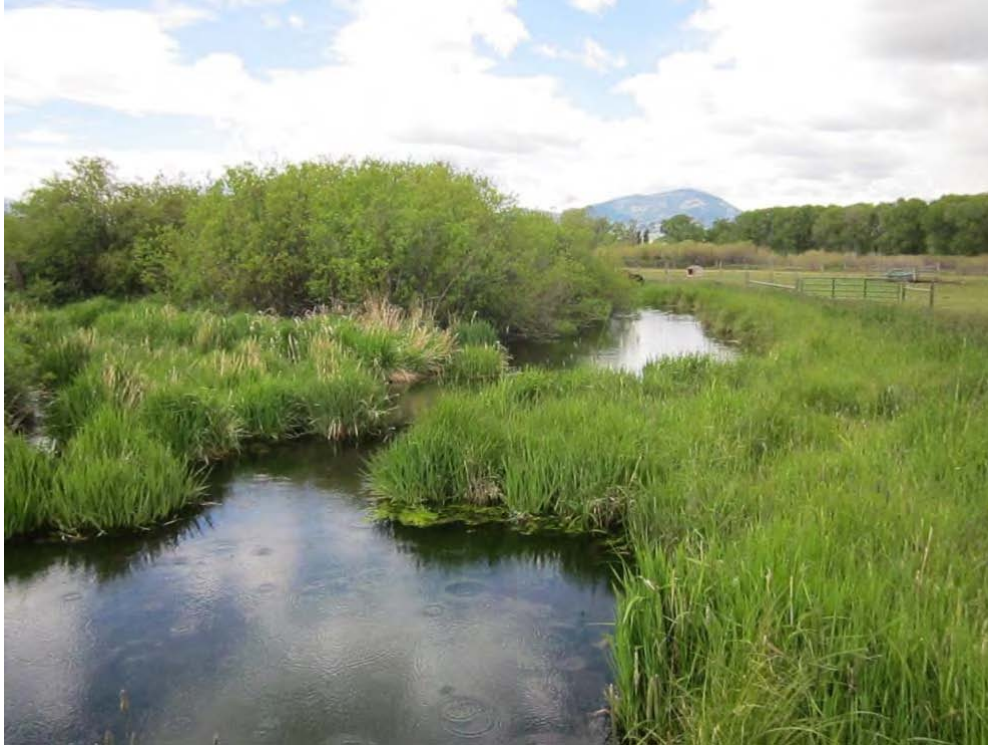
Photo 10: Upper end of enclosure.

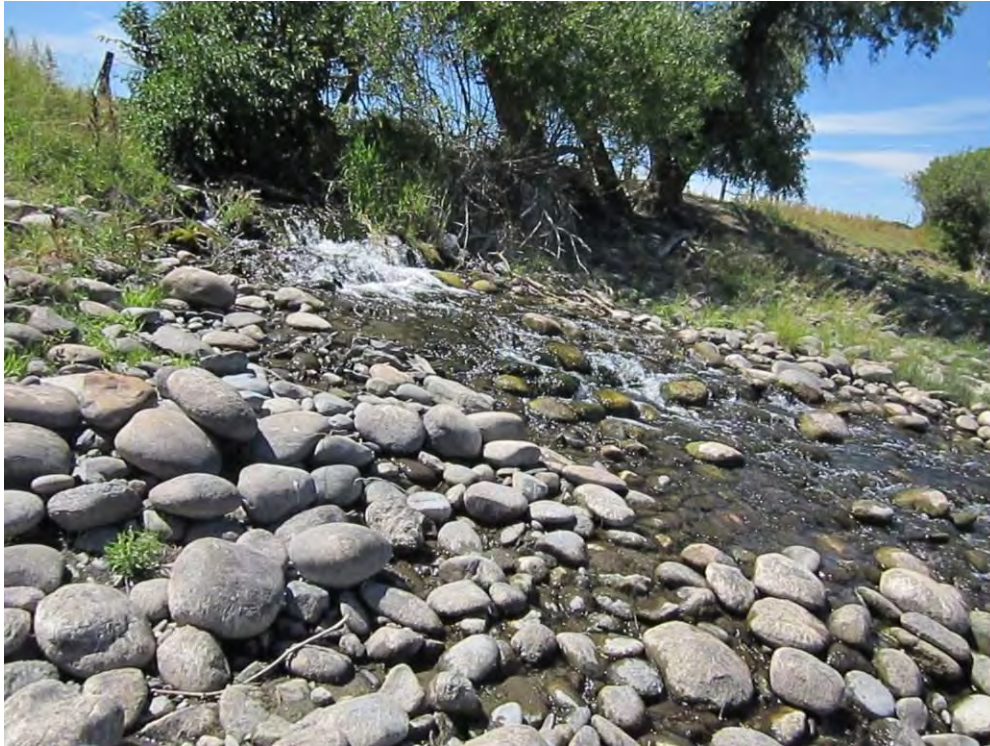
Step pools at the confluence looks passable still, but some of the large rocks that were placed there have been displaced most likely by ice jams.
 Willow recruitment is high. Chuck Roloff said that the current willow density is a total 180 from when he was working on the project.
 Good sections of spawning gravel though out sections. Some aquatic plants are present, but there is plenty CFS to flush areas of spawning habitat.
 Cattle do have access to a section for drinking/crossing. Area is very degraded. But is needed with out having off channel water
 Hounds tongue, Canada Thistle, Milk weed present in high numbers within enclosure.
 Would recommend shocking the stream in the future to obtain an up to date data set of what is currently using the stream. Last documented survey was in 2000.

Photo 2: Start of project should have step-pools, but larger rocks have been displaced do to possible ice jams.

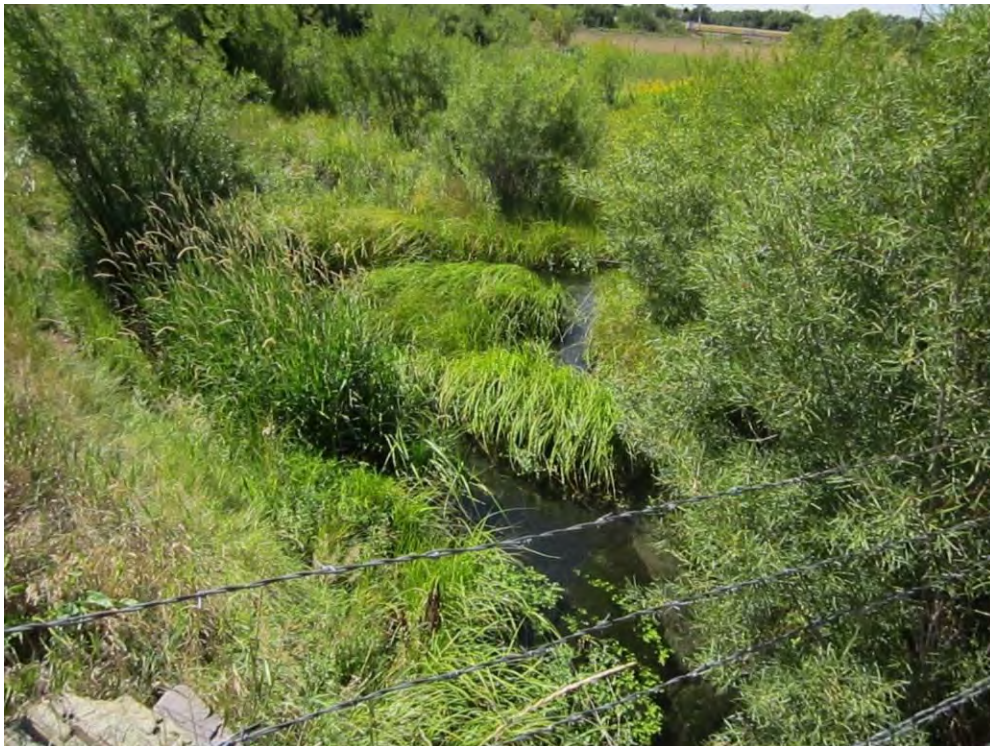
Photo 3: project above the downstream culvert.

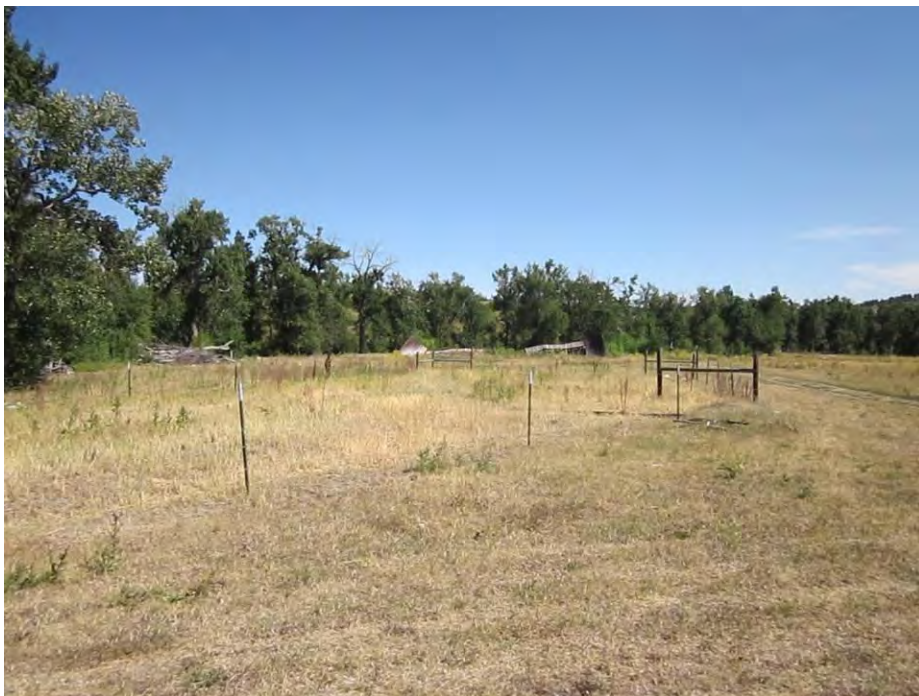
Photo 1: Riparian fencing and berm.

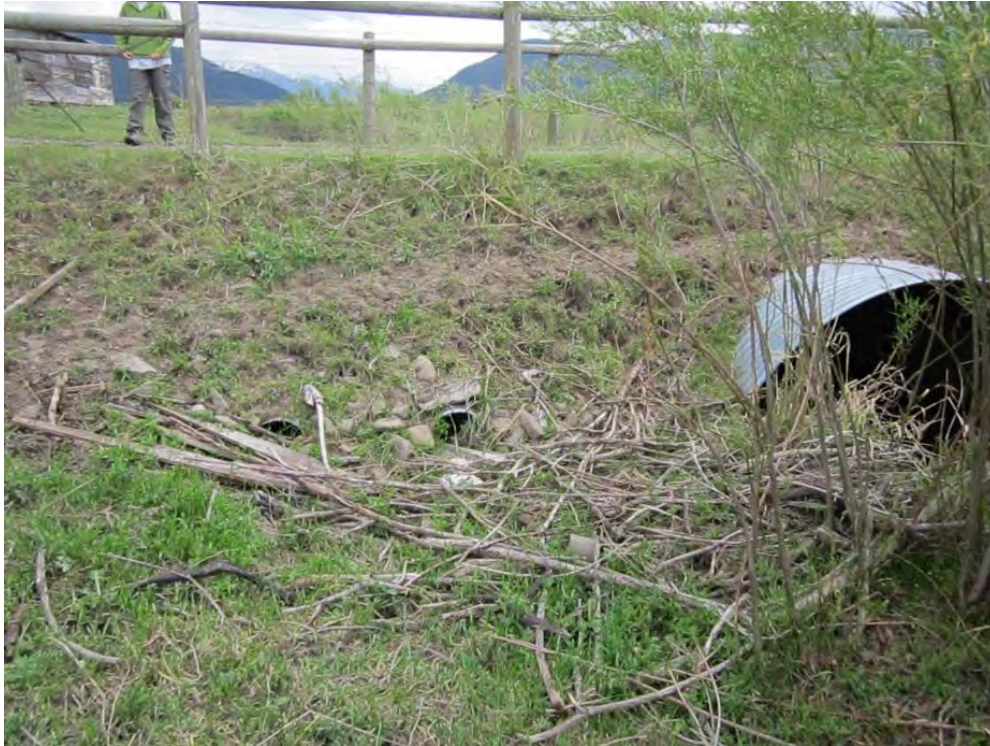
Photo 6: Bottomless culvert and overflow.

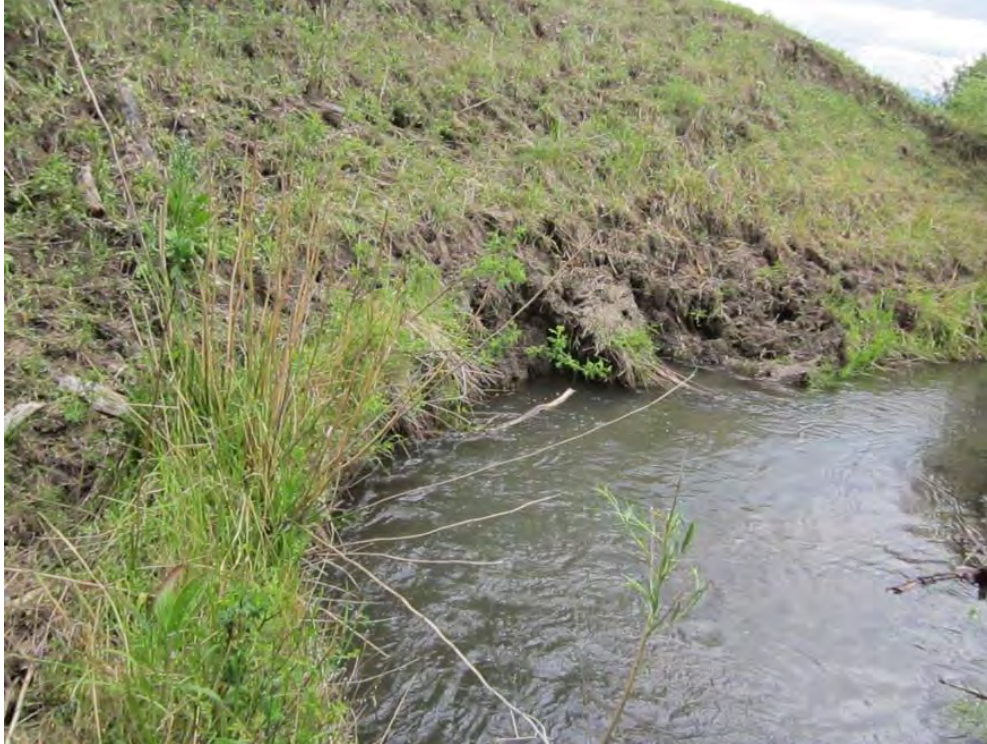
Photo 8: Cattle trail resulting in bank erosion.

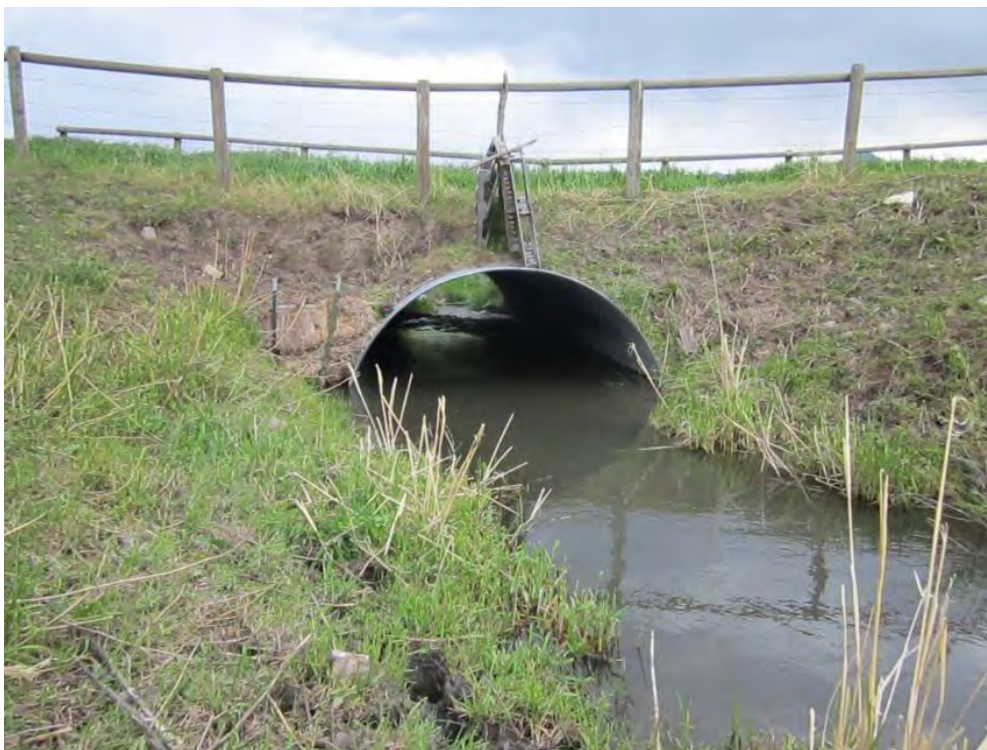
Photo 9: Second bottomless culvert.

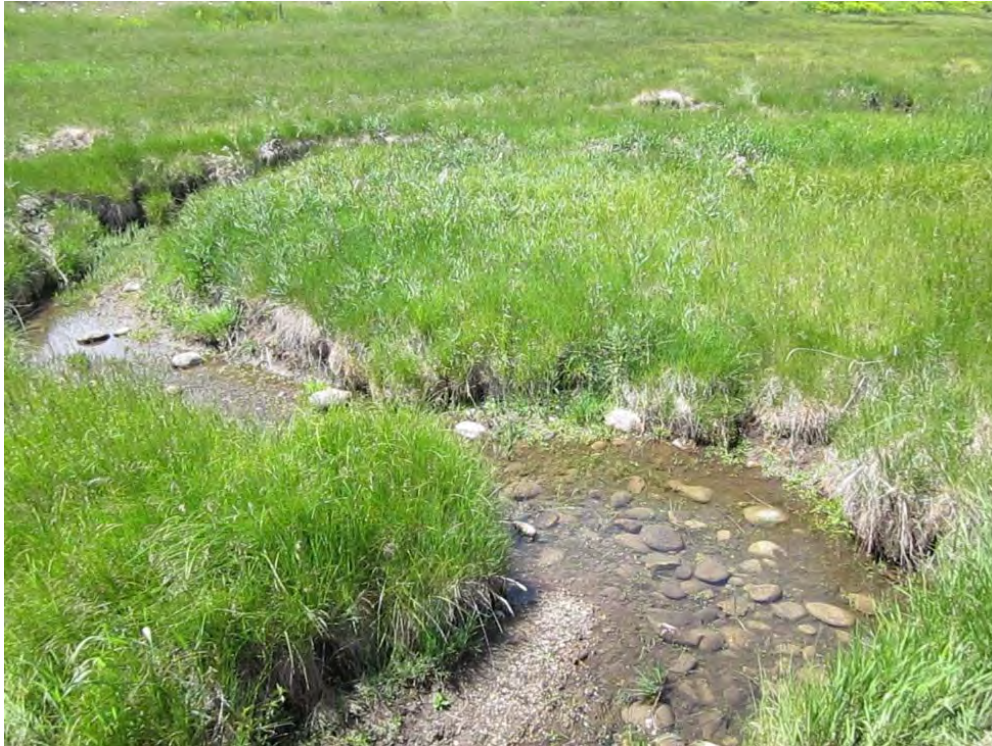
Photo 2: Start of project area.
