Future Fisheries Improvement Program Monitoring

2017

Future Fisheries Improvement Program
Project Monitoring 2017

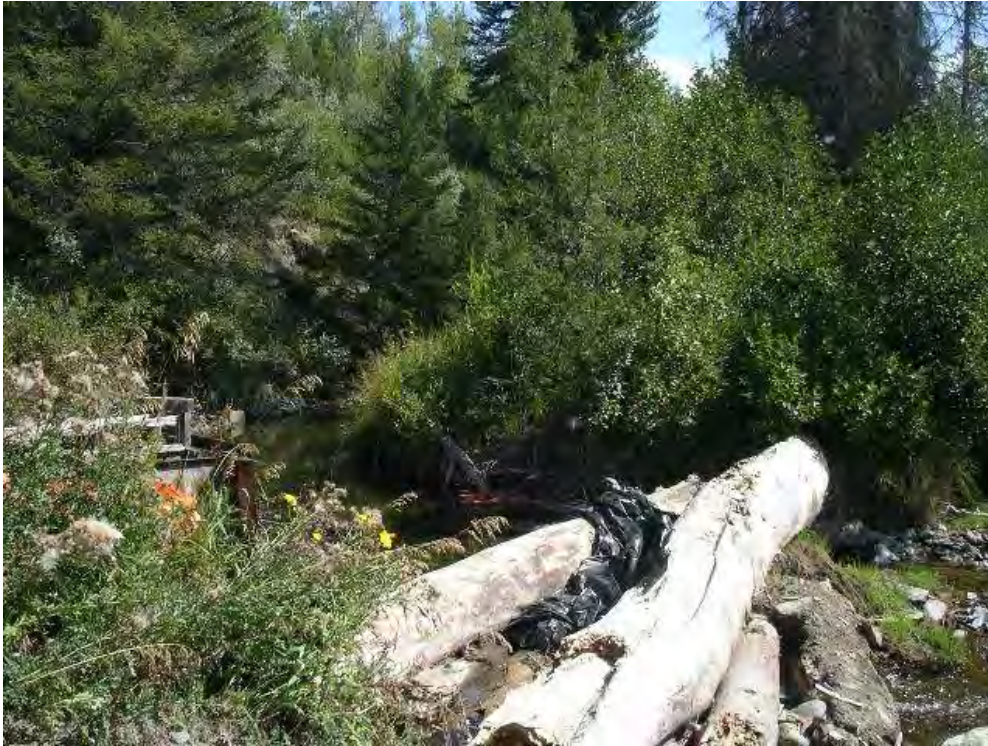
Pre-project photos document large logs with tarps backwatered the stream to deliver to the diversion (Figure 3). Considerable water leaked through the check boards at the head gate (Figure 4). The water savings with replacement of the leaking check boards with a Waterman gate would be beneficial and an appropriate use of FFIP funds.

Figure 3. Logs checking Cottonwood Creek's flows to deliver water to the pin and plank head gate.

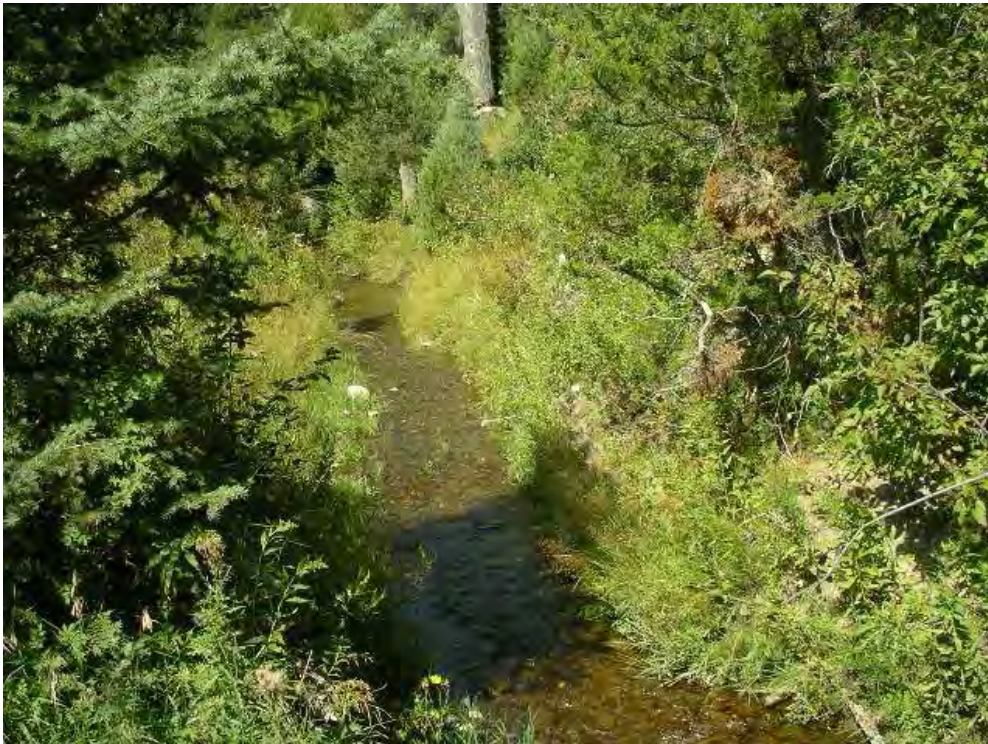
Figure 4. Water leaking into ditch on Cottonwood Creek when check boards were blocking flow.

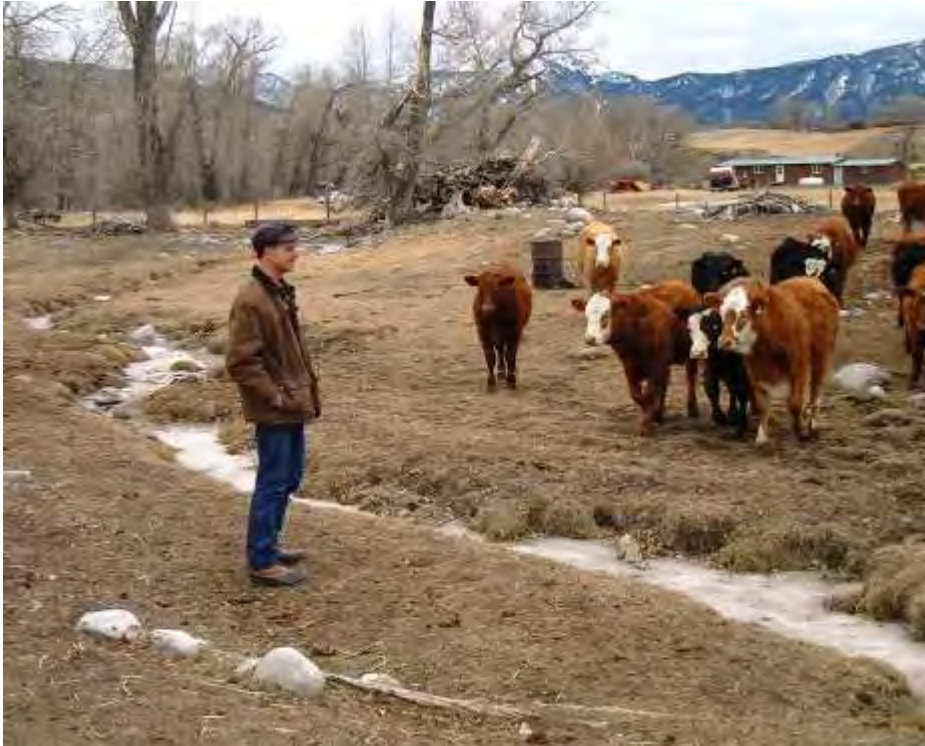
Pre-project photos illustrate the heavy use by livestock, trampled banks, and near lack of vegetation along the stream and within the corrals (Figure 6 and Figure 7). This corral meets the EPA's criteria as a point source of pollution, and the combination of bank erosion and accumulation of manure made this stream a source of nutrients and sediment to the East Boulder River. In addition, in its pre-project condition, the stream provided exceptionally poor habitat for fish.

Figure 6. Pre-project photo for the East Boulder Spring Creek channel realignment and stock water project.

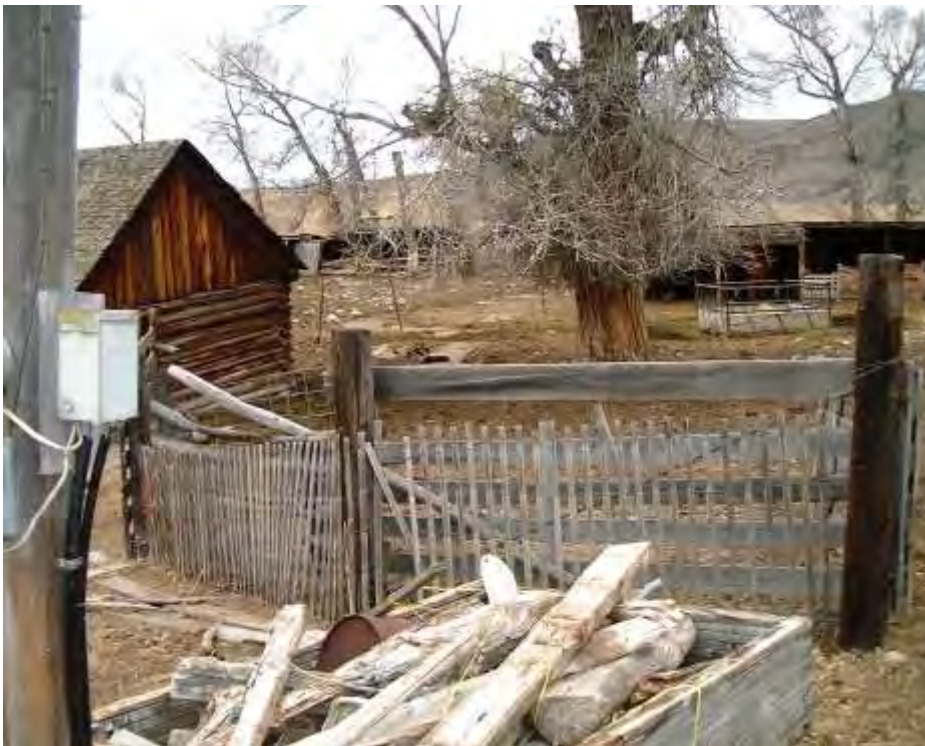
Figure 7. Corrals on East Boulder Spring Creek.

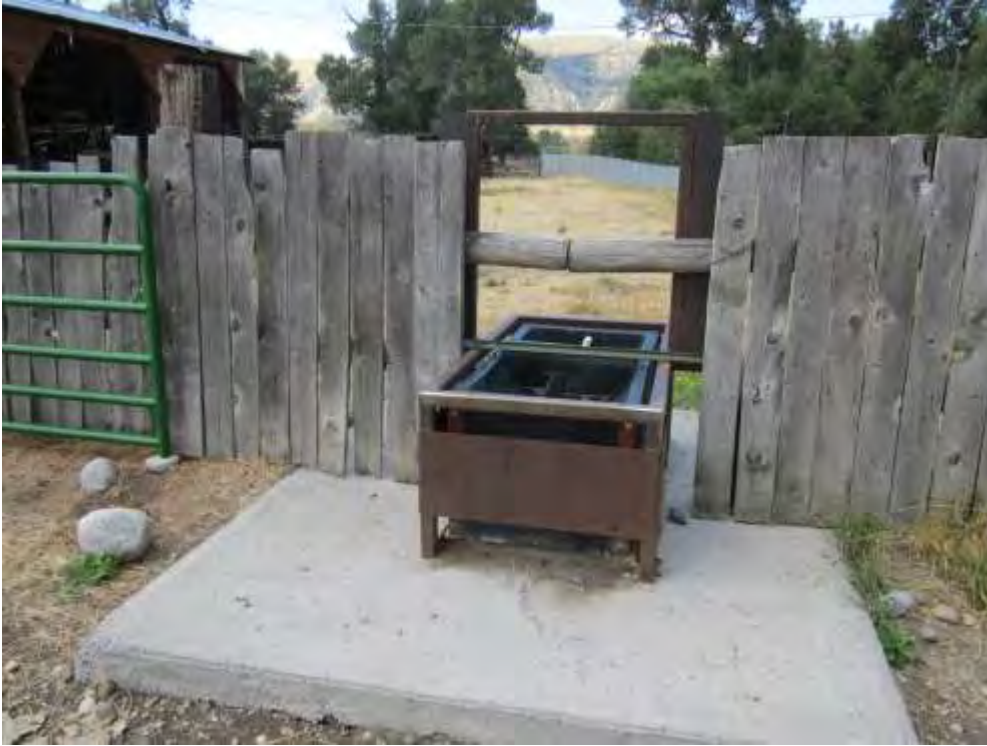
Figure 9. Example of an off-stream water source for corrals installed as part of this project.

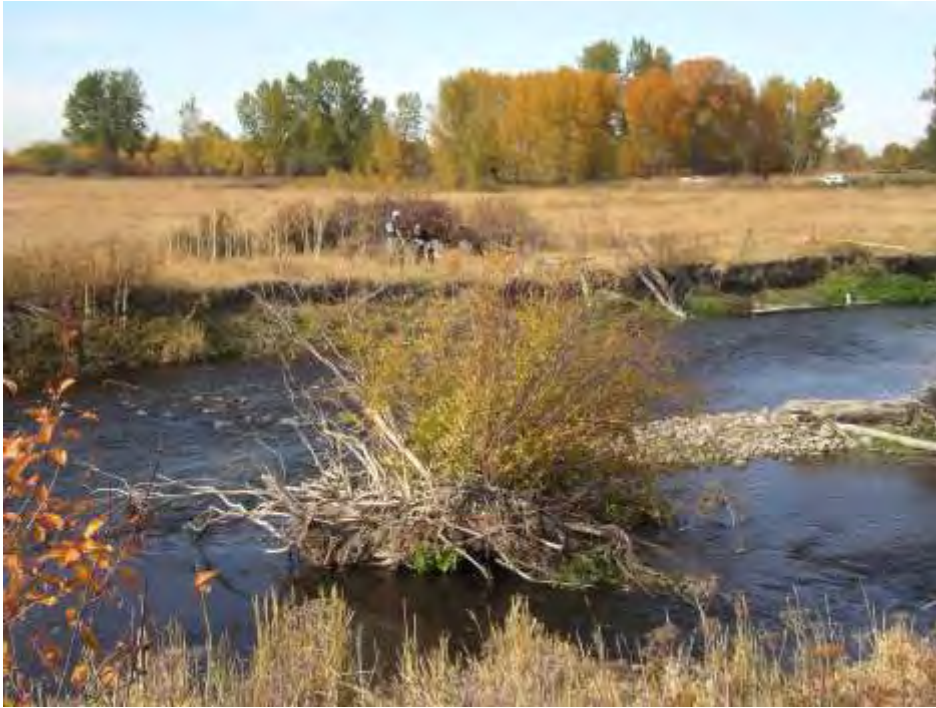
Figure 10. Mid-channel bar that was exerting pressure on banks 1 and 2 on the East Gallatin River.

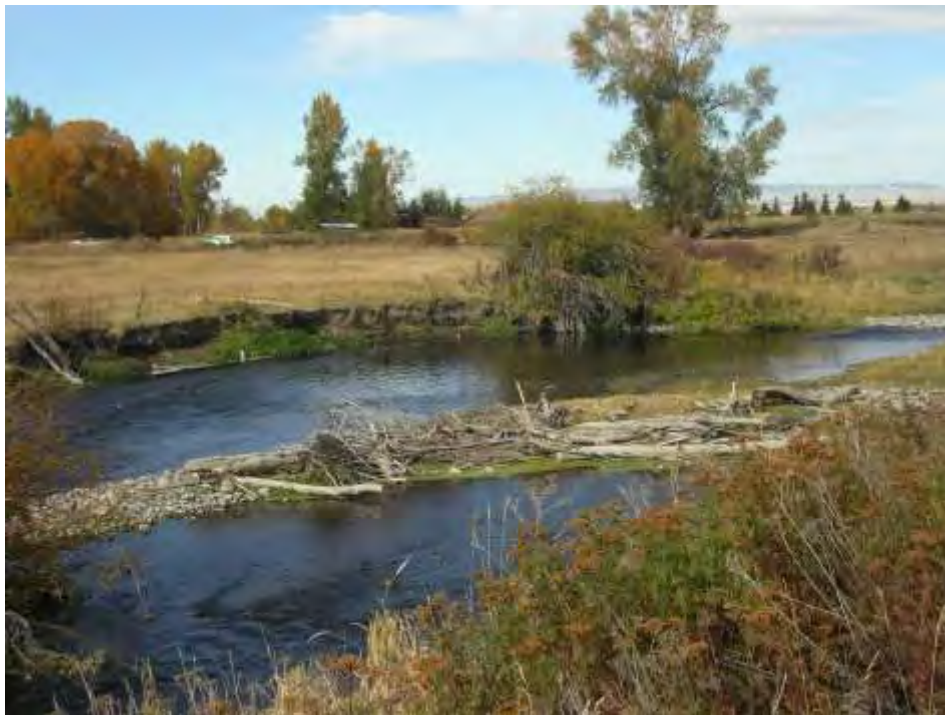
Figure 11. Mid-channel bar that was exerting pressure on banks 1 and 2 on the East Gallatin River.

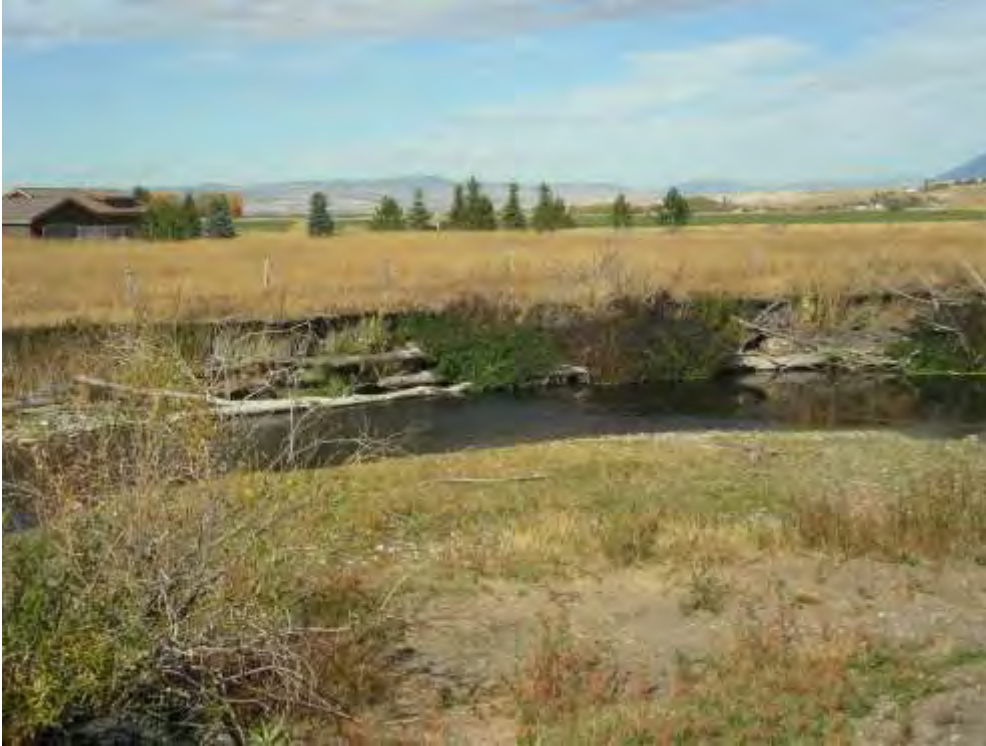
The third bank was on the outside of a meander bend and had vertical, eroding banks with slight protection afforded by woody debris and sparse shrubs. The cottonwoods were from an earlier attempt to stabilize this reach by anchoring large wood into the bank. Much of the large wood had been swept away, and the bank was laterally mobile.

Figure 12. Bank 3 on the East Gallatin River, showing cabled in cottonwoods that were part of an earlier bank stabilization effort.

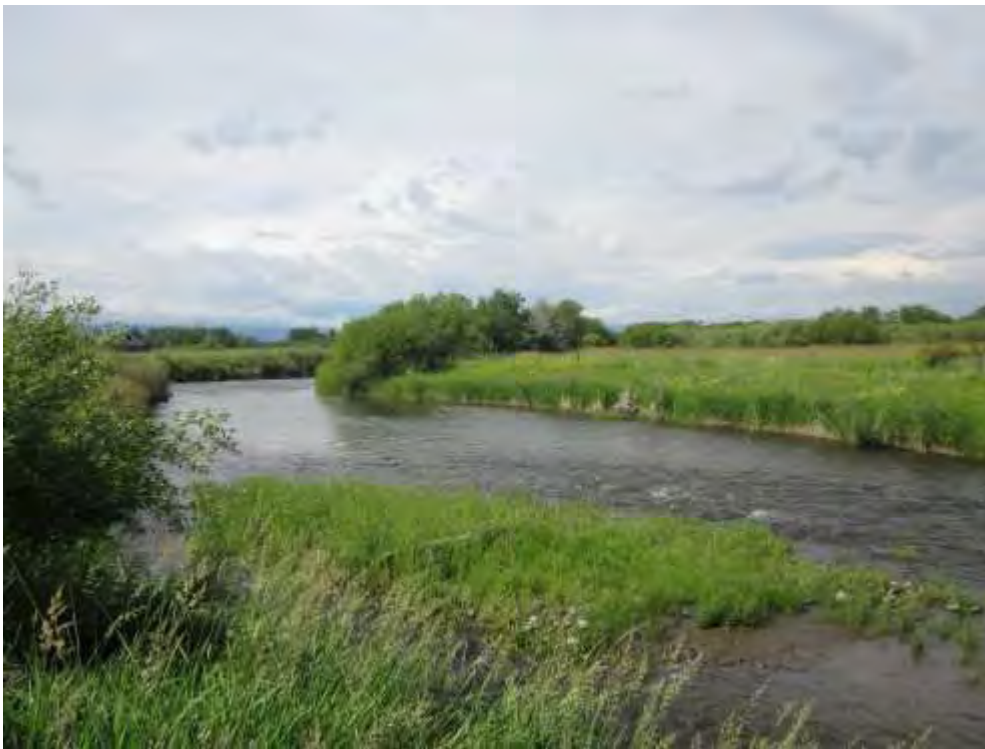
As described above, bank 1 was re-sloped, covered with erosion control fabric, revegetated, and stabilized at the toe with installation of rock modeled to be mobile at a 20-year recurrence interval event. This bank was stable with grasses and sedges providing most of the vegetative cover (Figure 17). The erosion control fabric was no longer visible and had likely decomposed with recovery of the bank vegetation, as is the intent when using this biodegradable material. The bank margin was vertical, with a 10-inch, 90° bank angle. The rock placed at the toe had been transported from under the bank, resulting in a stable undercut, which is an important habitat feature for fish. Fencing protected the bank from livestock over-use, and hoof shear or obvious types of disturbance from livestock were absent. A gravel bar had formed closed to the opposite bank; however, it was considerably smaller than the bar that had been excavated, and was not apparently exerted erosive force on banks 1 and 2.

Figure 18. Reestablished gravel bar near bank 1.

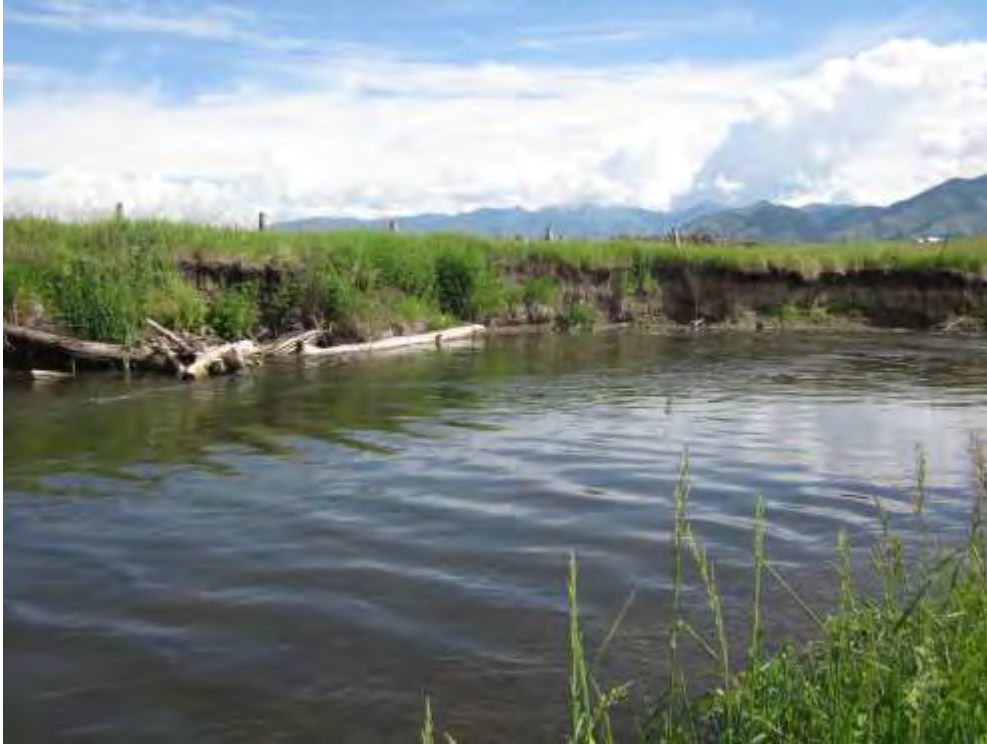
The third bank treatment entailing cabling juniper revetments to existing cottonwood logs was unsuccessful. Most of the cottonwood and junipers had washed away, the vertical, eroding banks were about 5-ft. high, and a hanging fence post were indicative substantial lateral adjustments (Figure 20). The juniper revetment treatment was unsuccessful in meeting project objectives.

Figure 20. Bank 3 on the East Gallatin River bank restoration project.

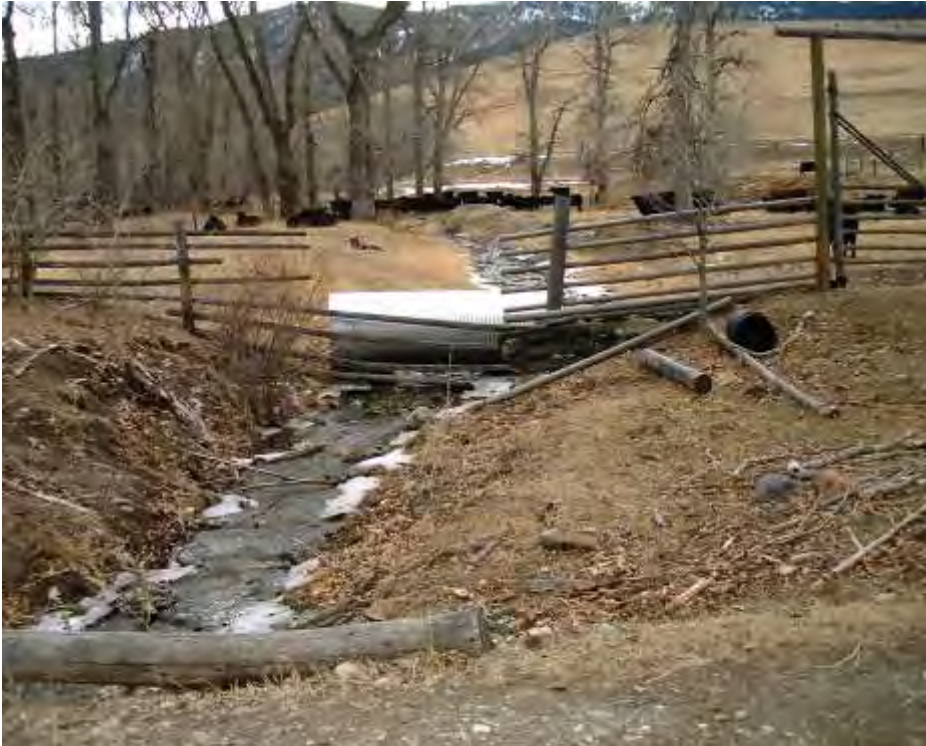
Pre-project photos a small, straightened spring creek that had experienced heavy, long-term disturbance by cattle. The stream was surrounded by bare ground, or closely cropped grasses (Figure 22). Hoof shear

was present and contributed to loading of sediment into the stream. Concentrating livestock on this small stream resulted in accumulation of manure. The absence of a healthy riparian area meant the functional attributes of filtering sediment and nutrients, providing shade and fish cover, and maintaining channel form and function were entirely disrupted.

Figure 22. View of the spring creek before project implementation.

The solution to reduce or eliminate contributions of sediment and nutrients from this spring creek was to divert 80 ft. of the stream into an underground pipe. Installation of a stock tank provided an alternative water source. A fence was installed to manage cattle's access to Elk Creek.

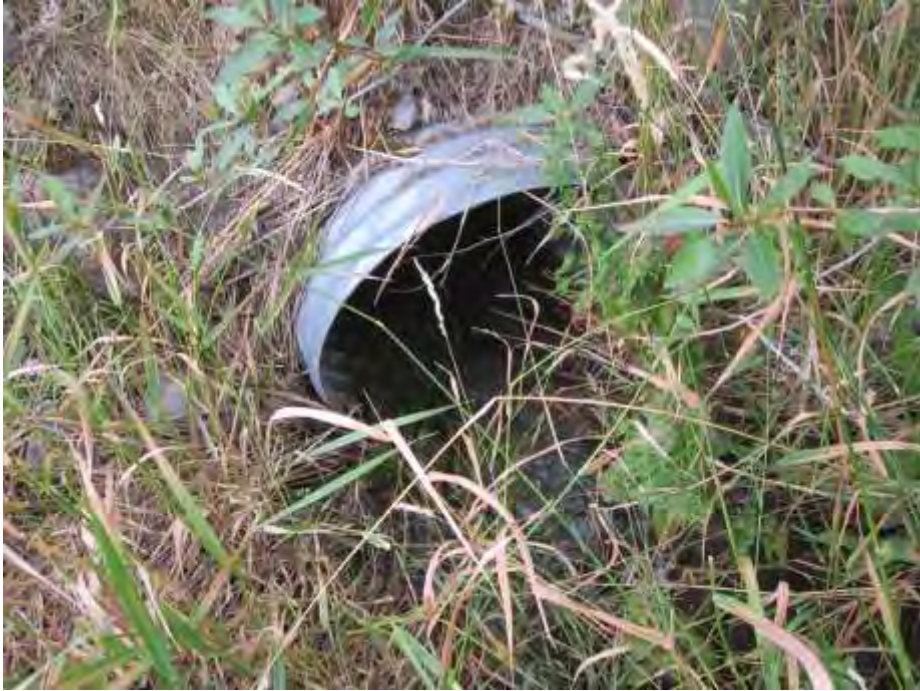
Kyrsten verified the stream had been piped under the corrals, and that alternative stock water had been provided. The inlet and outlet of the pipe were easily located (Figure 24 and Figure 25). In addition, the stock water component of the project had been installed (Figure 26), and cattle no longer relied on surface water, which eliminated bank trampling and near-stream sources of sediment and nutrients. The operator reported the waterer occasionally clogged, but regular maintenance easily remedied this problem.

Figure 24. Inlet of pipe that passes the unnamed spring creek under the corrals adjacent to Elk Creek.

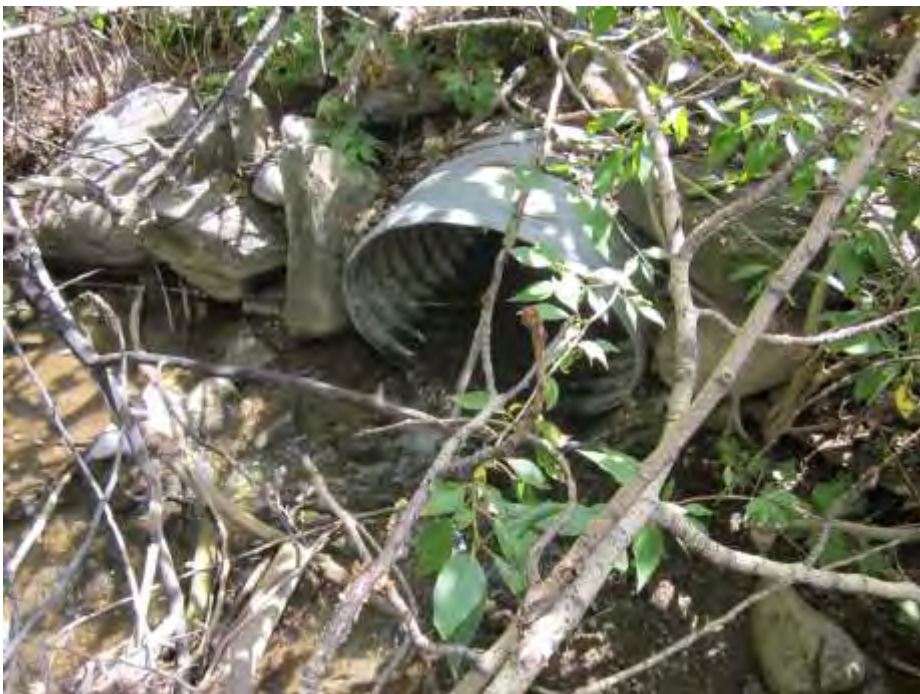
Figure 25. Outlet of pipe that passes the unnamed spring creek under the corrals adjacent to Elk Creek.

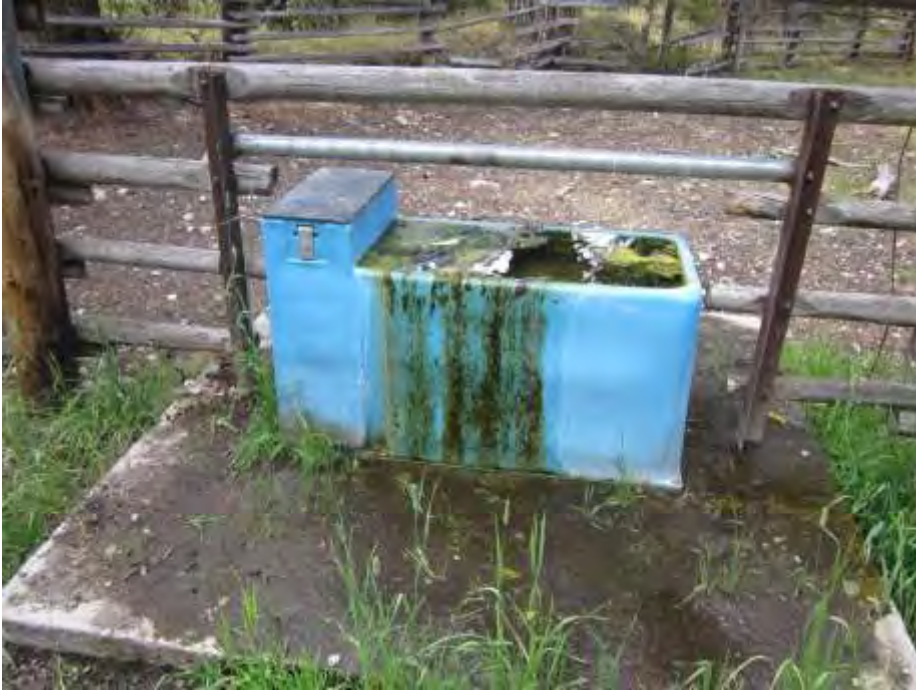
Figure 26. Off-stream stock water of the Elk Creek spring creek bypass project.

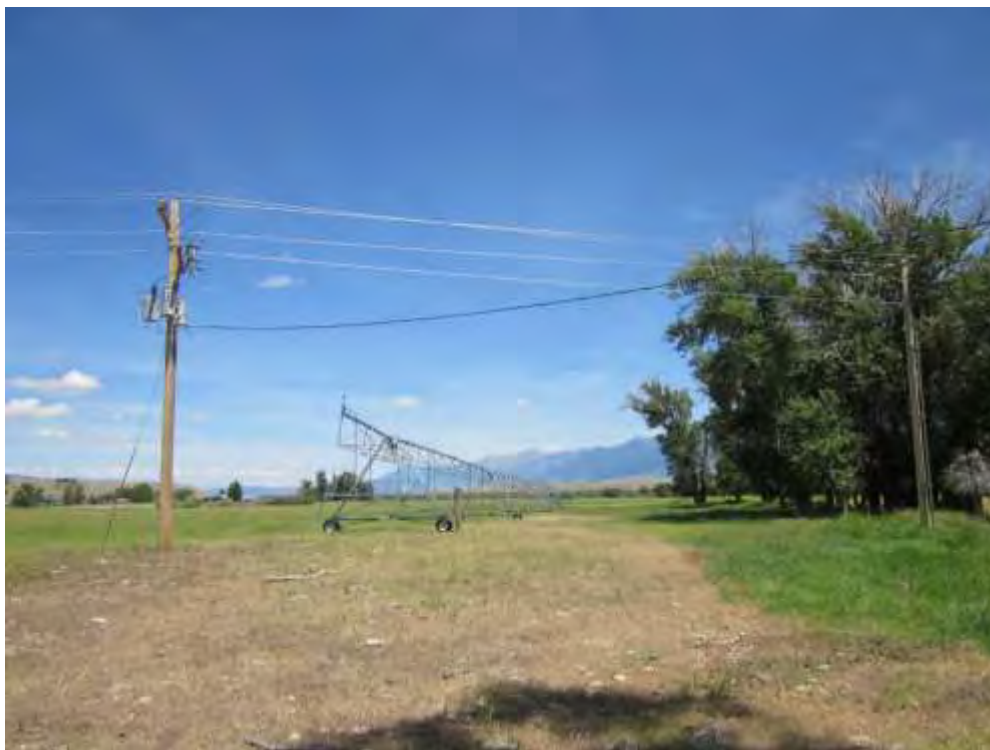
The water savings portion of the project was also implemented and still being used. Aerial photos show the center-pivots and location of the well that supplied the pivots with water (Figure 32). On-the-ground observations further confirmed the presence of the irrigation system installed to replace water diverted from North Fork Fridley Creek (Figure 33 and Figure 34).

Figure 33. Center pivot installed as a water savings measure for North Fork Fridley Creek.

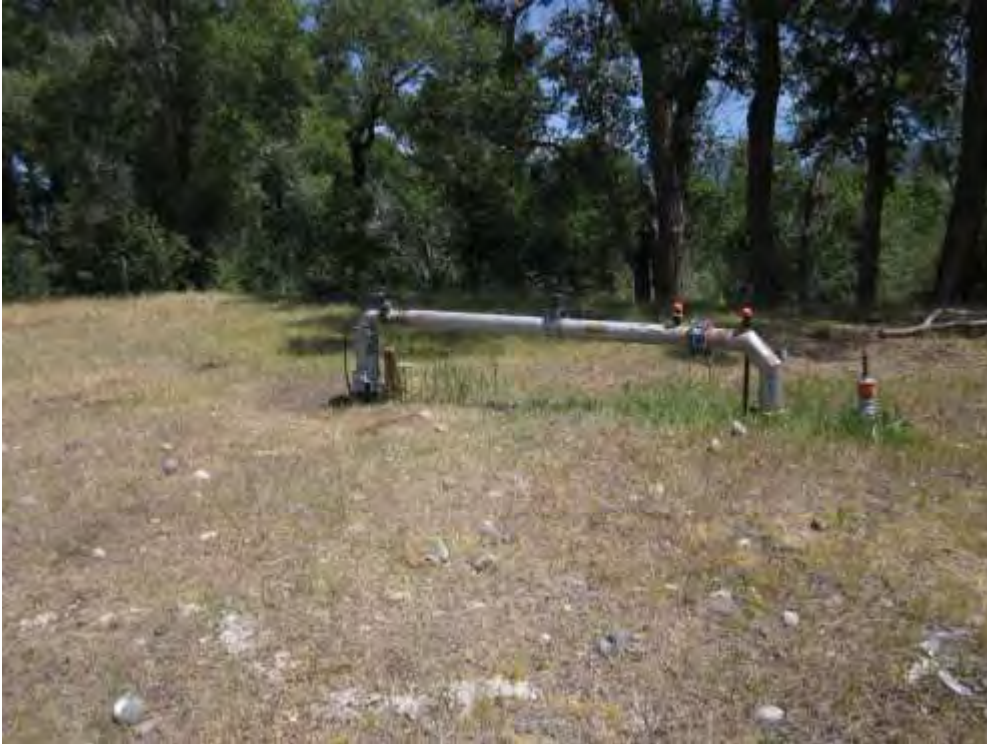
Figure 34. Pumping station supplying water to center pivots.

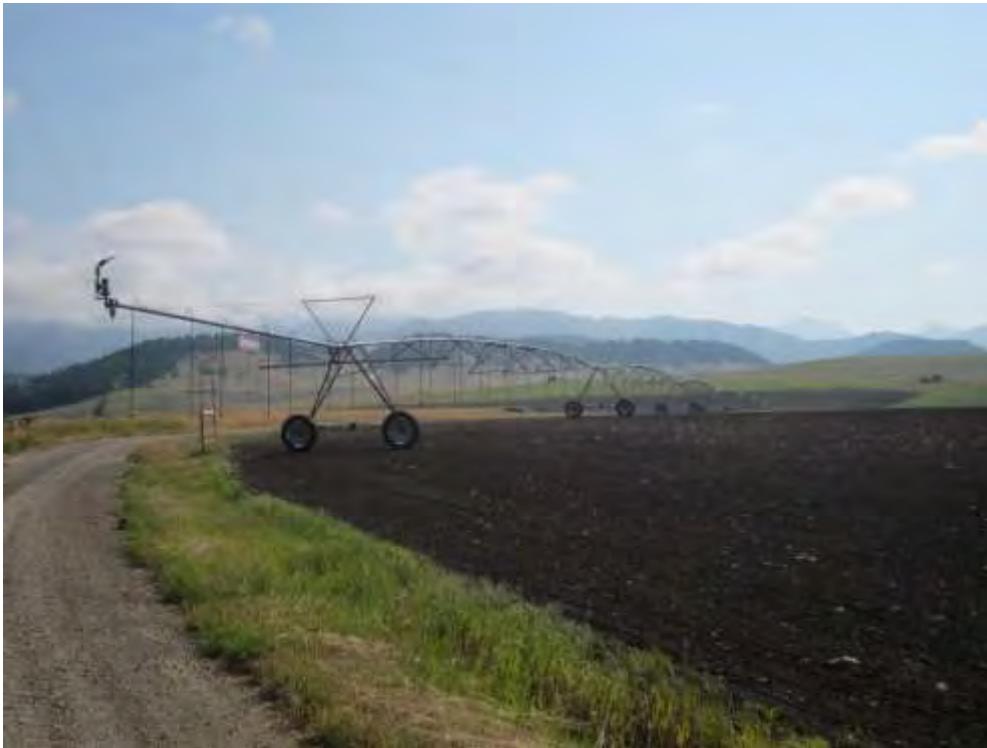
On June 22, 2017, Kyrsten Wolterstorff visited the project site. The center pivot was in place and being used to irrigate a hay pasture (Figure 35). Although not photographed, the pipe diverting water to the center pivot was in place at the fish screen (2.8 North Fork Horse Creek Fish Screen (022-04)) and delivering water through the pipe eliminated evaporative water loss or seepage.

Figure 35. Center pivot near North Fork Horse Creek.

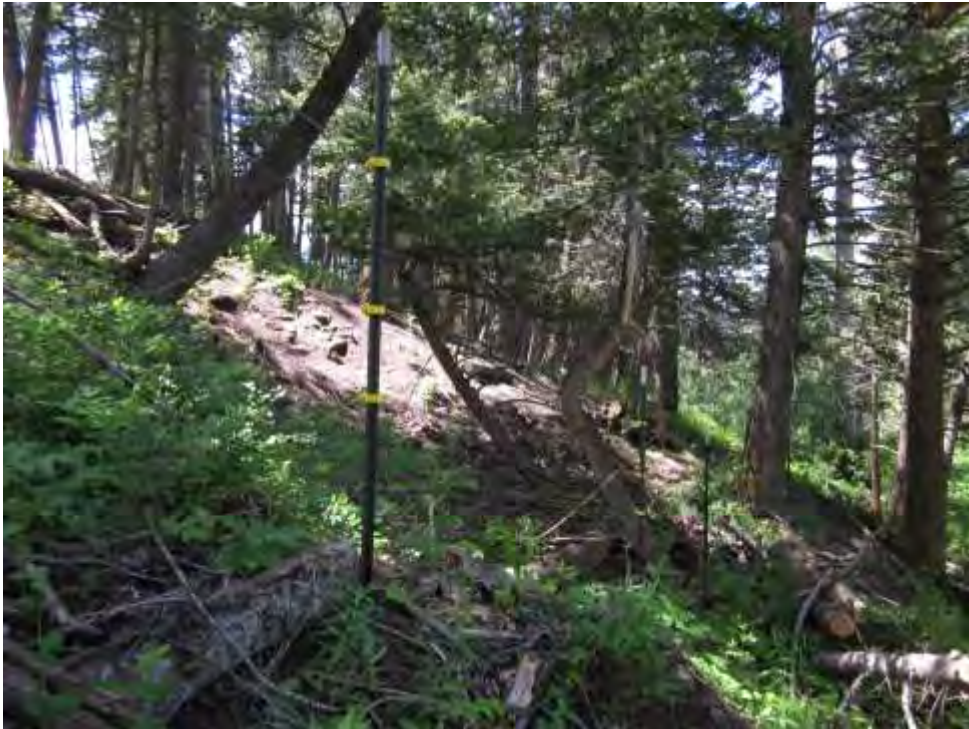
On June 22, 2017, Kyrsten Wolterstorff and Carol Endicott visited the property to determine if the fencing had been installed and evaluate the condition of the stream and riparian area. A robust fence had been constructed down-gradient from the bench and was an effective barrier to livestock (Figure 40). This hillslope showed no evidence of disturbance by livestock. This area had a dense, coniferous overstory, with a robust understory of herbaceous vegetation and mixed-aged shrub community (Figure 41).

Figure 40. New fence installed to prevent livestock from accessing North Fork Horse Creek from bench.

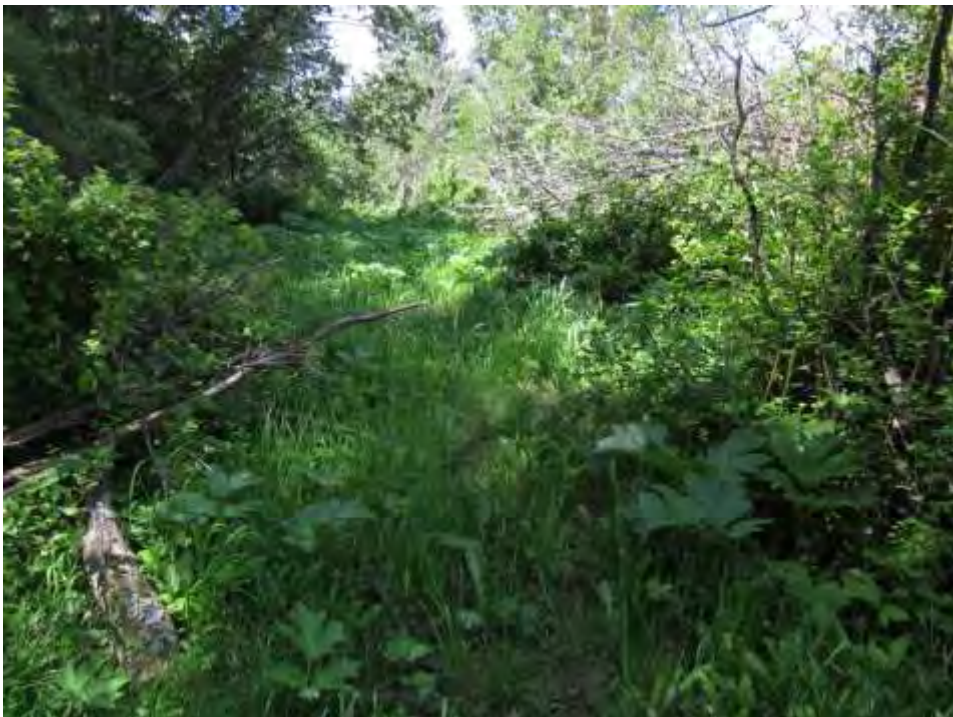
Figure 41. Typical view of the fenced off hill slope protected by fencing installed along the top of the bench.

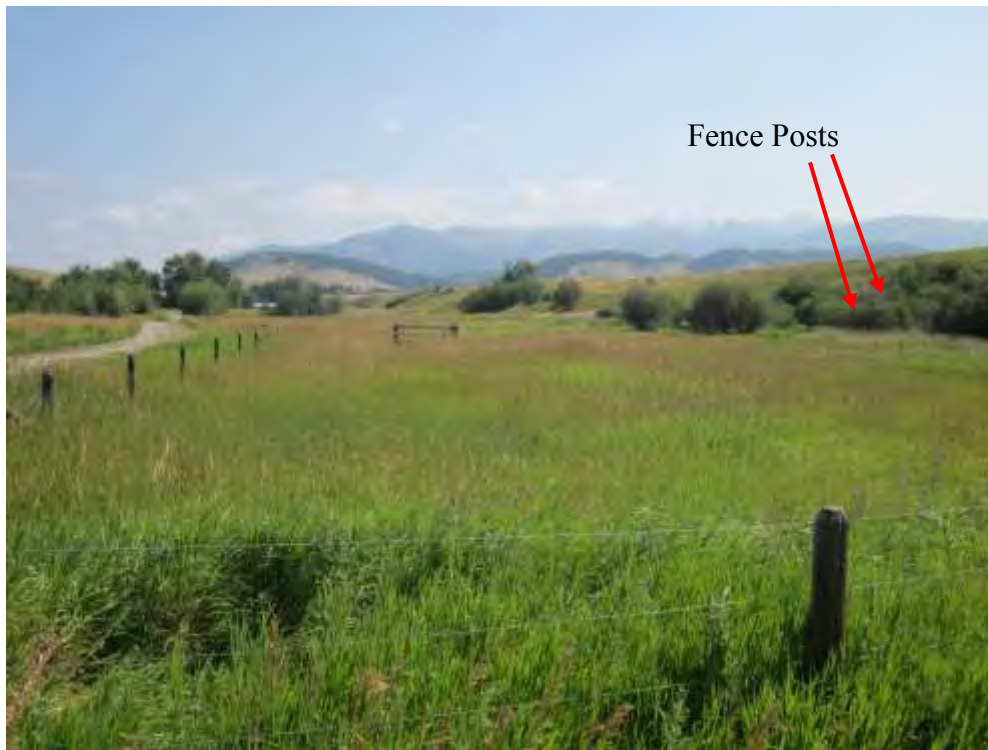
Fencing and installation of off-channel stock water had a positive effect on the riparian pasture at the downstream end of this property. Tall grasses within the pasture obscure much of the riparian fence; however, posts are visible at several locations (Figure 43). This photo replicates a pre-project photo (Figure 39). Indicators of improvement in the health of the riparian area include an apparent increase in density of willows, and the existing willows no longer have the umbrella-shaped morphology typical of grazed riparian areas. With exclusion of livestock from the riparian area, an alternative source of stock water was required. Kyrsten noted 2 automatic waterers within the fenced area (Figure 44). Combined,

Figure 43. Pasture at downstream of property with riparian fencing.

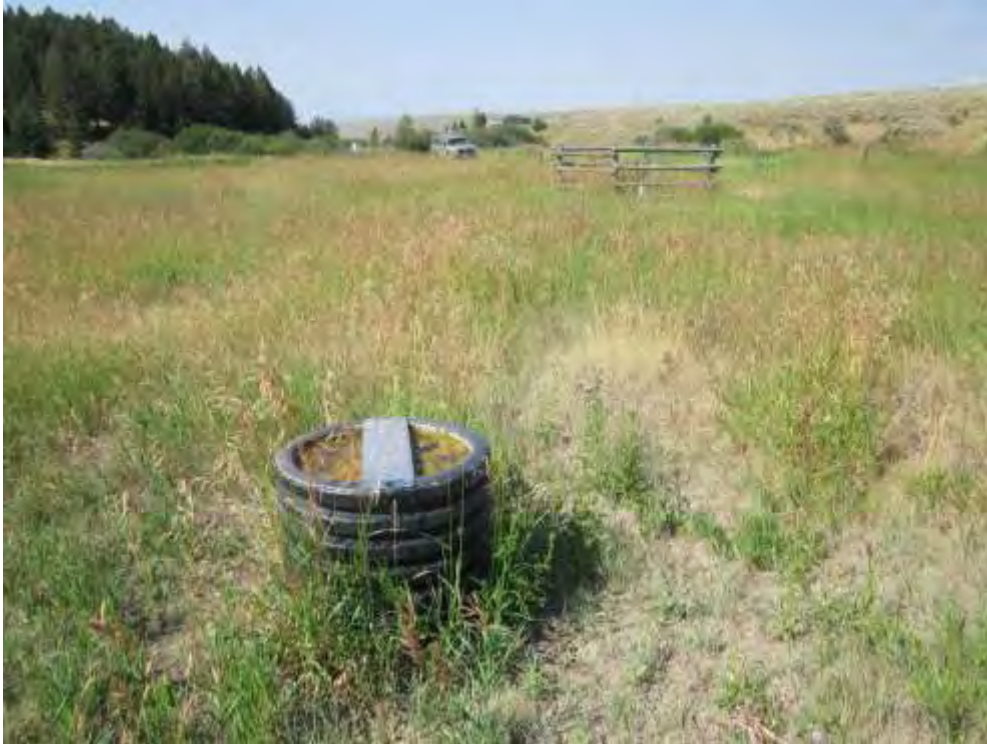
Figure 44. Off-stream stock waterer.

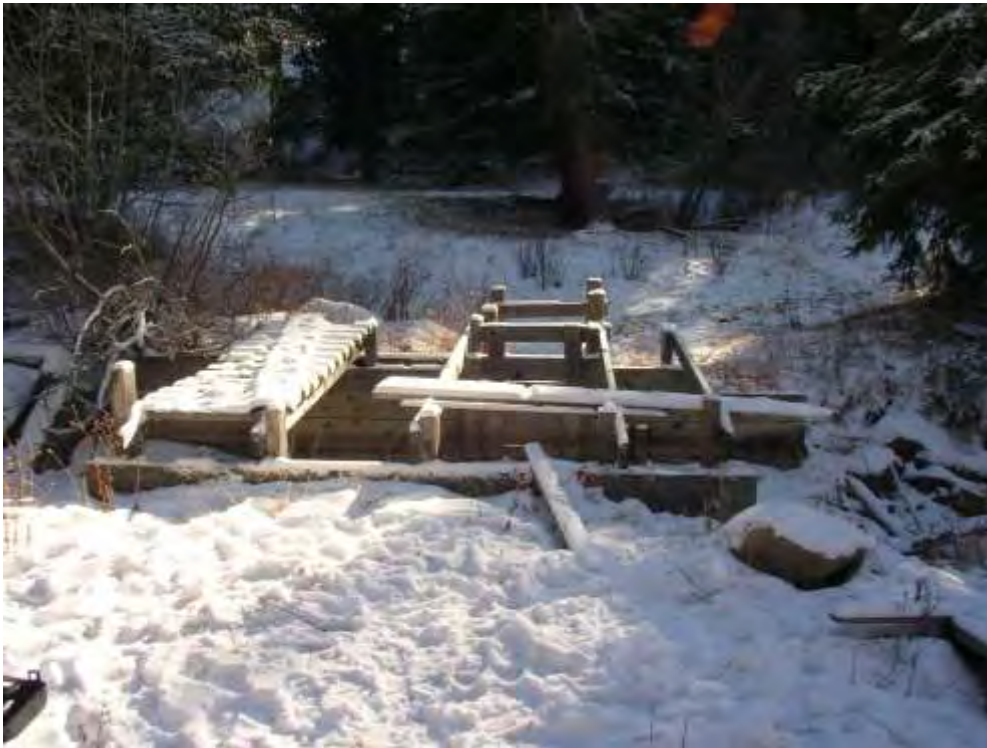
The goal of this project was to increase water use efficiency and prevent entrainment of nonhybridized Yellowstone Cutthroat Trout into an irrigation system on North Fork Horse Creek. The existing diversion was a wooden pin and plank structure that delivered water to an open ditch (Figure 45). Diversions that closed with check boards are notoriously leaky. Moreover, the ditch was an inefficient mode of delivering water, as it leaked and loss water to evaporation.

Figure 45. Pin and plank irrigation diversion on North Fork Horse Creek.

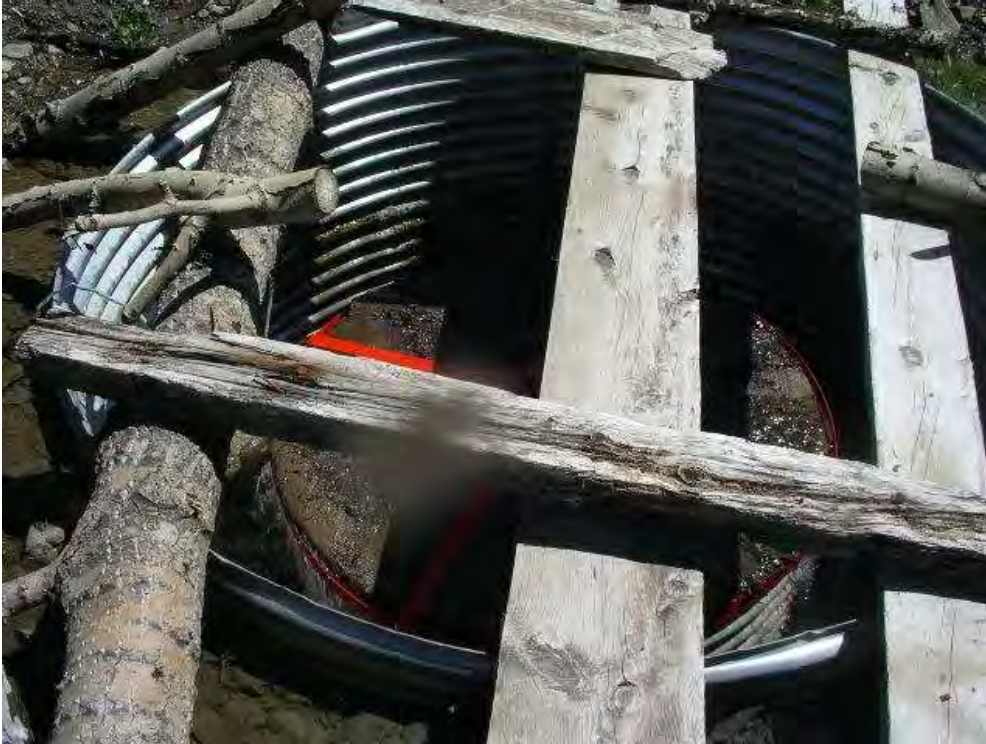
The fish screen on North Fork Fridley Creek has been visited several times. On August 11, 2010, Carol Endicott viewed the screen while it was not in use. Some detritus had settled on the face of the screen, but no fish were impinged. The detritus may have collected as the irrigation ceased for the season and flows decreased. The absence of dead fish on the screen suggested the turbulence was sufficient to flush fish off the screen. In addition, no dead fish were present in the tank surrounding the fountain, indicating the bypass pipe has sufficient draw to move fish back to the stream.

Figure 50. Turbulent fountain screen when not in use.

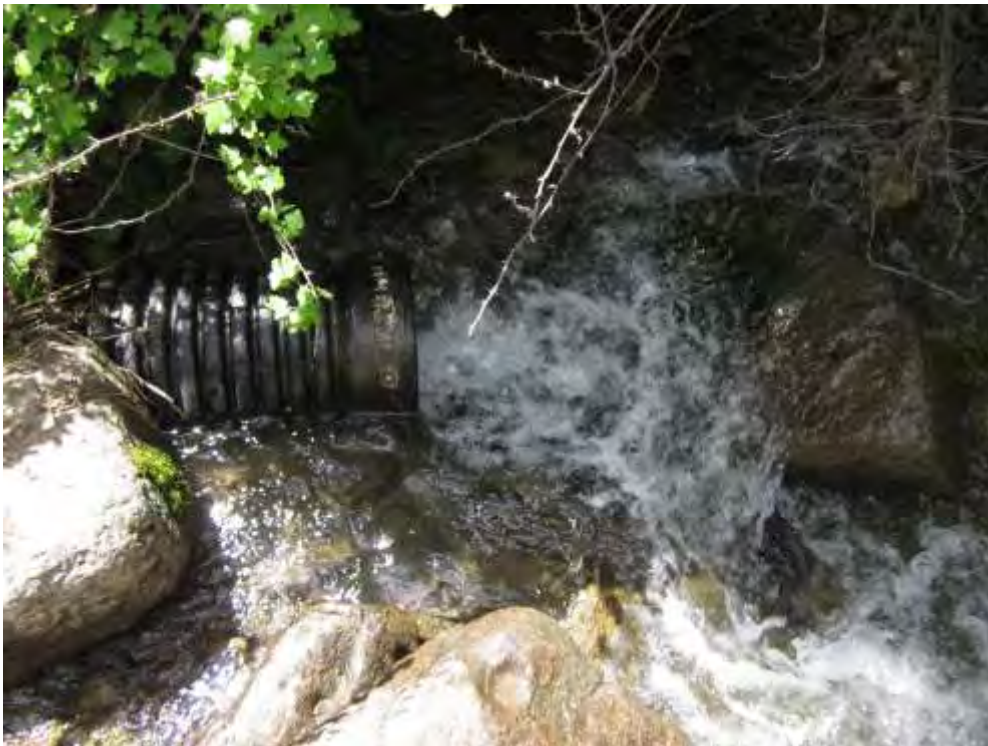
On June 22, 2017, Kyrsten Wolterstorff and Carol Endicott checked on the function of the screen. The turbulence was substantial and appeared to be sufficient to move detritus and fish off the screen (Figure 51). A substantial amount of water flowed through the bypass pipe (Figure 52). The check boards were in place and were likely a temporary barrier to fish movement (Figure 53).

Figure 52. Bypass pipe,

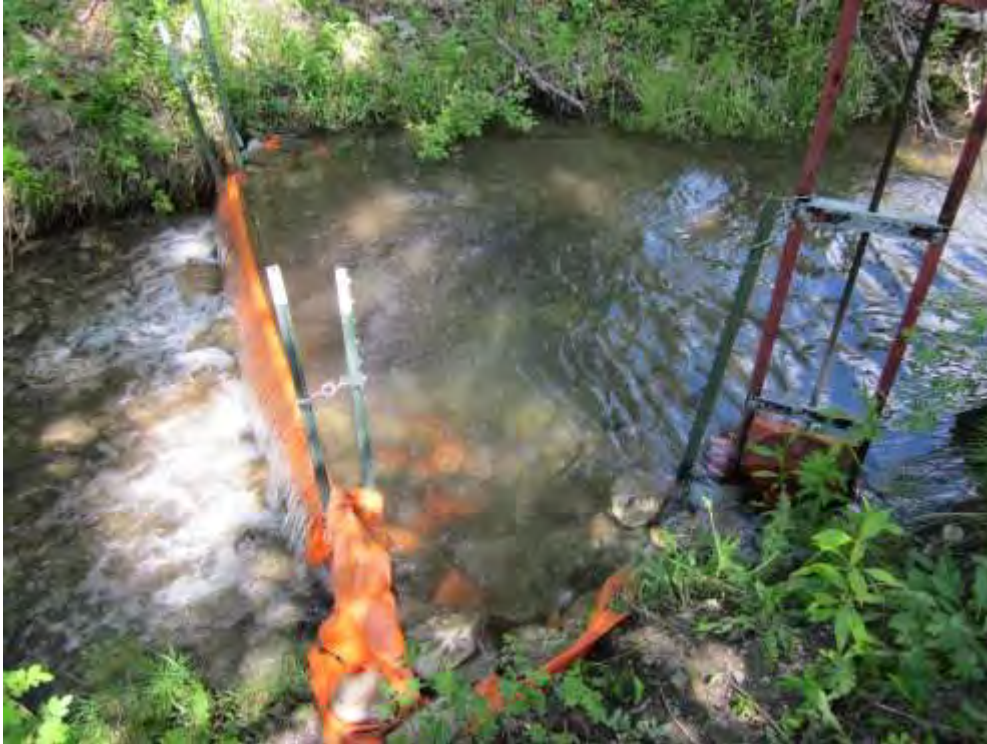
Figure 53. Check boards impounding flows to deliver water to the head gate.

The potential for the check boards to block fish movement is another consideration. According to the FFIP application, the previous diversion had been a total barrier to fish movement. The difference with the current checking of water is that the duration of diversion was decreased by a month as a condition of funding. Instead of diverting from May 1 through July 15, the water user agreed to restrict use to May 1 through June 25, with a 10-day period of use after July 15. This timing coincides with the spawning

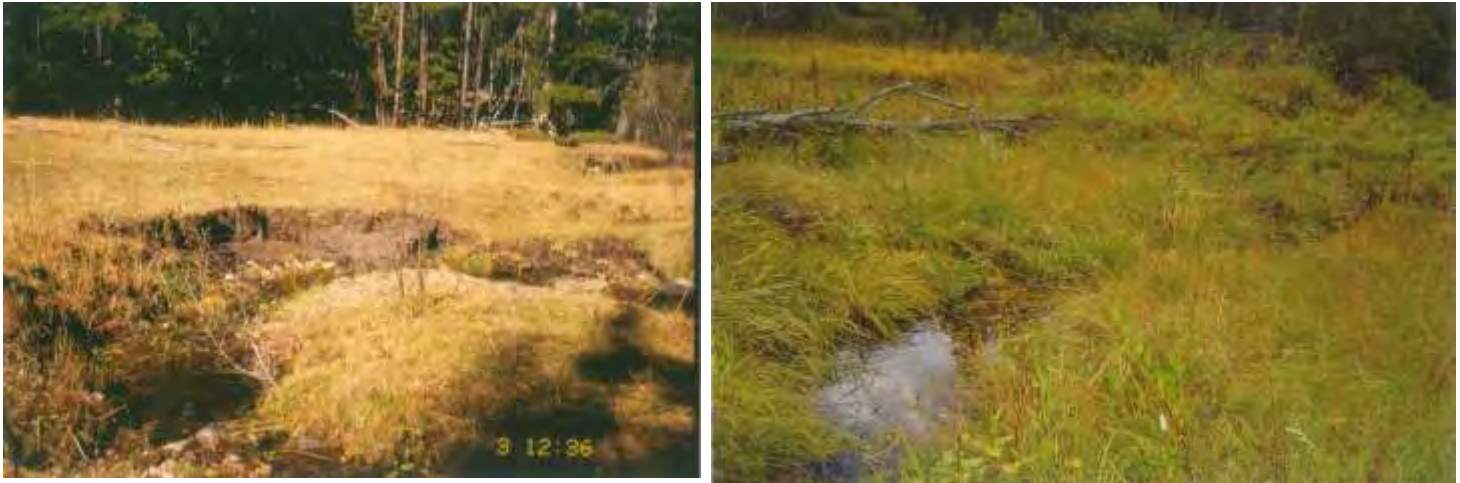
Available information includes pre-project photo points from 1996, matched with follow-up photos from 2005. The stream and riparian area had recovered substantially with installation of riparian fencing. Vertical eroding banks had stabilized with dense stands of sedges and willows (Figure 54). Although

Figure 54. Pre- and post-fencing photos taken on a meander bend on Richardson Creek, 1996 and 2005

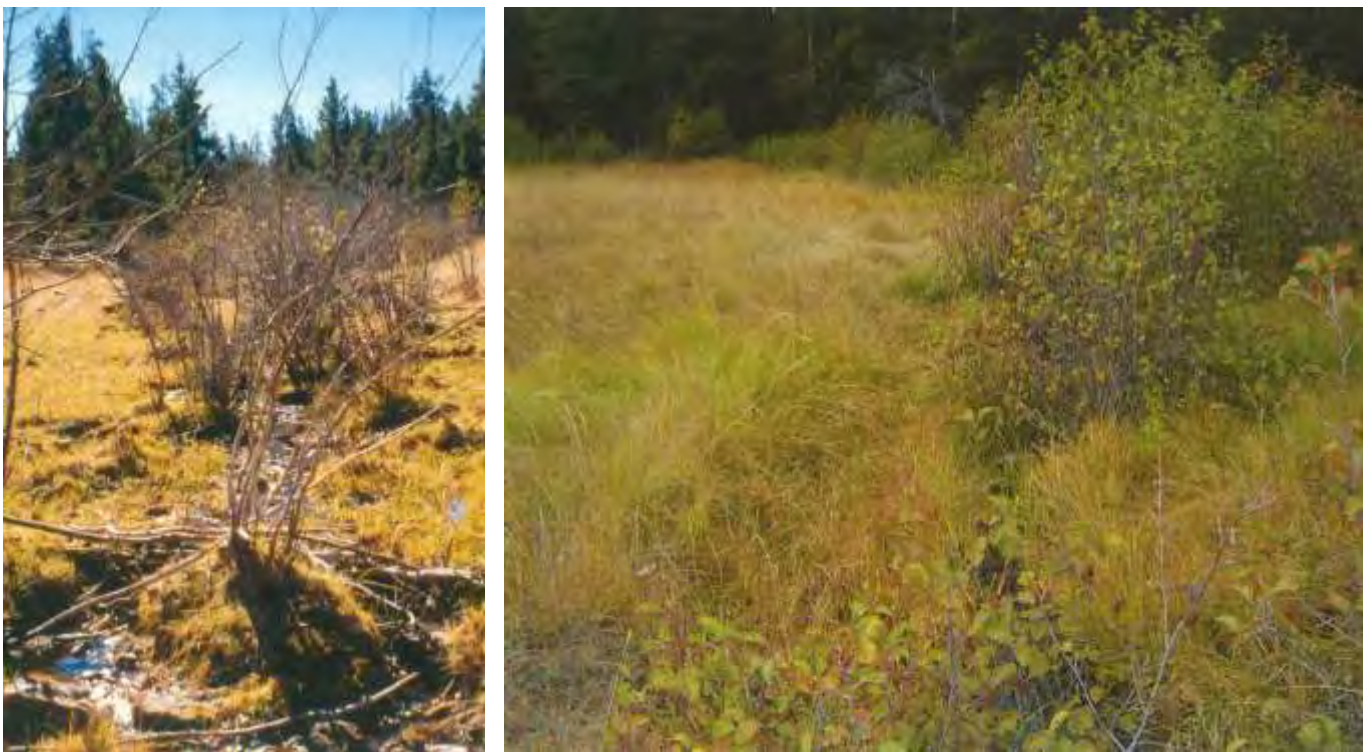
seasonality can bias interpretation of the photos, the stream and riparian area had recovered substantially. Herbaceous vegetation was closely cropped in the pre-fencing photo, but was tall and dense after 8 years of rest. A second pair of before and after photos showed similar recovery following exclusion of livestock, with banks not showing signs of trampling, and riparian shrubs being more robust and dense (Figure 55).

Figure 55. Pre- and post-fencing photos of Richardson Creek, 1996 and 2005.
