Future Fisheries Improvement Program Monitoring

2017

Future Fisheries Improvement Program
Project Monitoring 2017

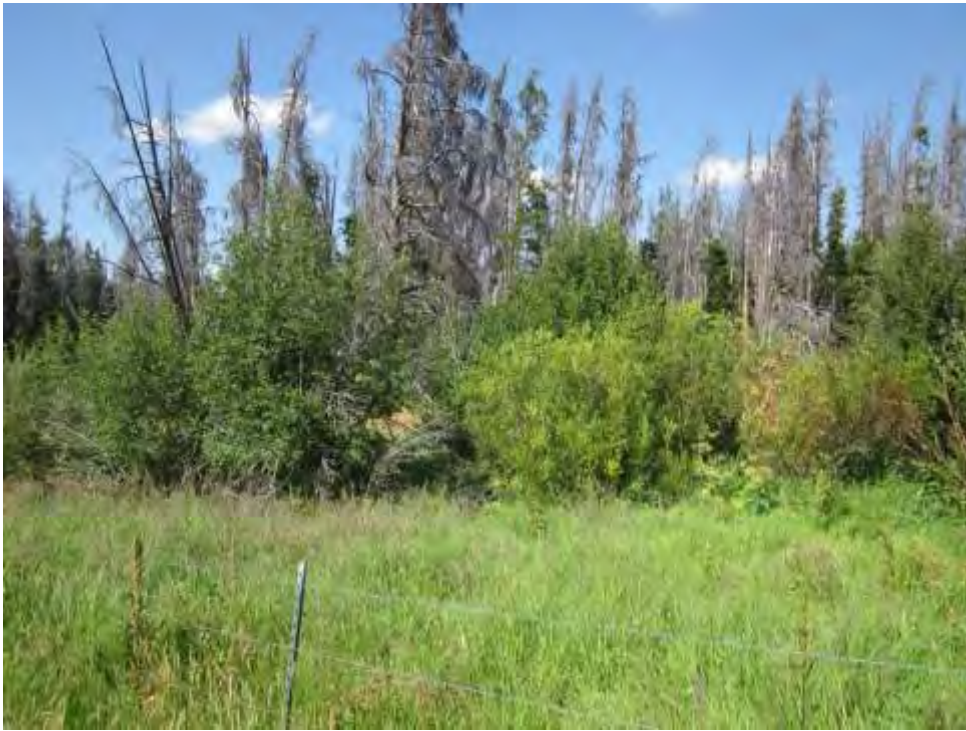
On August 3, 2017, Kyrsten Wolterstorff visited the restoration project on Richardson Creek. GPS data indicated she examined the entire length of the fenced area. The riparian exclosures were still in place, and a healthy riparian area and stable stream channel were present within the fenced area (Figure 56 and Figure 57). A water gap between fenced areas showed indications of heavy use by livestock (Figure 58)

Figure 56. Riparian fencing on Richardson Creek.

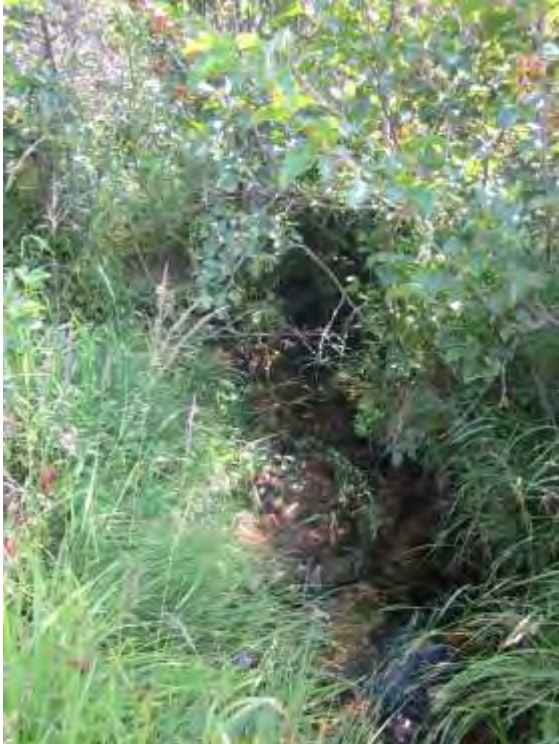
Figure 57. Stream channel within riparian enclosure on Richardson Creek.

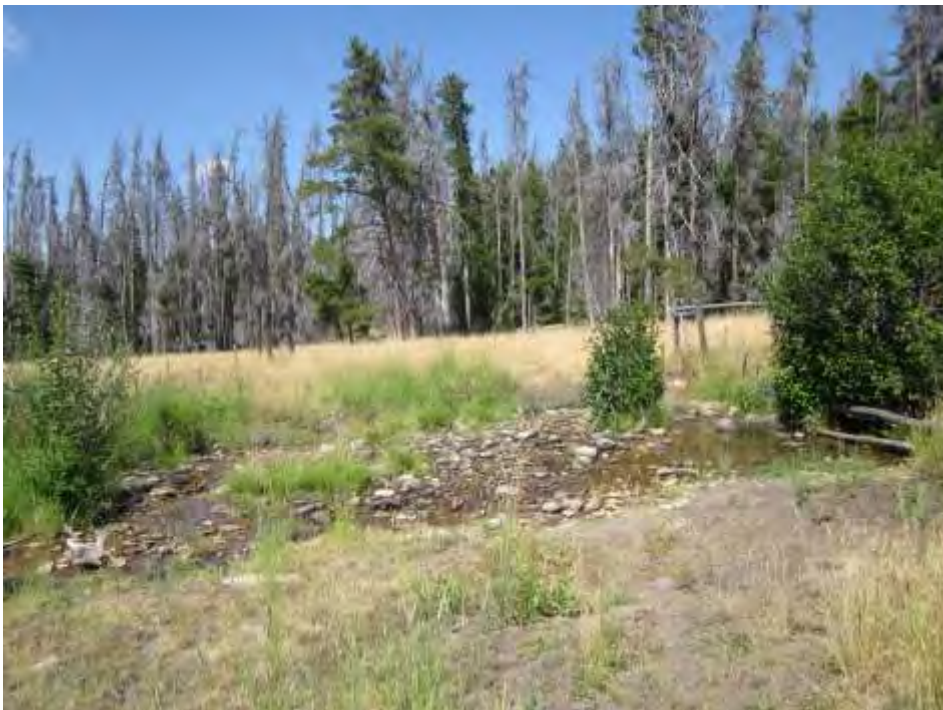
Figure 58. Water gap between fenced reaches on Richardson Creek.

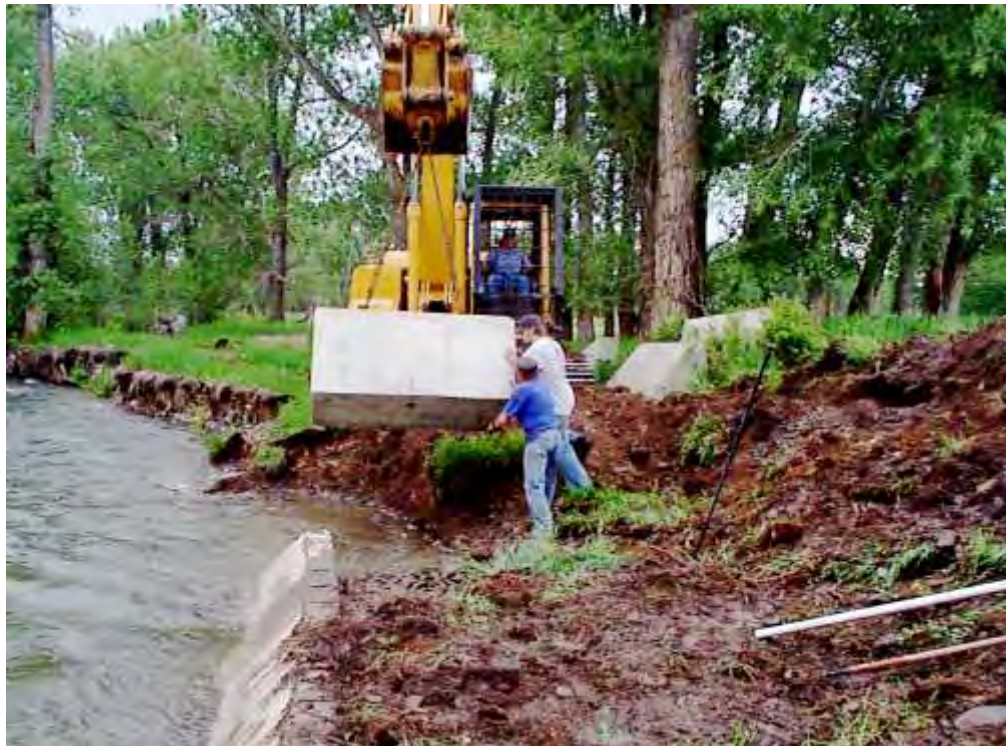
Photos from the construction show eroding banks, the constructed floodplain and the 2:1 slope to the terrace, along with installation of concrete blocks (Figure 60). The length of treated area was not reported; however, project photos indicated this bank was of considerable length (Figure 61).

Figure 60. Project construction photo showing existing eroding bank from a PowerPoint presentation prepared in 2002.

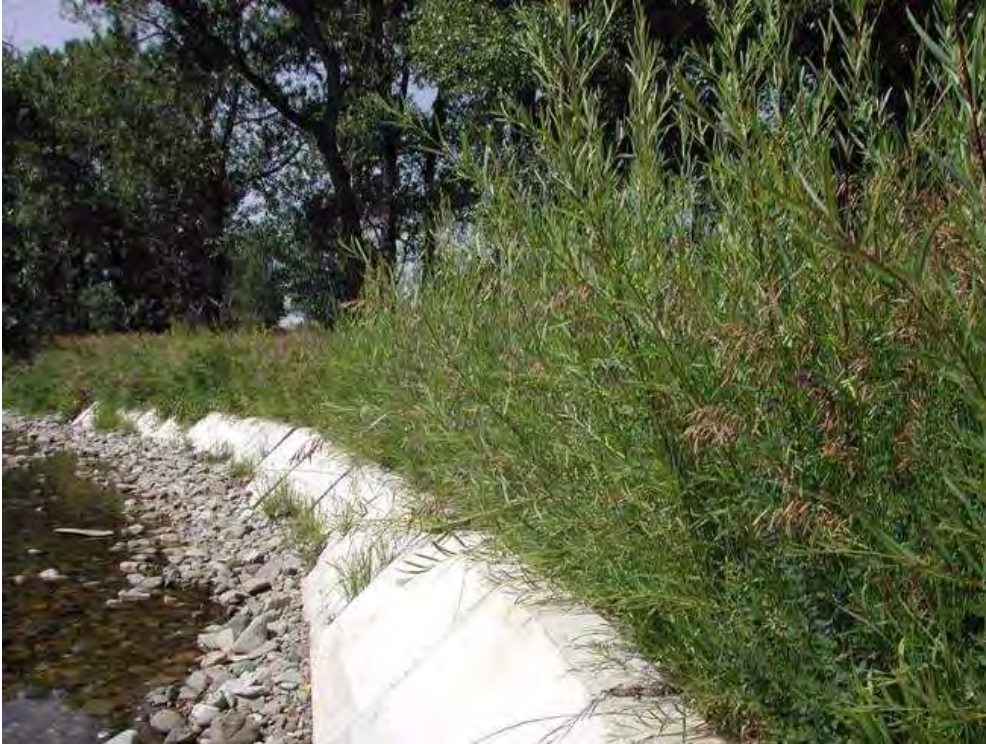
Post-construction photos show a dense mixed stand of nonnative grasses and sandbar willow adjacent to the concrete barriers (Figure 62). Apparently, a cobble toe was installed along the length of the bank treatment, as cobble extends onto the concrete and is at the toe of an eroding reach that was not covered with concrete blocks. The outer meander bend is an erosional area, not a depositional area, so it is unlikely that cobbles accumulated naturally. Neither the application nor post-project report mention installation of a cobble toe.

Figure 62. Stabilized bank on the Shields River.

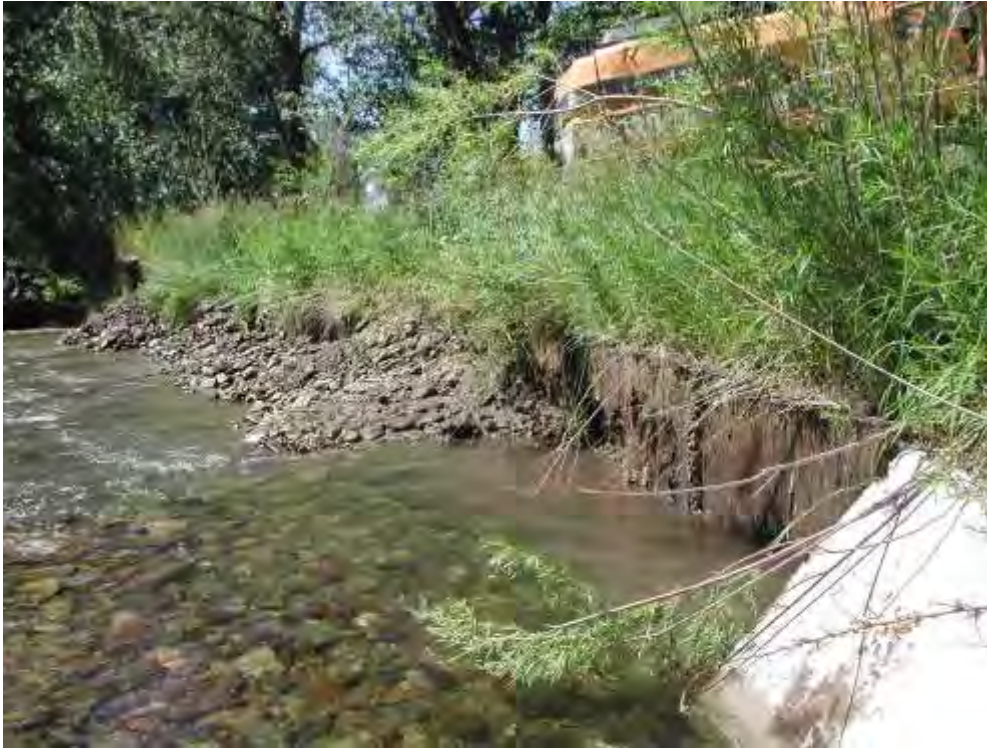
Photos illustrating the removal of the concrete barriers show the barrier left a bare, vertical bank (Figure 63). The nonnative agricultural grasses did not provide the root mass typical of riparian species, which promote soil cohesion and resilience against erosion. A cobble toe was clearly installed as part of the project, although this action was not described in background materials or the project budget.

Figure 63. Removal of Concrete block and installation of a rock toe.

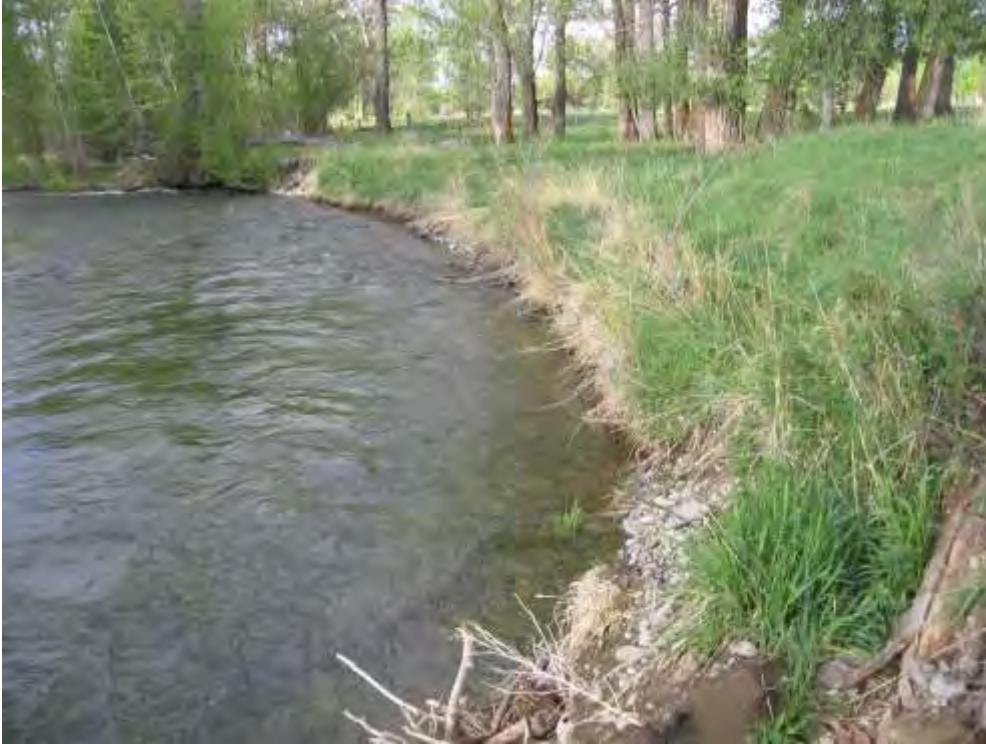
Background information includes photos that were apparently taken several years after removal of the concrete blocks (Figure 64). Willow survival was negligible, although the nonnative grasses had colonized the constructed floodplain. Remnants of the installed rock toe were still visible, but much of it had apparently been washed away, leaving undercut banks. As shallow-rooted, nonnative grasses line the banks, the long-term stability of this bank is questionable.

Figure 64. Post-project photo dated 2007

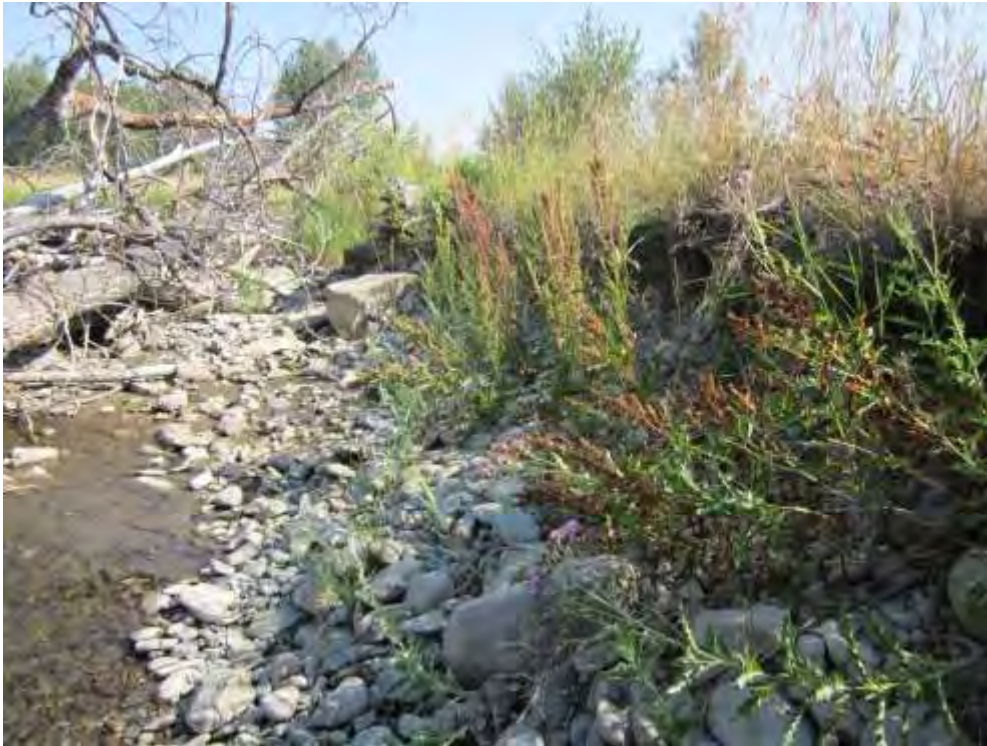
On August 22, 2017, Kyrsten Wolterstorff and Carol Endicott visited the project site. As noted, determining the bank that had been treated was problematic. A portion of the bank considered most likely to be the treated bank supported a community of nonnative grasses and Canada thistle (Figure 65). A cobble toe was present, as opposed to the raw dirt that was present before treatment. Nevertheless, the bank had receded several feet. Large woody debris had been deposited at the site and was providing bank protection. More aggressive efforts at bank stabilization were apparent with riprap being present at the downstream end of the bank (Figure 66).

Figure 65. Stream bank potentially being the restored bank.

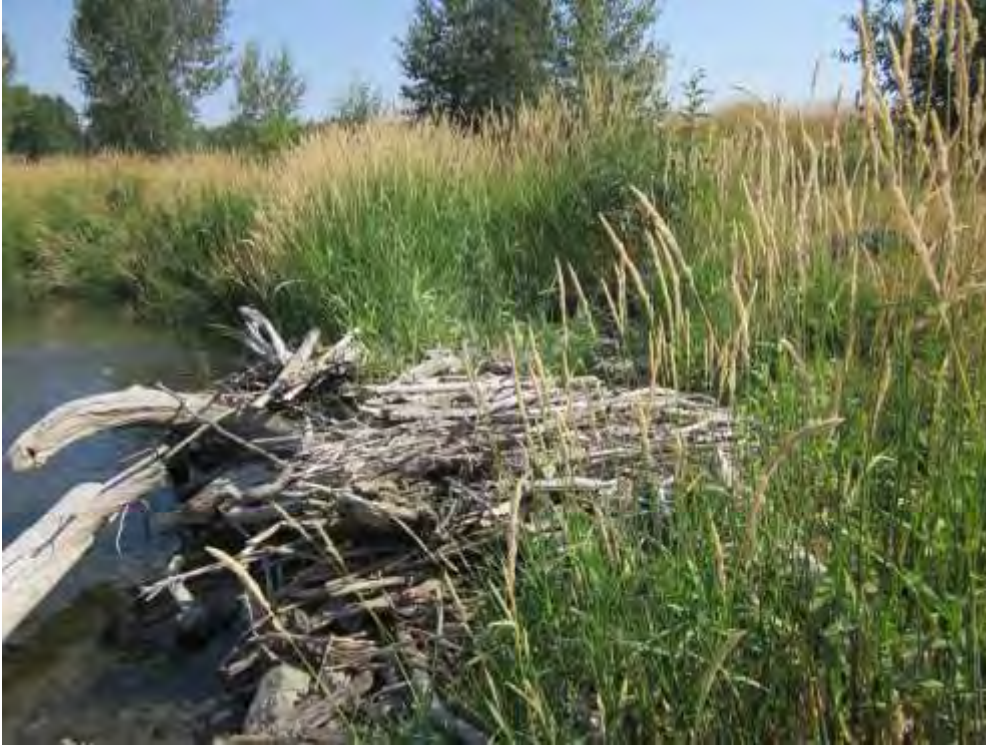
Looking upstream at the putative restored bank, reed canary grass had invaded the riparian area (Figure 67). This nonnative species is exceptionally invasive and hard to control. Although it functions to maintain bank stability, it does not provide the same ecological values as a native shrub community.

Figure 67. Reed canary grass infestation along putatively restored bank.

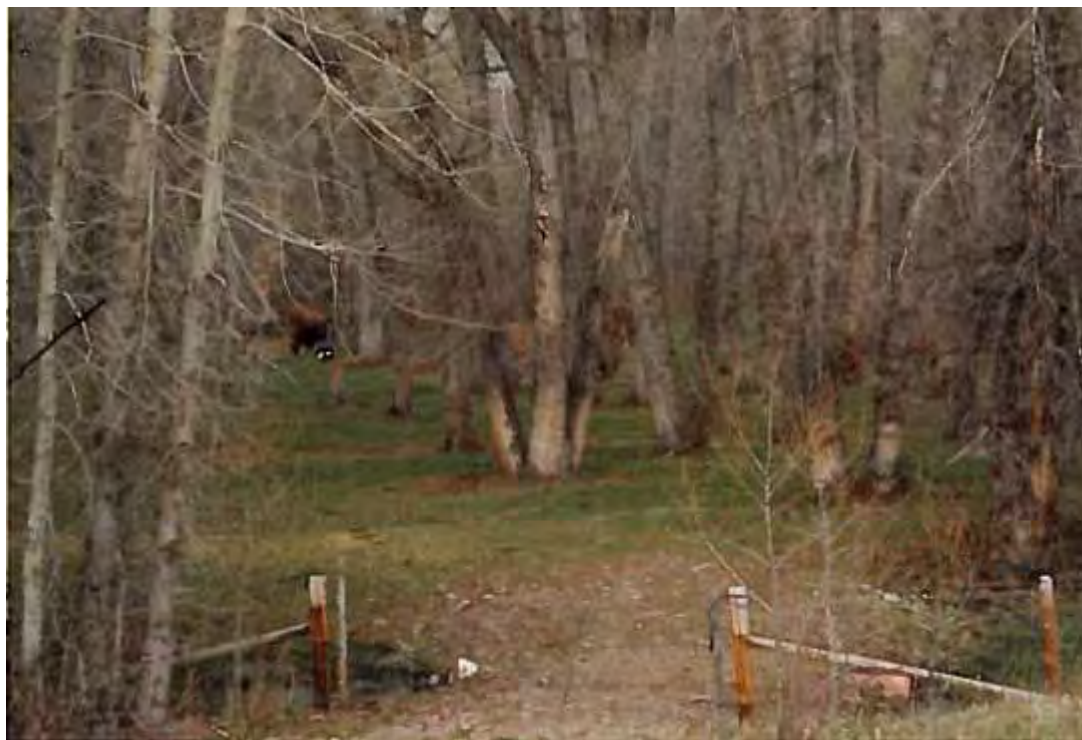
Across these properties, more than 800 cattle and other livestock grazed the riparian zones. Pre-project photos of the Shields River portion of the project are limited. One photo shows portion of a mature cottonwood gallery forest with closely cropped grasses and livestock within the riparian area (Figure 68). The second photo is an overview of the portion of the Shields River used as winter pasture. Determining the influence of livestock throughout the project area is not possible from these photos. The lack of an extensive photographic record of pre-project conditions is common with projects that predated common use of digital cameras and limits the ability to demonstrate recovery. Nevertheless, 800 cattle can exert considerable pressure on riparian areas, stream banks, and channel morphology, so substantial disturbance and degradation was likely.

Figure 68. Pre-project photo of the riparian area along the Shields River slated for implementation of BMPs.

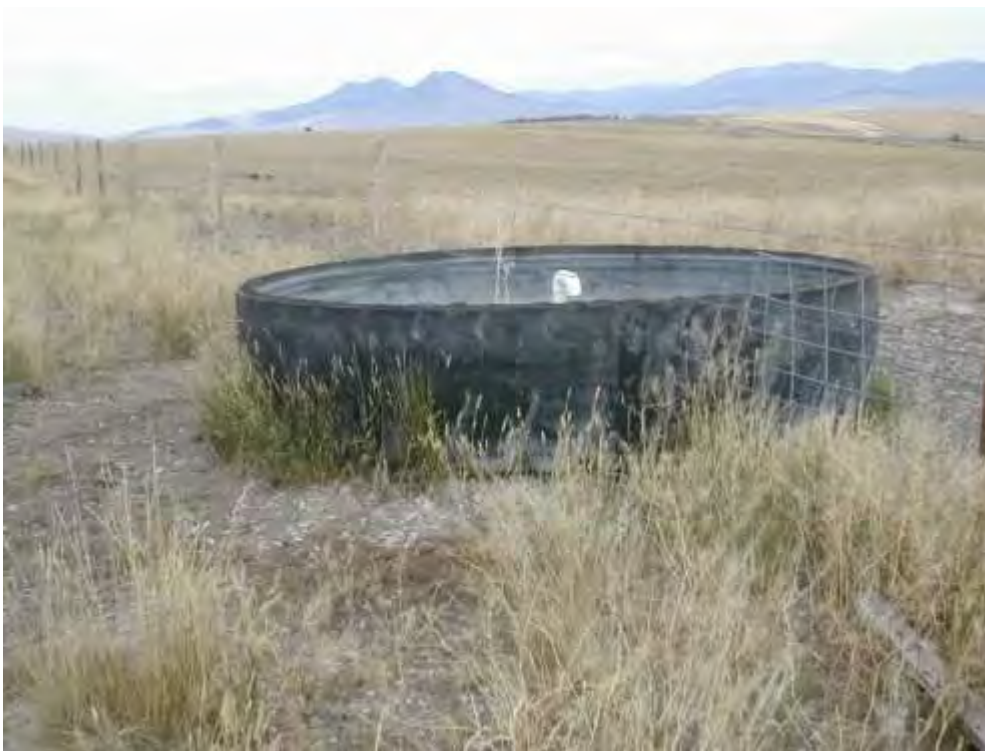
Other photos are dated 2000 and 2002, and document conditions soon after implementation of BMPs. Photos include documentation of a stock tank (Figure 70). Photos are that are likely from Elk Creek show variable conditions, with healthy reaches (Figure 71), areas where the channel was overly wide and devoid of riparian shrubs (Figure 72), and a reach with considerable down cutting and an exposed, highly erodible terrace (Figure 73). Historically, beavers likely had considerable influence on Elk Creek, and much of the stream was impounded by beaver dam complexes. Near extinction of beavers in the mid-1800s removed their influence on streams across the landscape of the West. These streams tend to be especially susceptible to channel down-cutting, as beaver dams trapped sediments for millennia, resulting in fine-grained banks that are susceptible to erosion and head-cutting.

Figure 70. Stock tank installed as part of BMPs for the Shields River and Elk Creek project.

The landowner reported the fence worked well in allowing him to manage grazing within the riparian area. The off-channel stock tanks have been problematic, with 1 failing, and others going out intermittently. He installed stanchion type water access points to provide stock water when the tanks are not working. He lost 7 calves with failure of a stock tank, and said they are costly to run.

The failure of some of the stock tanks is of concern. It is unclear how water was delivered to the tanks and the reason for failure. Technical assistance through the NRCS is recommended for future projects to ensure stock tanks are using the latest technology and are unlikely to fail. Loss of calves to inoperable stock tanks is unacceptable.

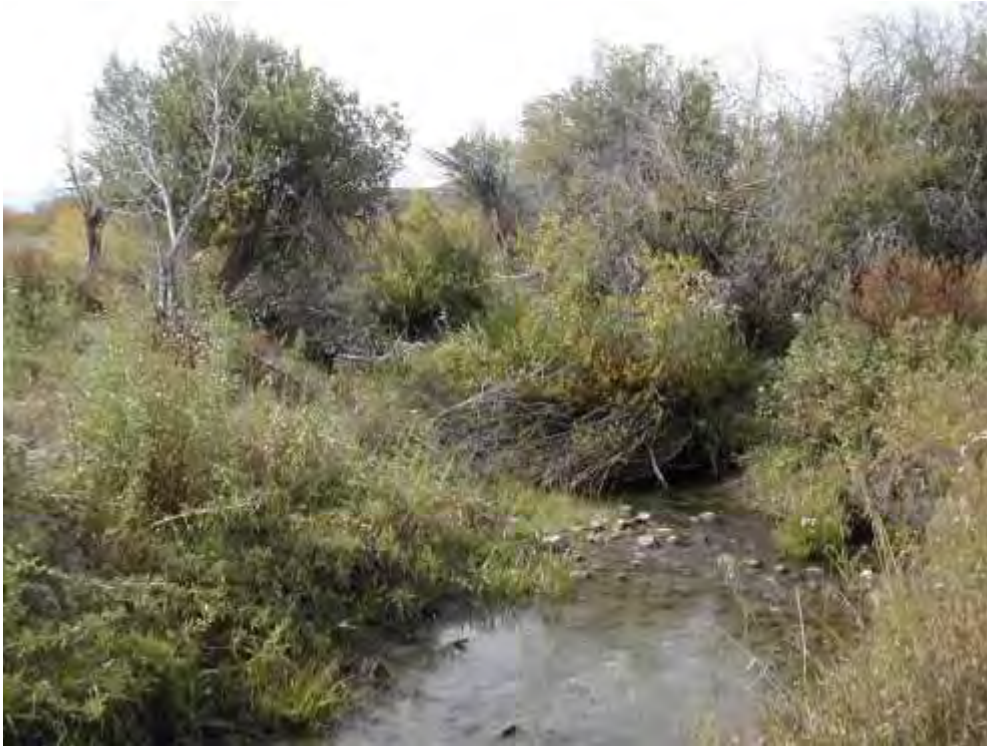
Figure 71. Healthy riparian area and intact stream morphology on Elk Creek in 2002.

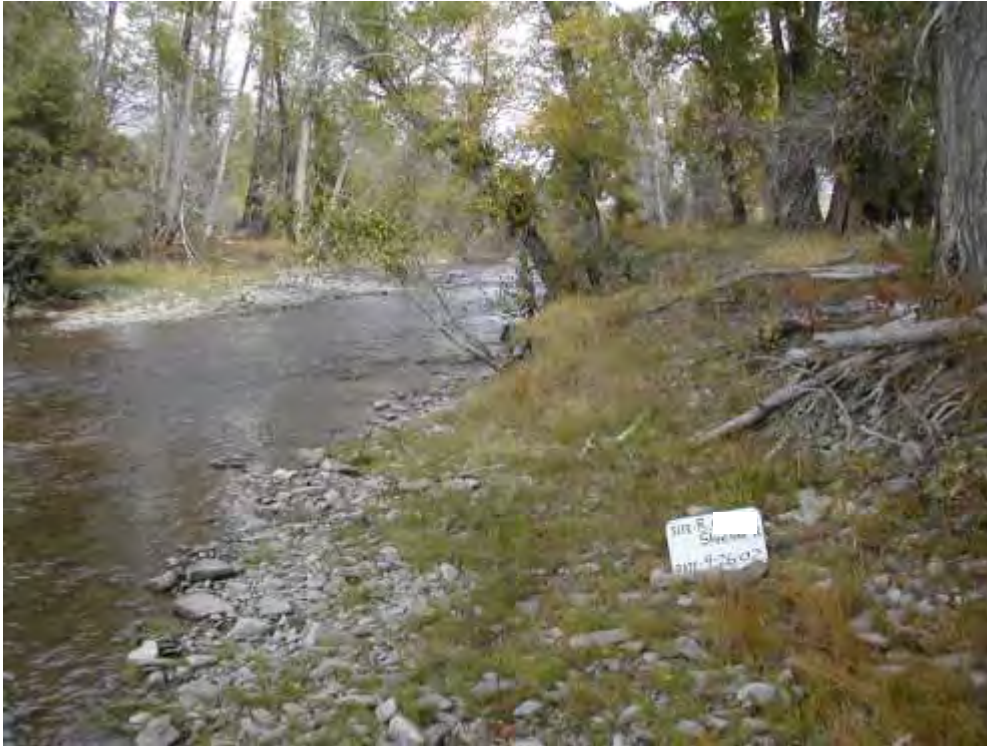
The Shields River is more resilient to disturbance than Elk Creek, as its cobble bed is not susceptible to vertical adjustments, and cobbles in the stream banks make them more resilient to trampling. Photos from 2002 show a mature cottonwood gallery forest, but little recruitment of cottonwoods from suckering and a lack of riparian shrubs (Figure 74). Another photo from 2002 shows a bank devoid of riparian vegetation, vegetated with closely cropped grasses (Figure 75), which suggests continued, heavy use by livestock.

Figure 74. Fenced reach of the Shields River in 2002.

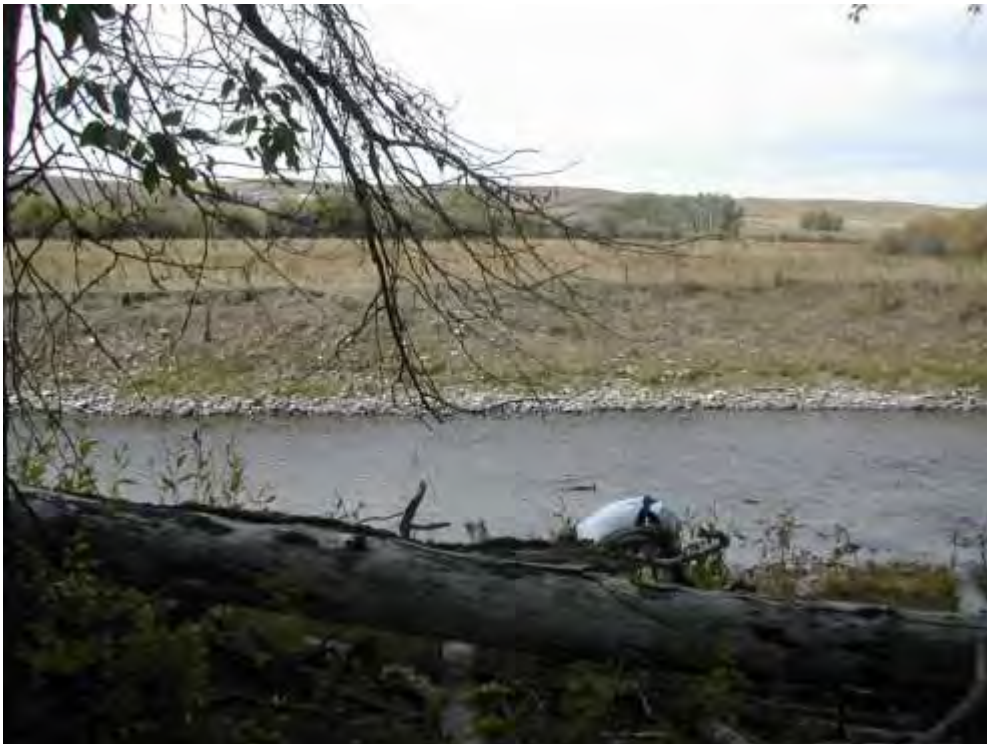
Figure 75. Fenced reach of the Shields River in 2002.

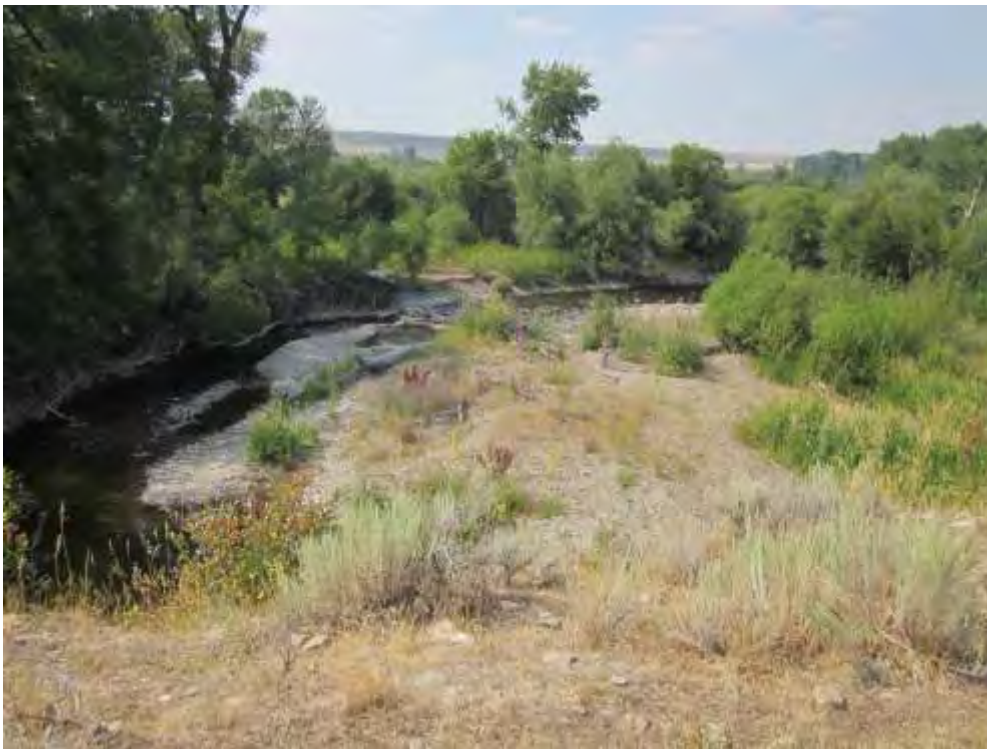
The fence was in good condition, and grazing pressure within the riparian area was light. Much of the riparian area was within a mature cottonwood gallery forest; however, shrubs and cottonwoods were recruiting on point bars (Figure 77). Owing to the substantial bed load supply, the channel was braided in some areas, but occupied a single thread in others (Figure 78). Dense riparian understory was present and afforded high quality habitat for wildlife (Figure 79). A hay field encroached on the stream bank on the west side of the river, and banks were calving due to lack of root protection, the cobble toe provided some protection against erosion

Figure 77. View of fenced section of the Shields River showing recruitment of woody vegetation on point bars.

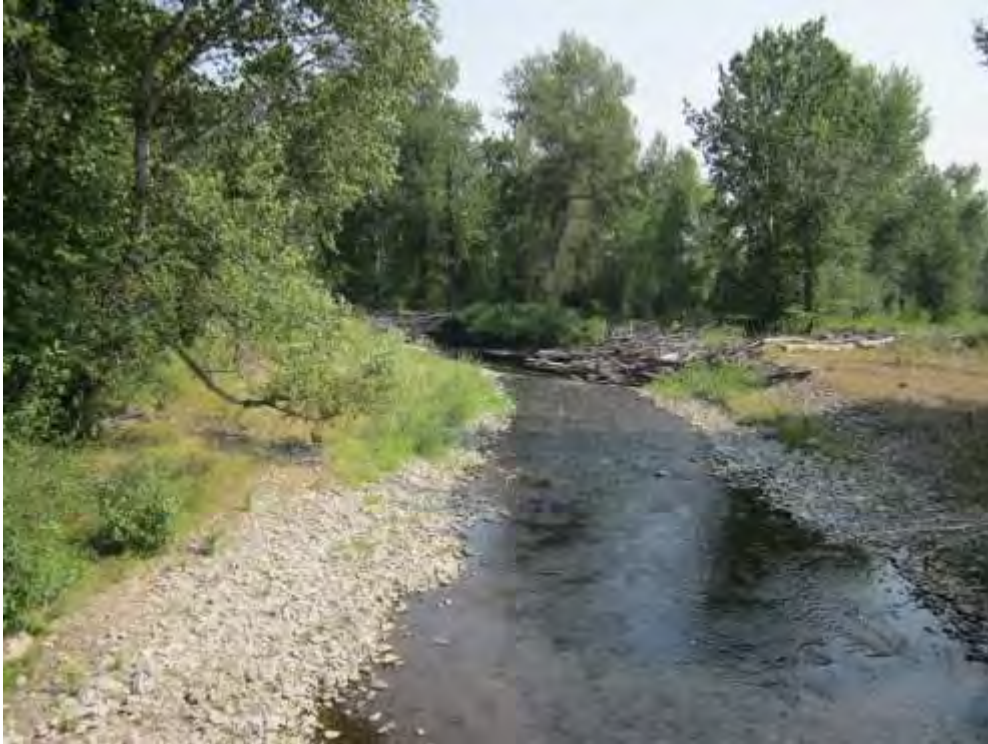
Figure 78. Fenced portion of the Shields River on property 1.

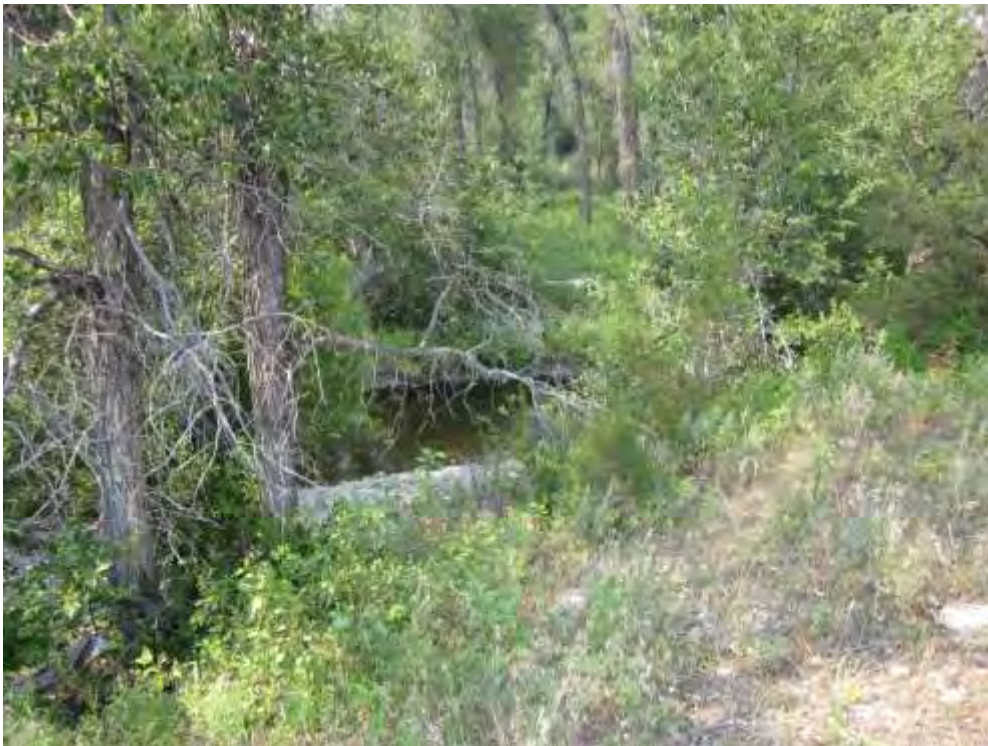
Figure 79. Riparian area with dense understory.

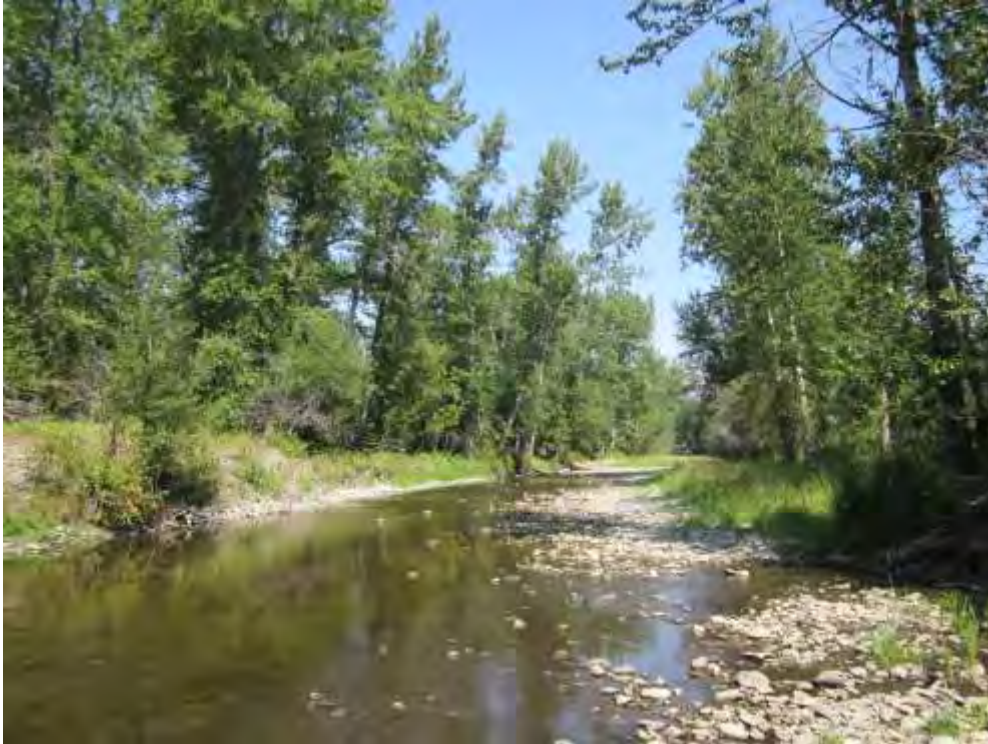
The Shields River flows through a cottonwood gallery forest, and is single thread throughout the property (Figure 82). An old attempt at bank stabilization using riprap was only partially protecting the stream, as the channel had moved away from a considerable length of the applied rock (Figure 83). Although not locally derived, the streambed was heavily silted throughout this reach (Figure 84). The Shields River is listed as impaired for siltation on Department of Environmental Quality’s list of impaired streams, and the watershed group has a plan to reduce sediment loading from bank erosion, hill slope erosion, and roads.

Figure 82. Typical view of property 2.

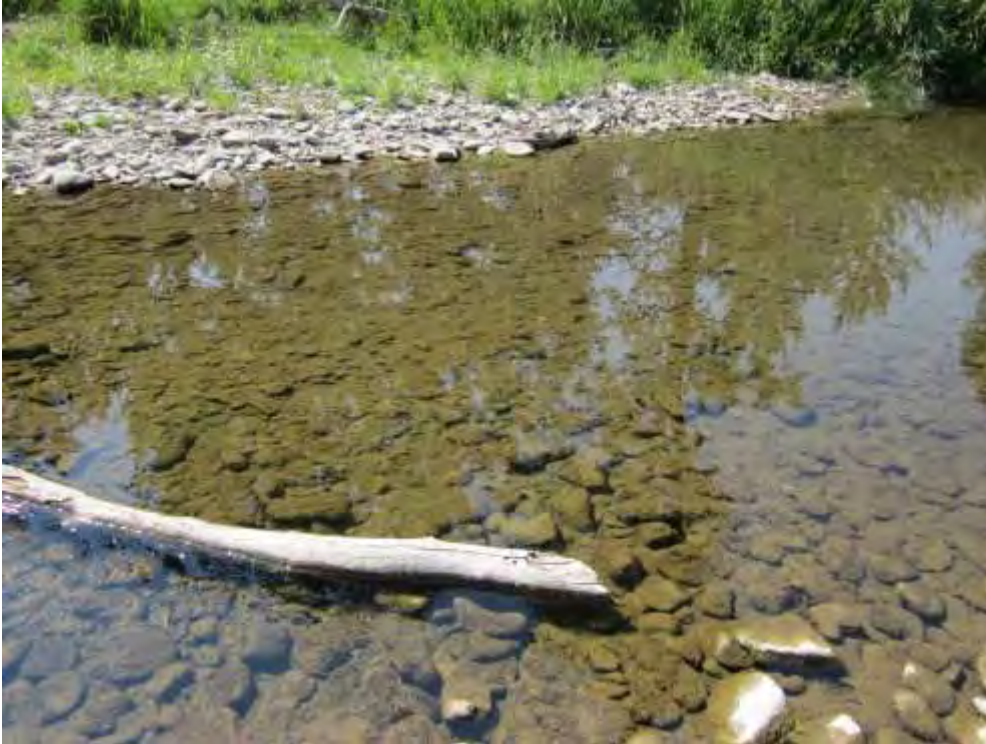
Figure 84. Siltation of the Shields River's streambed.

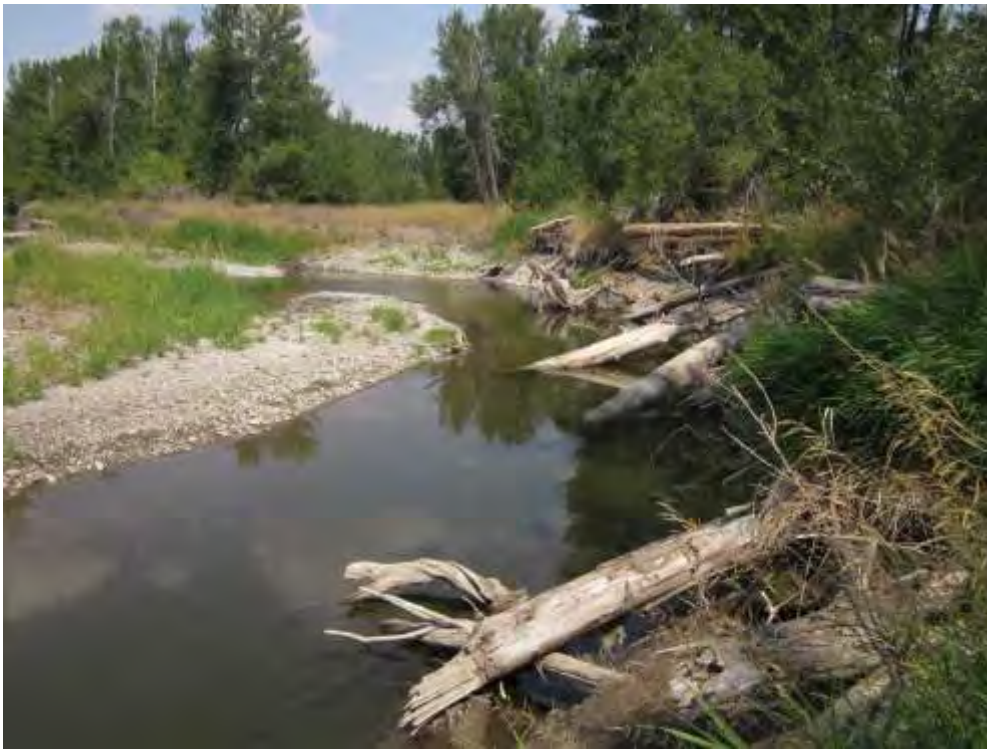
Although fencing and development off-stream stock water benefited the length of the Shields River treated in this project (Figure 81), Kyrsten observed this reach to have the best habitat of all the reaches (Figure 85 and Figure 86). The channel was stable, had high quality pools with large woody debris. Some light browse was present, although there were no signs that cattle accessed the stream. The landowner does not produce livestock, but does grow irrigated hay. Localized infestation of reed canary grass was the only feature that detracted from the functions and values of the riparian area (Figure 87). Likewise, the streambed was heavily silted; however, the fine sediment was likely contributed from upstream sources.

Figure 85. High quality pool, with large woody debris and recruitment of woody vegetation on recent alluvial bars.

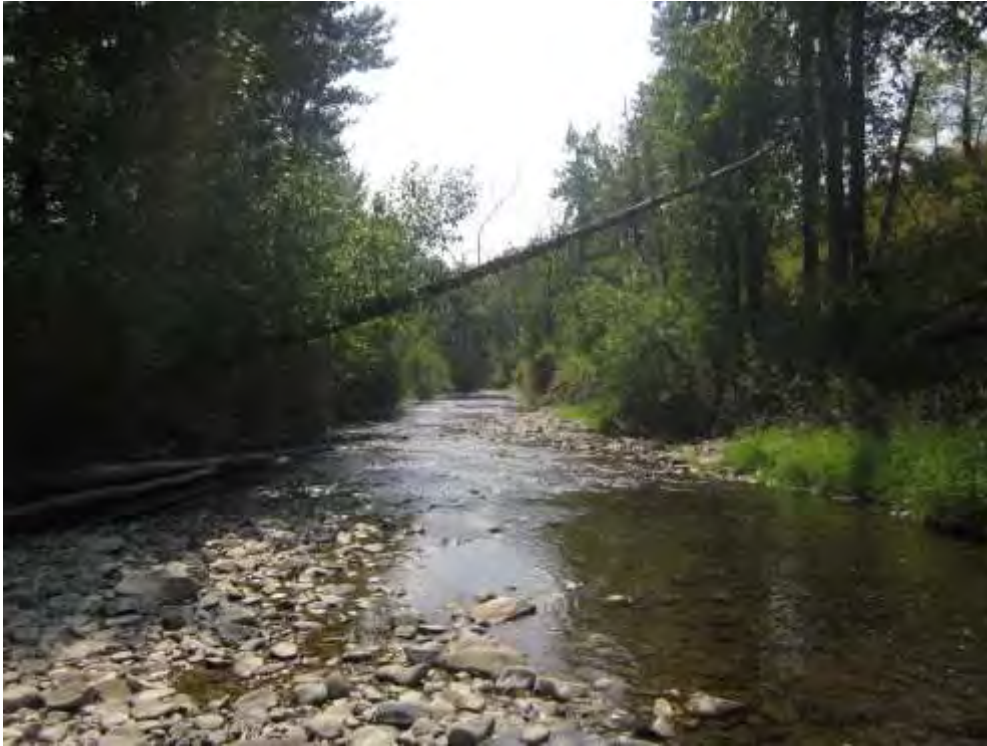
Figure 86. Shields River in property 3 with mixed conifer and cottonwood overstory.

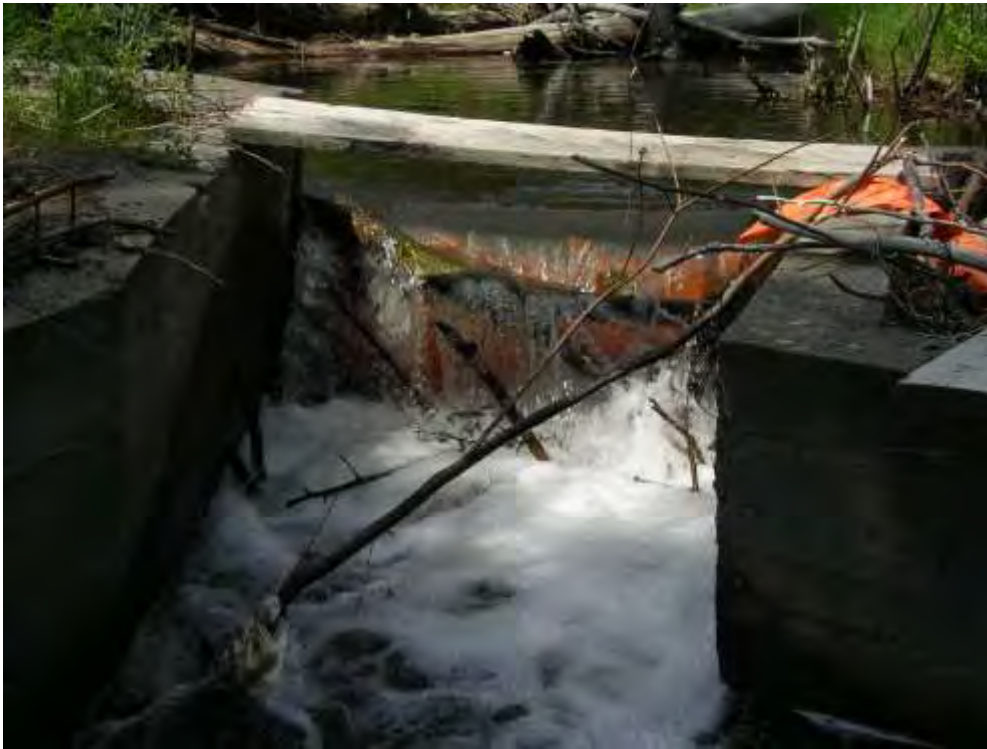
South Fork Fridley Creek is a tributary of the Yellowstone River located upstream of Emigrant in Paradise Valley. An irrigation diversion that used check boards to divert its flows into an irrigation canal was a barrier to upstream movement of fluvial spawners (Figure 88). The solution was to replace the existing diversion with a similar diversion equipped with a Denil fish ladder, and this ladder was constructed in 2008. The ladder was constructed with cast concrete, with wooden baffles installed at 45° angles.

Figure 88. Irrigation diversion on South Fork Fridley Creek.

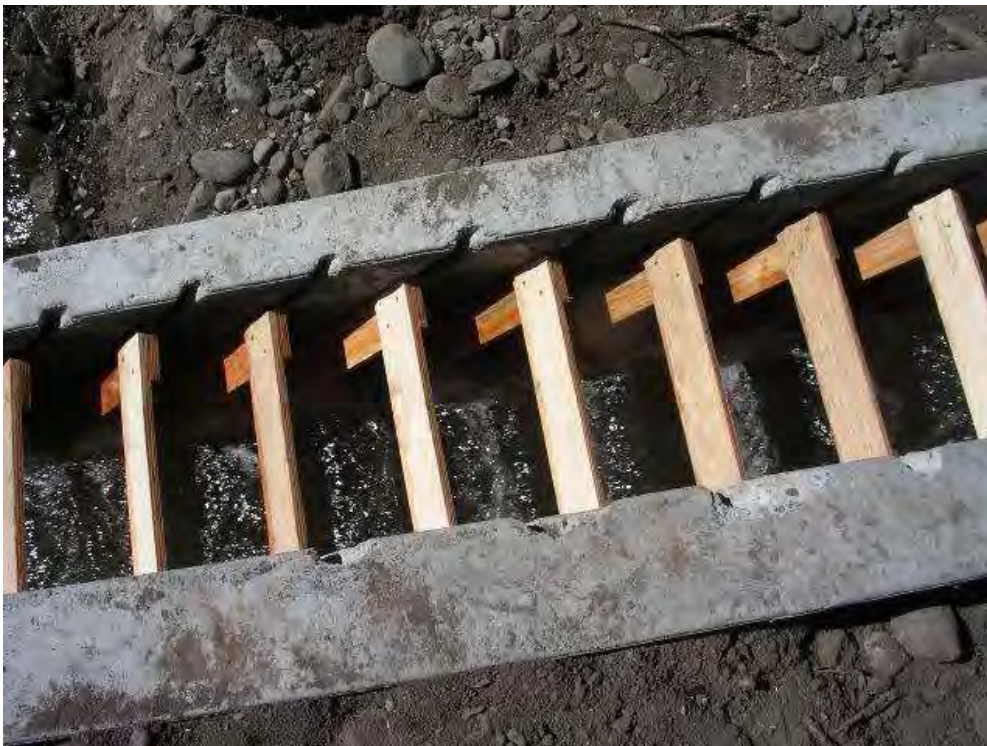
Figure 90. Wooden baffles in the South Fork Fridley Creek fish ladder.

Soon after construction was completed, South Fork Fridley Creek experienced a flood of significant magnitude. Emergency riprap was installed to keep the stream from cutting around the new structure. This flood also embedded the baffles with cobble, making them impossible to remove without mechanical assistance.

Recommendations include clearing the cobble and removing the baffles to check their condition. Another set can be installed if they are damaged. In addition, personnel with expertise in fish passage should evaluate if the ladder is passable in its current condition.

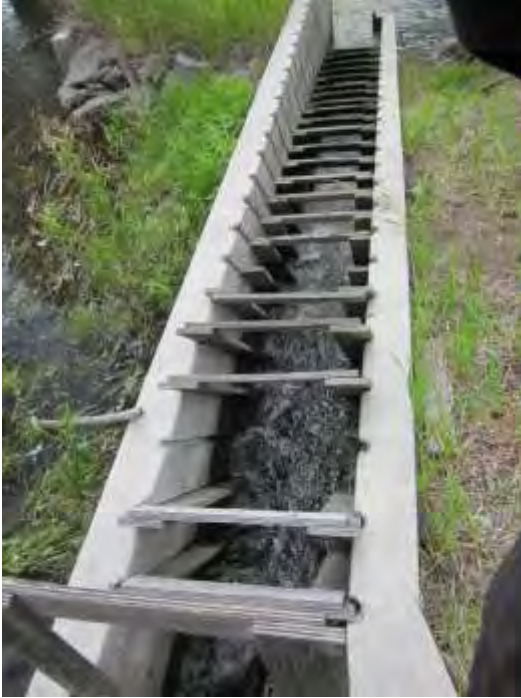
Assessment of the South Fork Fridley fish screen included visual inspection of the ladder, installation of a trap to capture fluvial fish ascending the ladder, and trapping fry out-migrating downstream of the fish ladder. The Denil fish ladder was designed according to the established standard, with closely spaced baffles that create turbulence that dissipates energy. Visual inspection of the ladder found highly turbulent water; nevertheless, the velocity appeared to be substantial in the ladder and may exceed the burst swimming ability of fish. Other observations were that cobbles had embedded the baffles, which are now immobile. In addition, the baffles are wooden and have swollen. Digging out the cobbles or using a mechanical winch may be advisable to reset the baffles. A second set of baffles is stored at the Livingston Fisheries Office; however, metal baffles may be an improvement, as they would not swell, and may be easier to extract in cleaning the ladder, despite their greater weight.

Figure 91. Denil fish ladder on South Fork Fridley Creek.

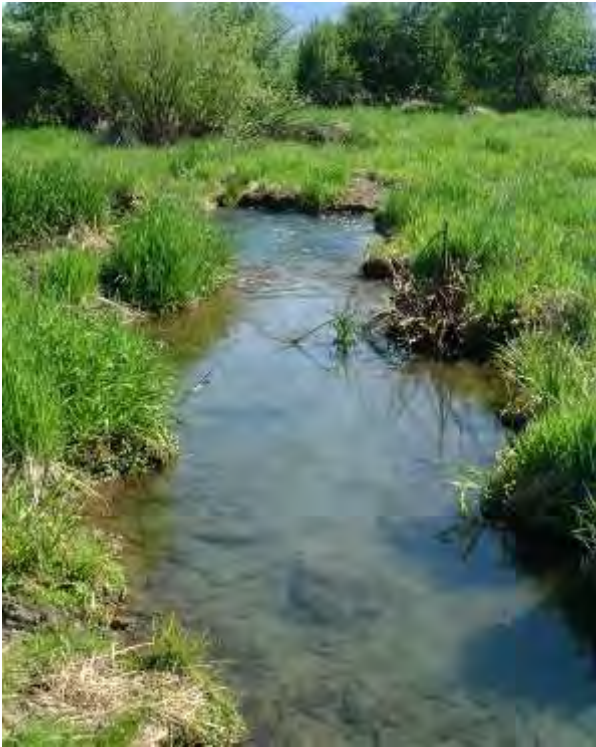
Nevertheless, South Fork Ross Creek appeared to be relatively overly wide, with heavy siltation of the streambed (Figure 92). Other photos showed highly turbid flows (Figure 93) or a poorly defined channel, suggesting relatively recent use by livestock, or inadequate stream flow for channel maintenance (Figure 94). Nevertheless, thick sedges maintained stable banks, and mature willows were present.

Figure 92. Pre-project view of South Fork Ross Creek.

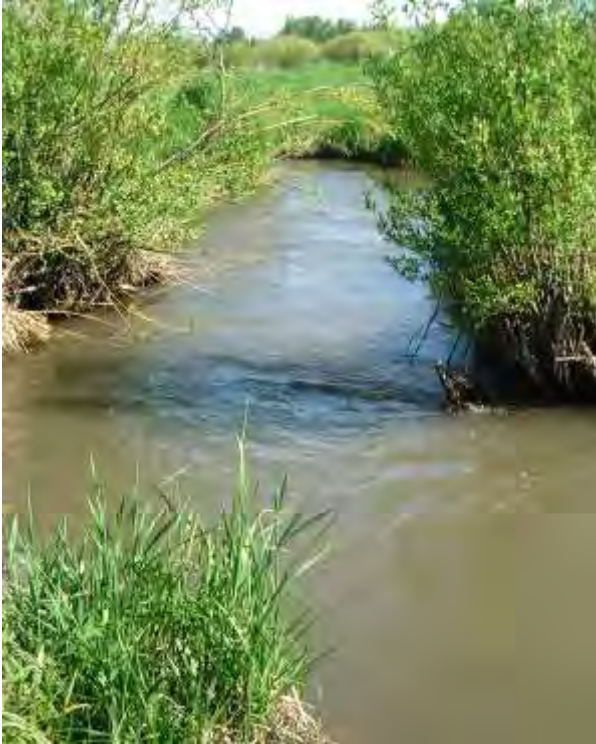
Figure 93. Turbidity in South Fork Ross Creek.

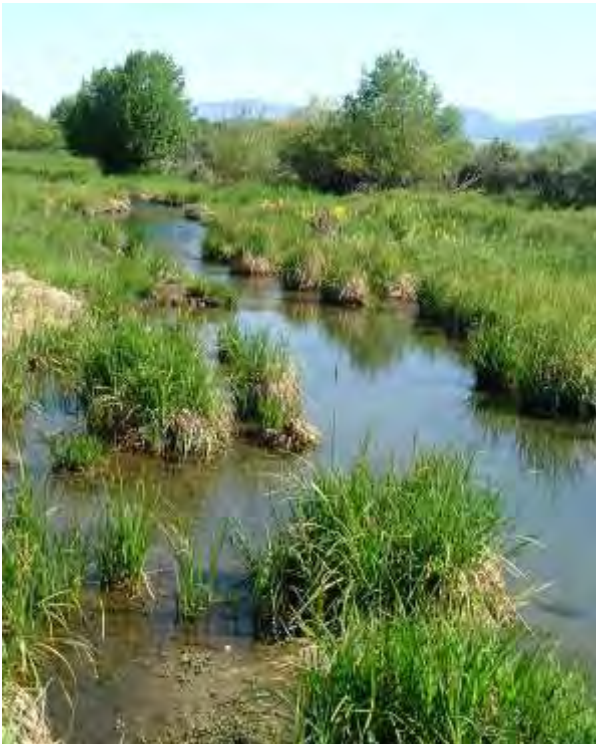
Figure 94. Hummocky, poorly defined channel.
