Future Fisheries Improvement Program Monitoring

2017

Future Fisheries Improvement Program
Project Monitoring 2017

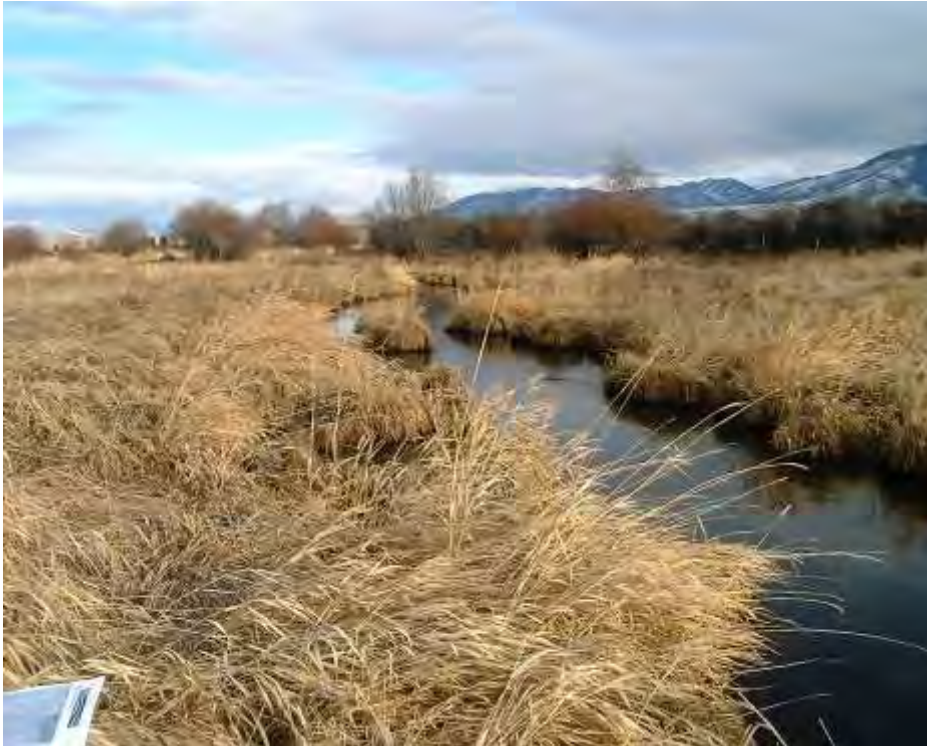
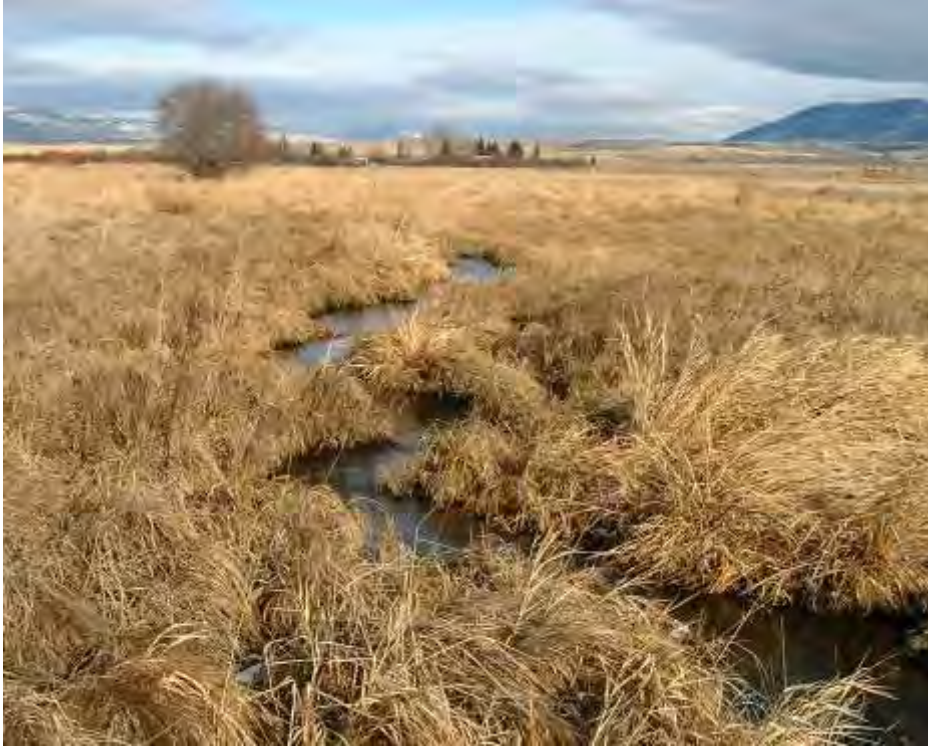
Photos presumably of the unnamed tributary show sedge covered stream banks and variability in channel width (Figure 95 and Figure 96). Willows were rare to absent along the channel. Formation of a sedge covered, mid-channel bar suggested insufficient energy to maintain a narrow, deep E channel that is typical of spring creeks.

Figure 95. Unlabeled photo potentially showing unnamed tributary.

Figure 96. Unlabeled photo potentially showing unnamed tributary.

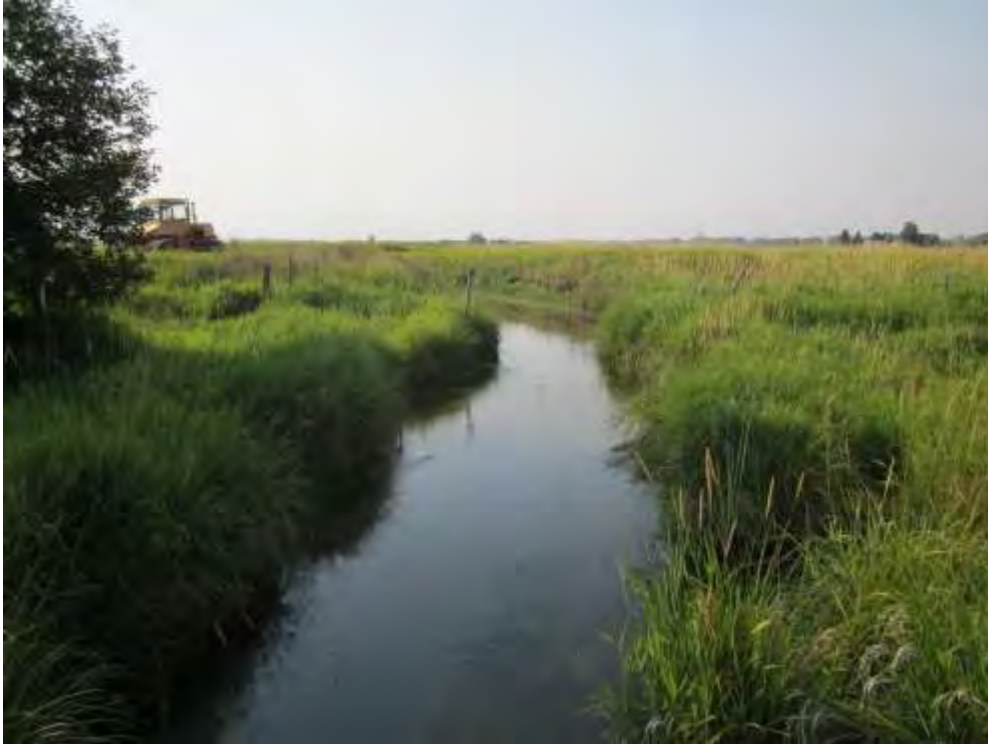
On August 4, 2017, Kyrsten Wolterstorff visited the South Fork Ross Creek project site, accompanied by the landowner. The channel had reverted to its overly wide configuration, and accumulation of fine sediment was again substantial (Figure 97). A robust stand of undisturbed sedges occupied the bank line, so lateral adjustments were not the result of bank erosion. Fine sediment did not fill in the entire channel, as a discrete reach maintained clean gravel (Figure 98).

Figure 97. Overly wide channel on restored portion of South Fork Ross Creek.

As the FFIP and other funding sources have contributed substantially to spring creek restoration, and these streams have high ecological and conservation value, approaches to spring creek restoration need thorough review, application of an adaptive approach, where stream restoration practitioners learn from successes and failures.

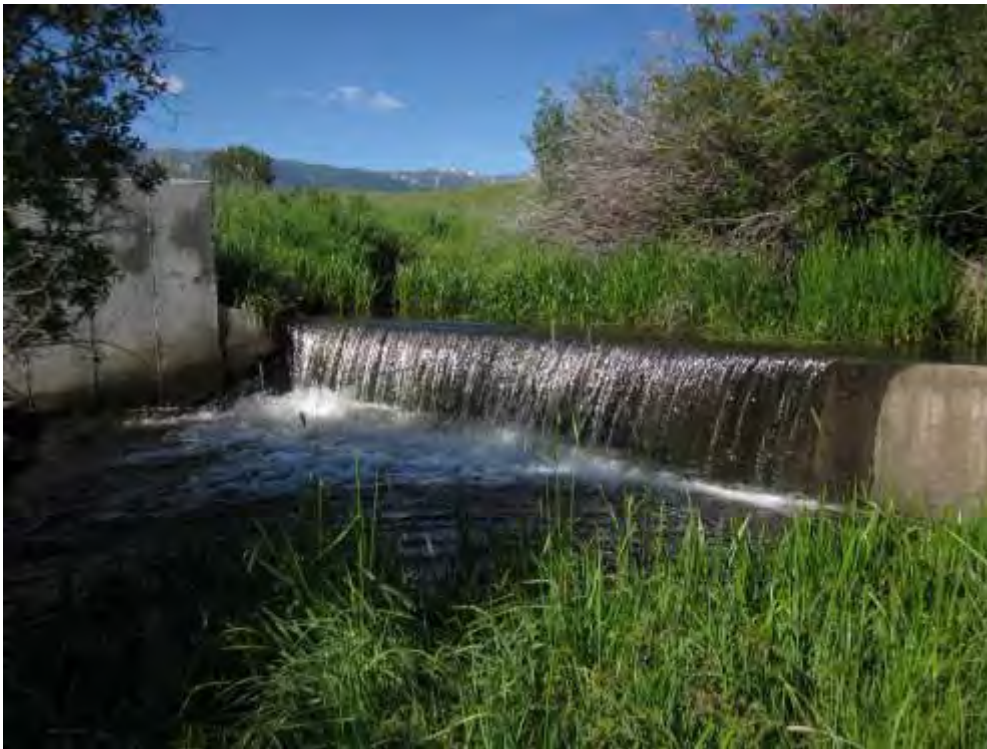
The fish barrier was present (Figure 103); however, it is in disrepair. Concrete on the right side of the barrier was crumbling (Figure 104). In addition, Kyrsten observed the potential for large flows to cut around the left side of the barrier. Otherwise, the barrier was built as described in the FFIP application, with exception that the apron was concrete, not metal, as proposed in the application.

Figure 103. The Thiel Creek fish barrier.

Currently, the barrier is not providing benefit for fish. It is likely detrimental to the resident Brook Trout, as it blocks movement. Moreover, it is in disrepair and has potential to fail, with the left side being vulnerable to erosion, and the right side experiencing spalling of the concrete. Its location in open rangeland make it considerably less secure than a barrier confined by rock walls.

FWP biologists in Region 5 should reexamine the need for this structure, evaluate the risk of its failure, and consider alternative uses, should it be repairable and secured. Mechanical removal of Brook Trout was unsuccessful in Thiel Creek, and its dense shrub cover would likely impede additional efforts at Brook Trout removal. If reestablishment of a population of Yellowstone Cutthroat Trout is desired, chemical removal of Brook Trout would likely be necessary. Thiel Creek provides about 7 miles of stream habitat upstream of the barrier, which exceeds the recommended minimum of 5 miles of habitat to promote long-term persistence of an isolated population.

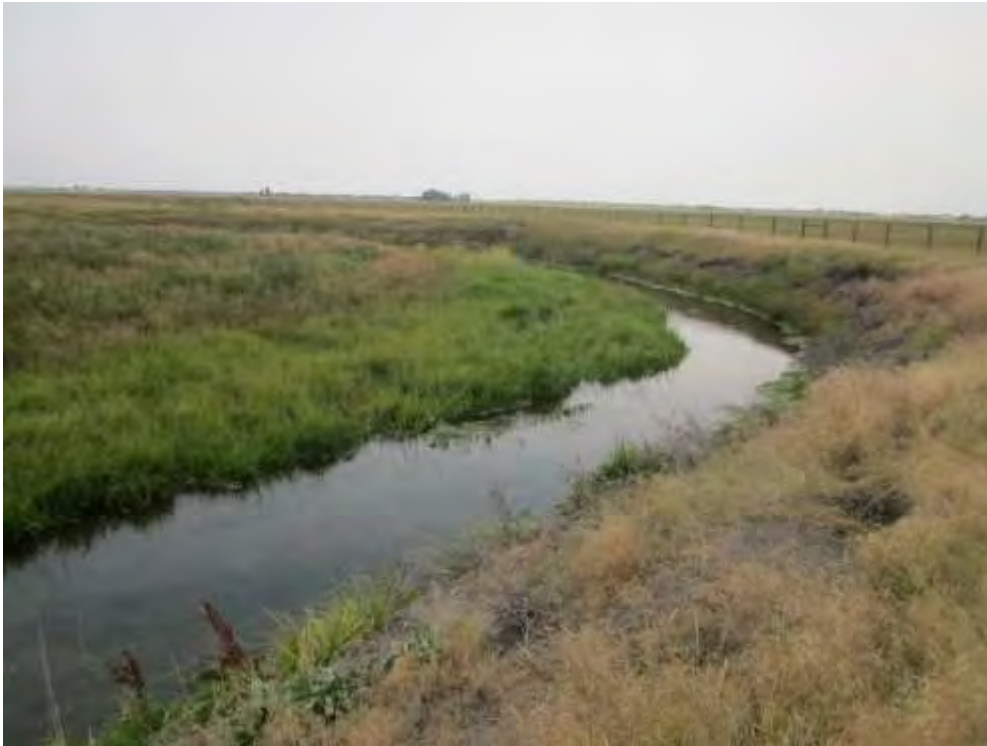
Kyrsten Wolterstorff visited the Thompson Creek project on August 8, 2017. The riparian area was fenced (Figure 106), although not according to the FFIP application. Some hoof shear and manure were present, but grazing pressure was otherwise light (Figure 107).

Figure 106. Riparian fencing on Thompson Creek.

The amount of fine sediment choking the streambed was a factor limiting the ability of Thompson Spring Creek to meet project goals of providing spawning habitat for fish migrating from the East Gallatin River (Figure 106 and Figure 109). The channel was relatively shallow and wide. Combined with the buffered flows typical of spring creeks, the stream lack the energy to transport fine sediment from its bed.

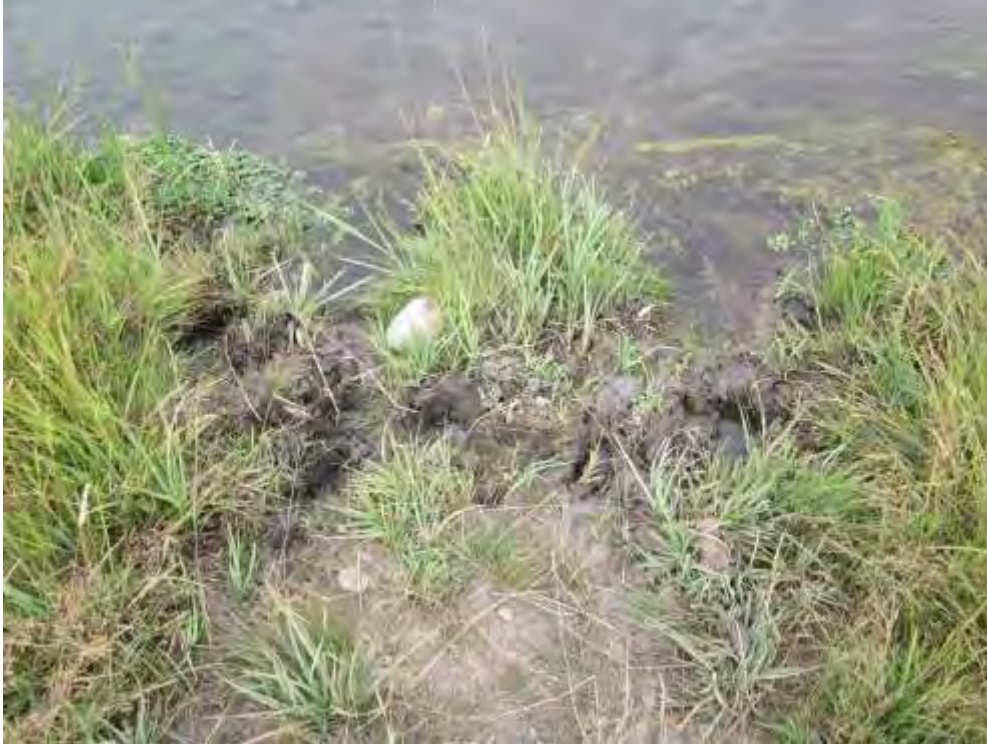
Figure 107. Slight trampling by livestock along Thompson Creek.

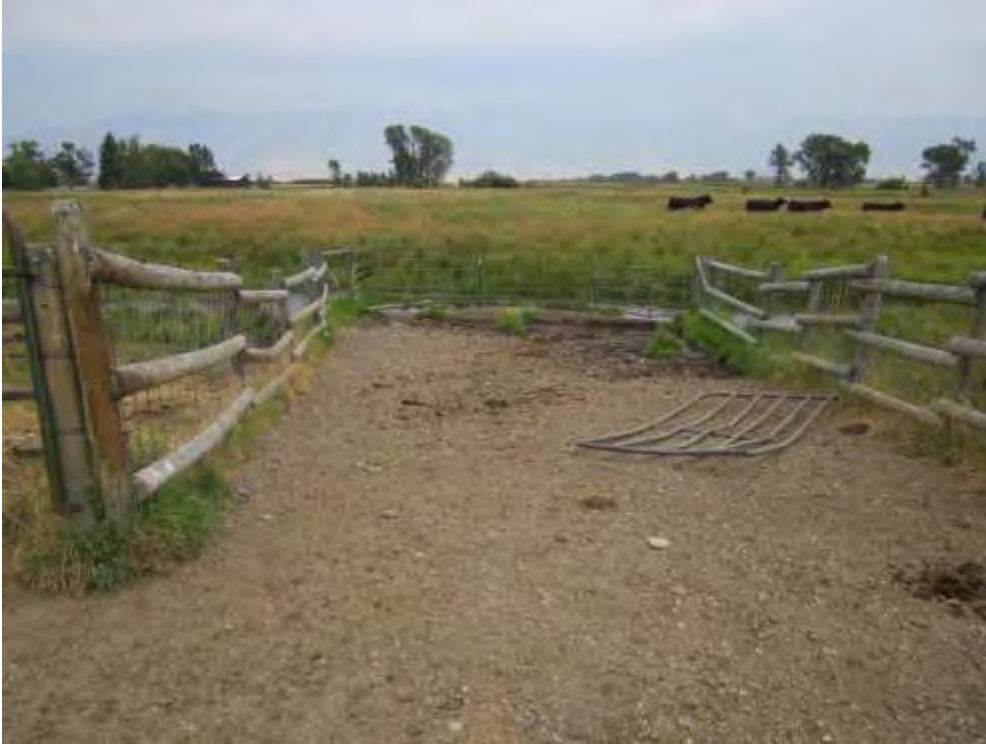
Armored water gaps had been installed as described in the FFIP application (Figure 108). Although it was unclear if the grazing followed a developed grazing management plan, the combination of fencing, water gaps, and limited use of the riparian area resulted in dense herbaceous vegetation within the riparian area. Shrubs were sparse to absent; however, many spring creeks do not provide habitat suitable for establishment of riparian shrubs.

Figure 108. Armored water gap on Thompson Creek.

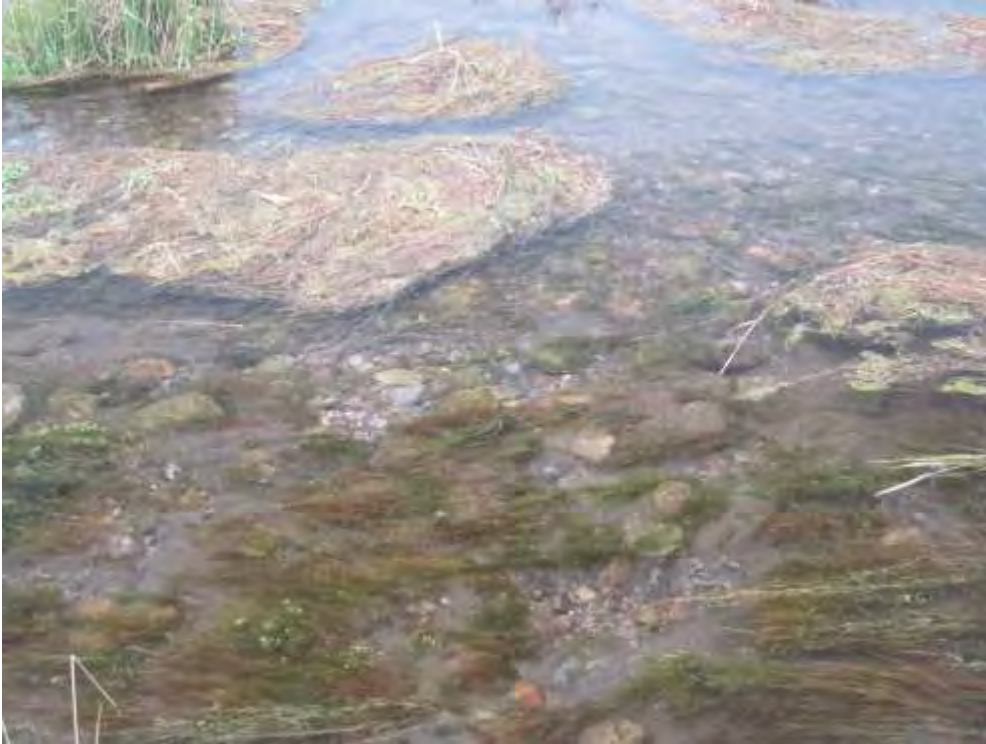
Figure 109. Thompson Creek's streambed, showing high levels of fine sediment and sparse gravel.

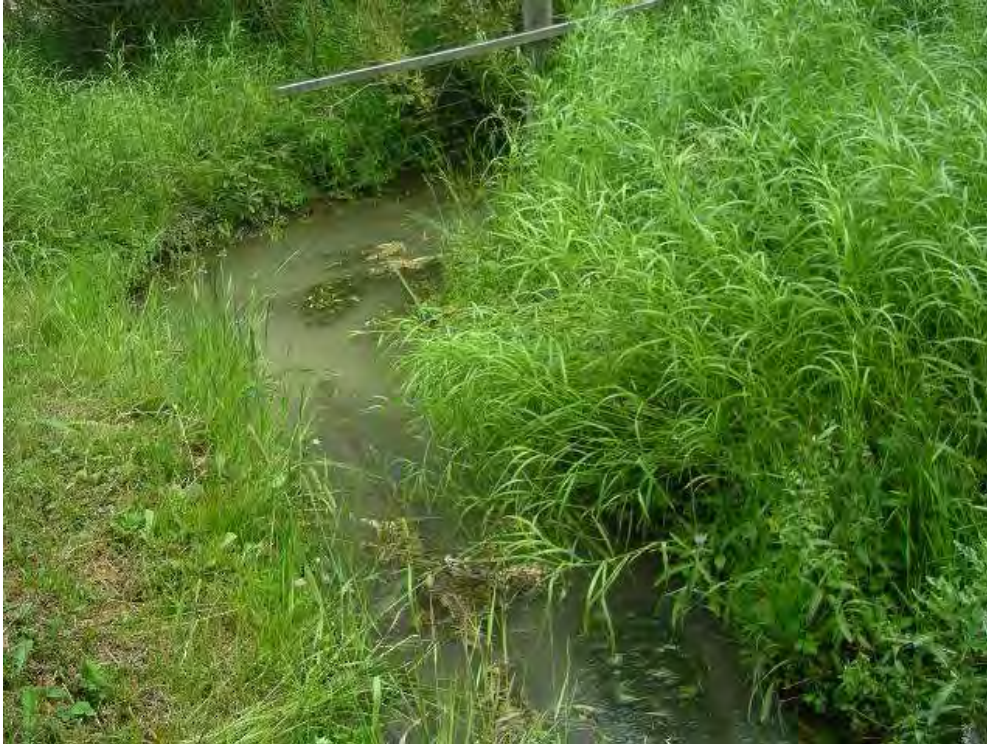
The stream flows through residences and business in Silver Gate. For much of its length, the riparian area was functioning and healthy, but the channel was overly wide, and the streambed mucky (Figure 110 and Figure 111). Dense stands of aquatic macrophytes further trapped and held sediment. The reaches that still supported spawning were considerably more narrow, deep, and had a gravel substrate (Figure 112). Although the impressive runs were gone, Yellowstone Cutthroat Trout still spawned in Willow Creek (Figure 113), and it supported some resident Yellowstone Cutthroat Trout.

Figure 111. Another view of Willow Creek with poor spawning habitat.

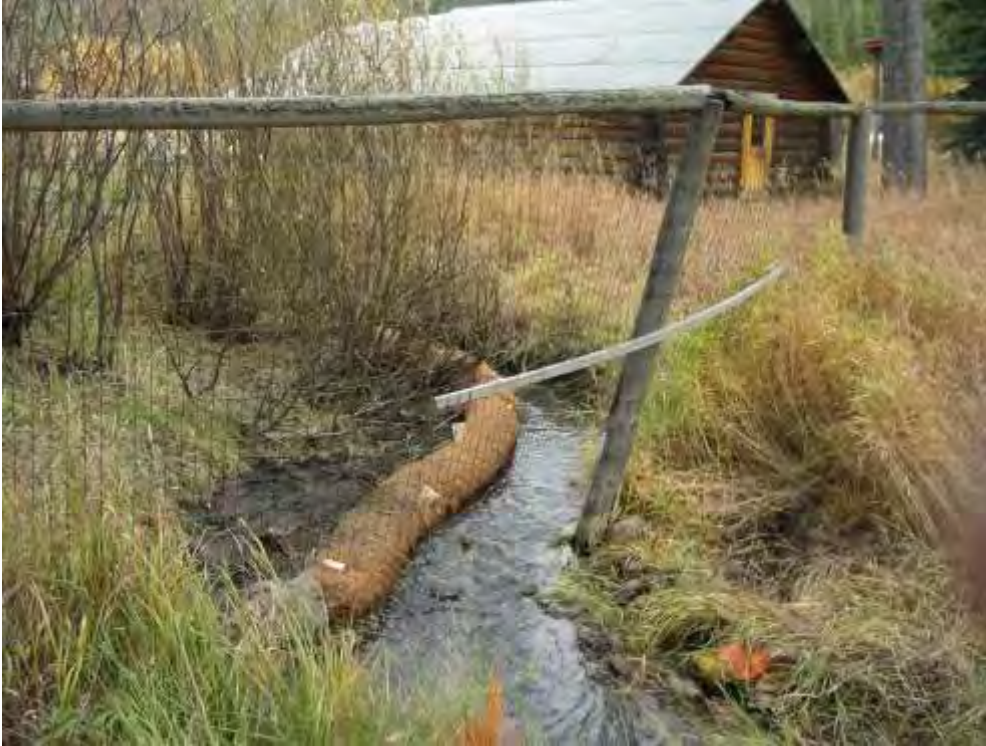
Figure 114. New bank built with straw wattle and back filled with sediment excavated from channel.

The restoration approach was to excavate the channel 1-ft deeper than the desired bed elevation, construct a narrow and deep channel, using straw wattles at the edge of the banks. The muck excavated from the existing channel was placed behind the wattles, and planted with container stock of sedges and rushes (Figure 114). Much of the muck substrate appeared to be soot delivered from the surrounding hillsides after the 1988 wildfires. Spawning size gravel was imported to the stream, and was 1-ft deep, providing substantial depth for Yellowstone Cutthroat Trout to dig redds. Several culverts were replaced with larger, squashed pipes to improve flow and sediment conveyance. Restoration occurred in May of 2013.

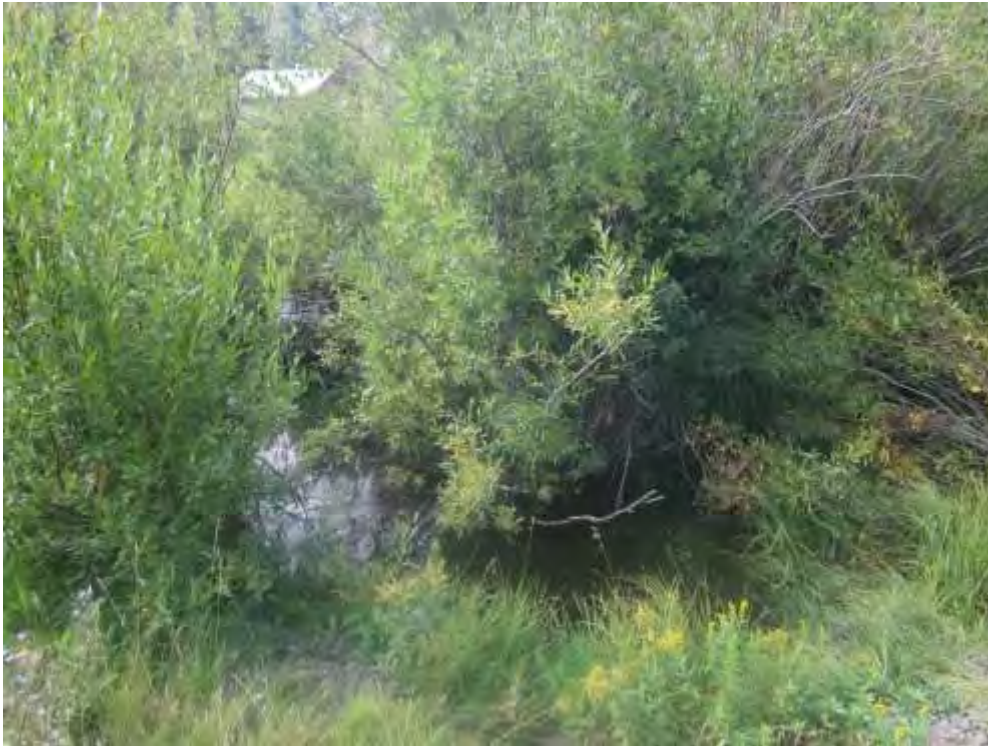
Carol Endicott and Kyrsten Wolterstorff visited Willow Creek on August 24, 2017. Beavers had impounded the upper 70 feet of channel (Figure 115). Otherwise, the channel had retained its constructed dimensions (Figure 116). Substantial amounts of fine sediment had accumulated in some areas; however, significant portions had clean gravel that was suitable for spawning (Figure 117). No fish were observed in Willow Creek; however, Soda Butte Creek had been treated with rotenone in 2015, as part of a Yellowstone Cutthroat Trout conservation effort aimed at eradicating invasive Brook Trout. Nevertheless, locals reported few sightings of Yellowstone Cutthroat Trout in Willow Creek after construction, and the ability of fish to swim into Willow Creek from Soda Butte Creek was questioned, given a substantial drop near the confluence, and accumulation of a large cobble bar in Soda Butte Creek upstream of the confluence. Carol Endicott had noted the abrupt change in channel grade during a previous visit; however, Willow Creek's slope towards Soda Butte Creek was gradual during this site visit.

Figure 115. Beaver impounded reach of Willow Creek.

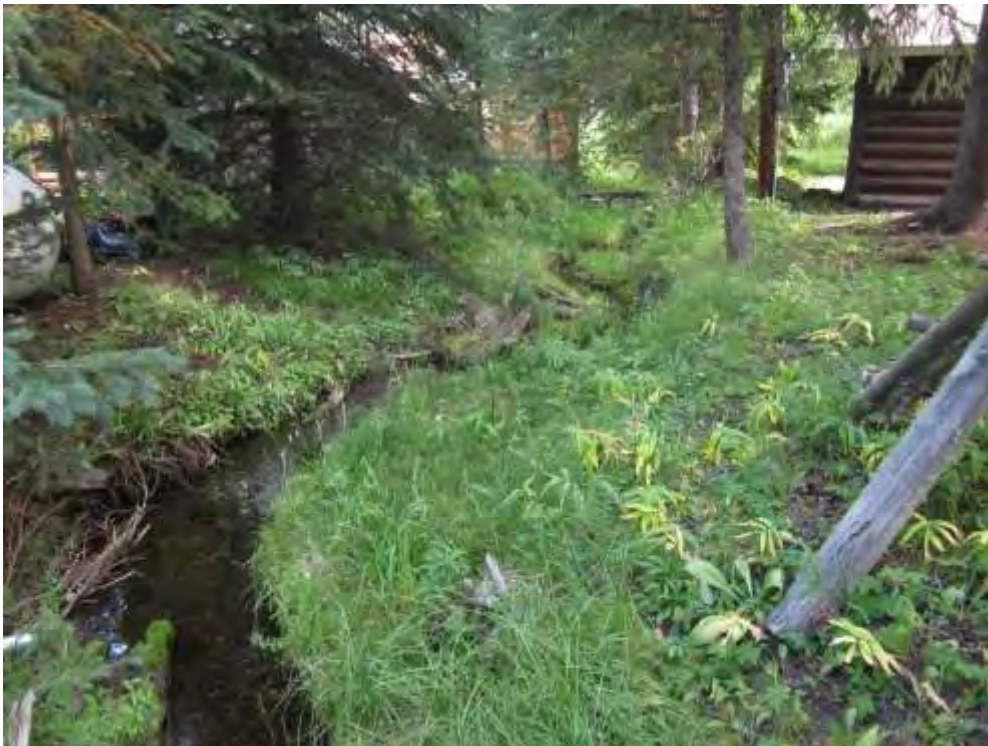
Figure 116. Typical reach of Willow Creek, retaining its cross-sectional dimensions.

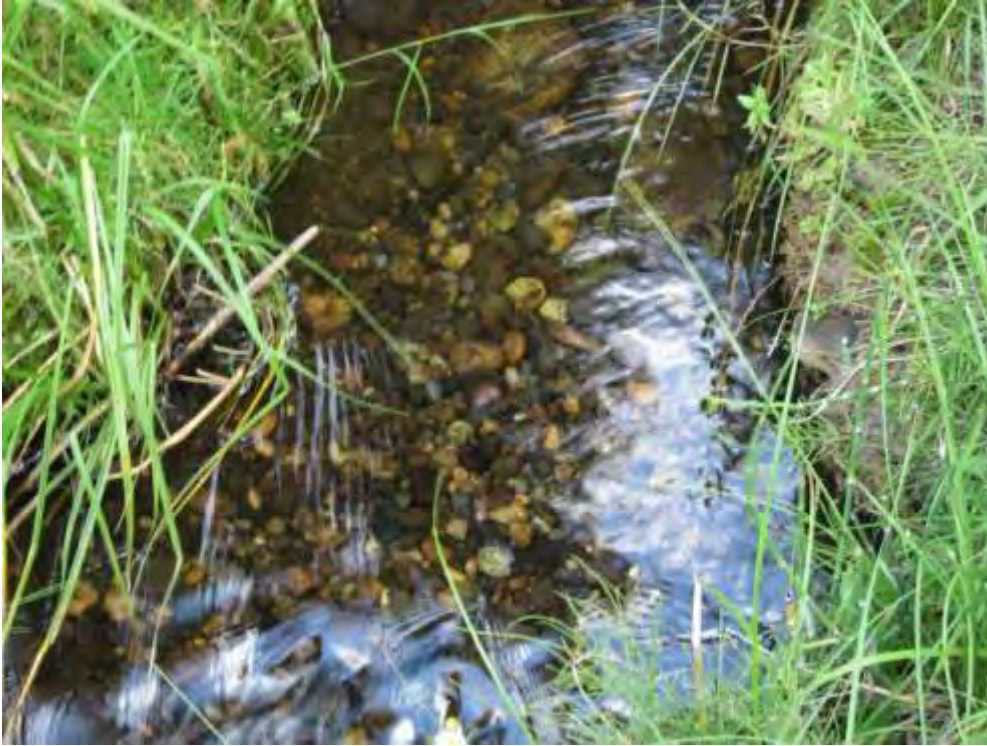
Figure 117. Gravel substrate in Willow Creek.
