FFIP PROJECT & LAND USE MONITORING FORM

Project #:	004-08	Project Title:	Cottonwood Creek Irrigation Diversion
Date:	8/23/2017	Evaluator:	Kyrsten Wolterstorff
Waterbody Name:	Cottonwood Creek	Project Type:	Irrigation Diversion

Cottonwood Creek Diversion Replacement (004-08)

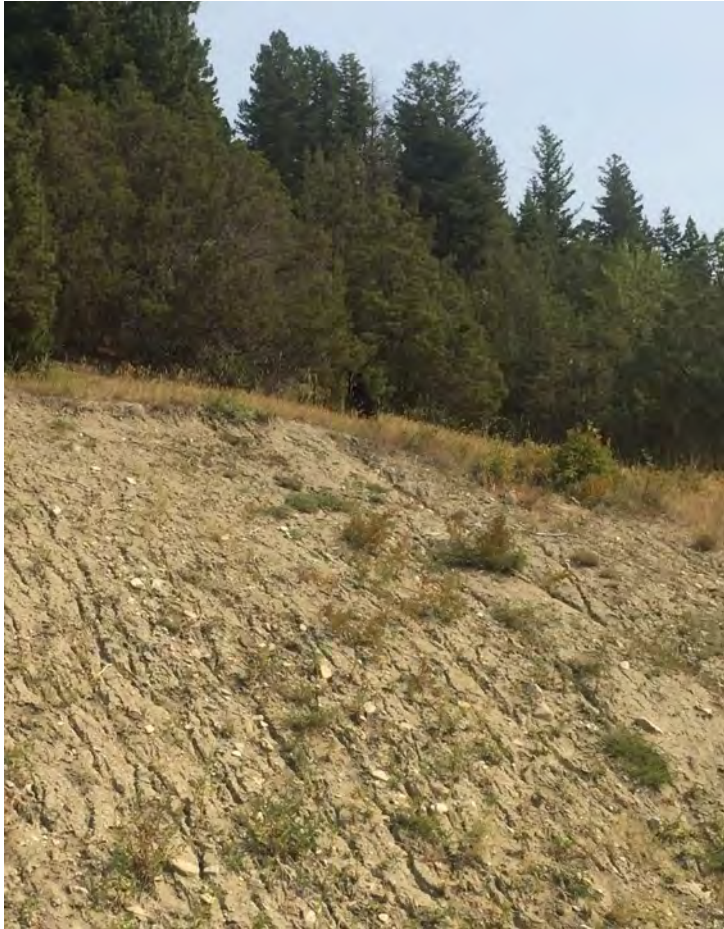
Image 9

Frame #	Lat	Long	Facing?	Scene description/Previous Photo
1	45.938925	-110.542305	North	Looking upstream at check dam
2	45.938925	-110.542305	South	Looking downstream from check dam
3	45.938960	-110.542380	East	Looking at diversion intake from ditch
4	45.938920	-110.542317	East	Looking across check dam
5	45.938920	-110.542317	East	Looking across check dam
6	45.938920	-110.542317	East	Pool below check dam
7	45.938920	-110.542317	North	Looking across diversion intake
8	45.938960	-110.542380	West	Water in ditch with diversion intake closed
9	45.938832	-110.544121	North	Bear above ditch
