FFIP PROJECT & LAND USE MONITORING FORM

Project #:	016-01	Project Title:	Shields River
Date:	8/22/2017	Evaluator:	Carol Endicott, Kyrsten Wolterstorff
Waterbody Name:	Shields River	Project Type:	Bank Stabilization

Project #:	047-03	Project Title:	South Fork Fridley fish ladder
Date:		Evaluator:	Carol Endicott, Kyrsten Wolterstorff
Waterbody Name:	Shields River	Project Type:	Passage

Project #:	018-07	Project Title:	SF Ross Cr habitat and wetland enhancement
Date:	8/4/2017	Evaluator:	Kyrsten Wolterstorff
Waterbody Name:	South Fork Ross Creek	Project Type:	Channel Reconstruction

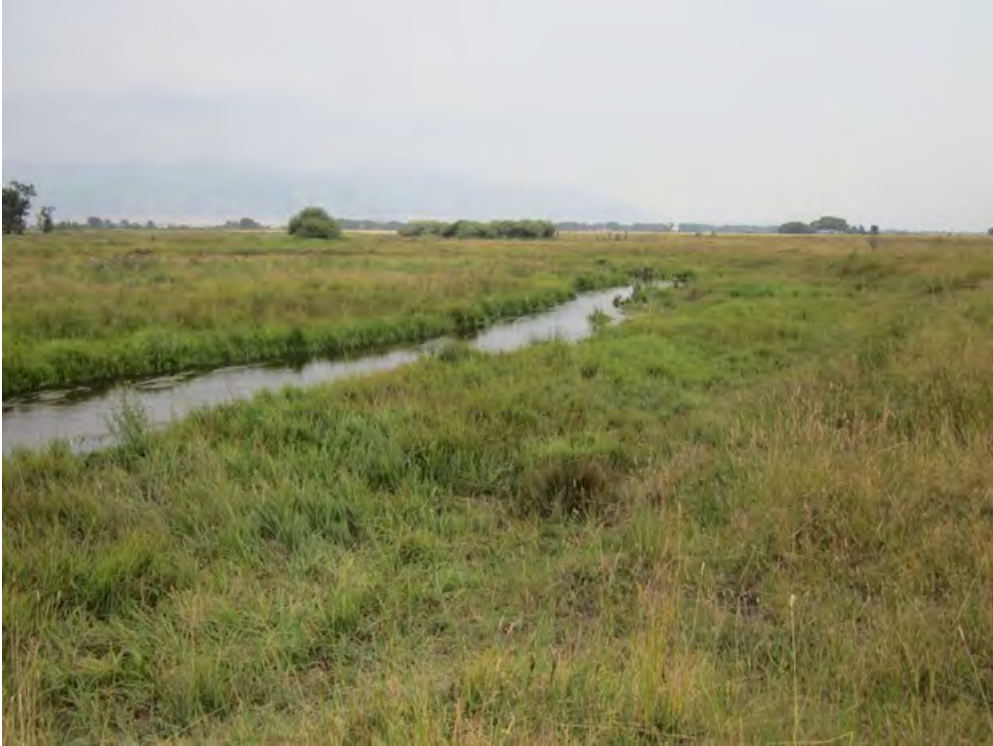
Figure 6

Frame #	Lat	Long	Facing?	Scene description/Previous Photo
1	45.81669	-111.15673	South	New fencing
2	45.81643	-111.15643	South	Steep, but stable bank
3	45.81677	-111.15530	East	Hoof marks in stream
4	45.81677	-111.15530	East	Gravel
5	45.81549	-111.15603	Southwest	"Heavy Use" area(on original map)
6	45.81381	-111.15604	East	Armored stanchion water access
7	45.81377	-111.15589	East	"Heavy Use" area(on original map)
8	45.81455	-111.15643	East	Slight grazing near stream
9	45.81455	-111.15643	North	Difference in grazing (left is pasture right is near stream)

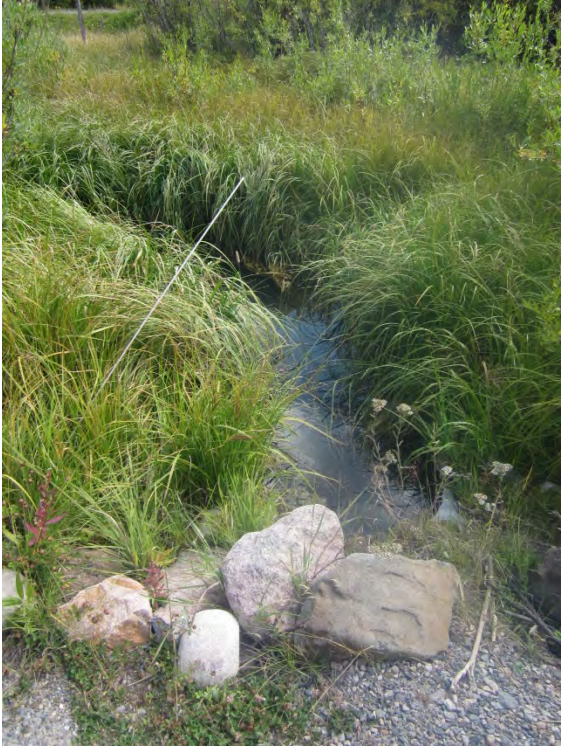
Figure 2

Frame #	Lat	Long	Facing	Scene description
1	45.00748	-109.98814	South	Upstream end of project reach
2	45.00720	-109.98827	North	Facing upstream from culvert 1
3	45.00720	-109.98827	South	Facing downstream from culvert 1
4	45.00717	-109.98832	West	Sedges downstream from culvert 1 on old Burdette property
5	45.00717	-109.98832	South	Bridge on old Burdette property, matches old photo
6	45.00706	-109.98857	North	Facing upstream from culvert 2
7	45.00706	-109.98857	South	Facing downstream from culvert 2, culvert 3 in background
8	45.00702	-109.98867	North	Facing upstream from culvert 3, culvert 2 in background
9	45.00702	-109.98867	South	Facing downstream from culvert 3
10	45.00698	-109.98885	South	Facing downstream towards Olson property
11	45.00690	-109.98892	South	Facing downstream on Olson property, culvert 4 at road crossing, matches old photo
12	45.00680	-109.98905	East	Spawning gravel on Olson property

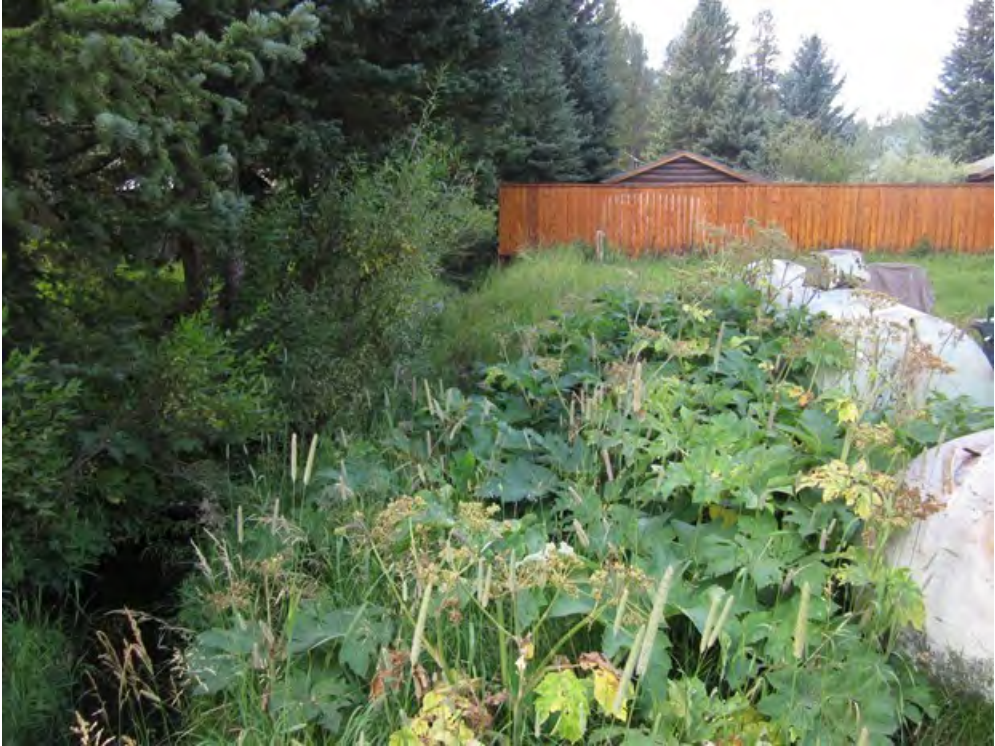
Figure 14

13	45.00674	-109.98923	North	Facing upstream from culvert 4 towards Olson property, matches old photo
14	45.00674	-109.98923	South	Facing downstream from culvert 4, matches old photo
15	45.00665	-109.98939	South	Facing downstream, taken from south of culvert 4 by blue propane tank, matches old photo
16	45.00652	-109.98962	South	Facing downstream, taken from south of culvert 4, showing exposed wattles
17	45.00637	-109.98980	North	Facing upstream, taken from south of culvert 4 by jack-leg fence, matches old photo
18	45.00637	-109.98980	West	Spawning gravel
19	45.00637	-109.98980	North	Looking upstream from jack leg fence, showing exposed wattles
20	45.00626	-109.98991	South	Looking downstream, taken from just north of culvert 5, showing exposed wattles in the shade
21	45.00626	-109.99012	North	Looking upstream from culvert 5
22	45.00626	-109.99012	South	Looking downstream from culvert 5
23	45.00602	-109.99032	West	Looking downstream towards confluence with Soda Butte Creek
