## FFIP PROJECT & LAND USE MONITORING FORM

<b>Project #:</b>	045-04	<b>Project Title:</b>	North Fork Horse Creek
<b>Date:</b>	6/22/2017	<b>Evaluator:</b>	Kyrsten Wolterstorff
<b>Waterbody Name:</b>	North Fork Horse Creek	<b>Project Type:</b>	Water savings

<b>Project #:</b>	048-2003	<b>Project Title:</b>	North Fork Horse Creek
<b>Date:</b>	6/22/2017	<b>Evaluator:</b>	Carol Endicott, Kyrsten Wolterstorff
<b>Waterbody Name:</b>	North Fork Horse Creek	<b>Project Type:</b>	Riparian

<b>Project #:</b>	022-04	<b>Project Title:</b>	North Fork Horse Creek fish screen
<b>Date:</b>	6/22/2017	<b>Evaluator:</b>	Carol Endicott, Kyrsten Wolterstorff
<b>Waterbody Name:</b>	North Fork Horse Creek	<b>Project Type:</b>	fish screen

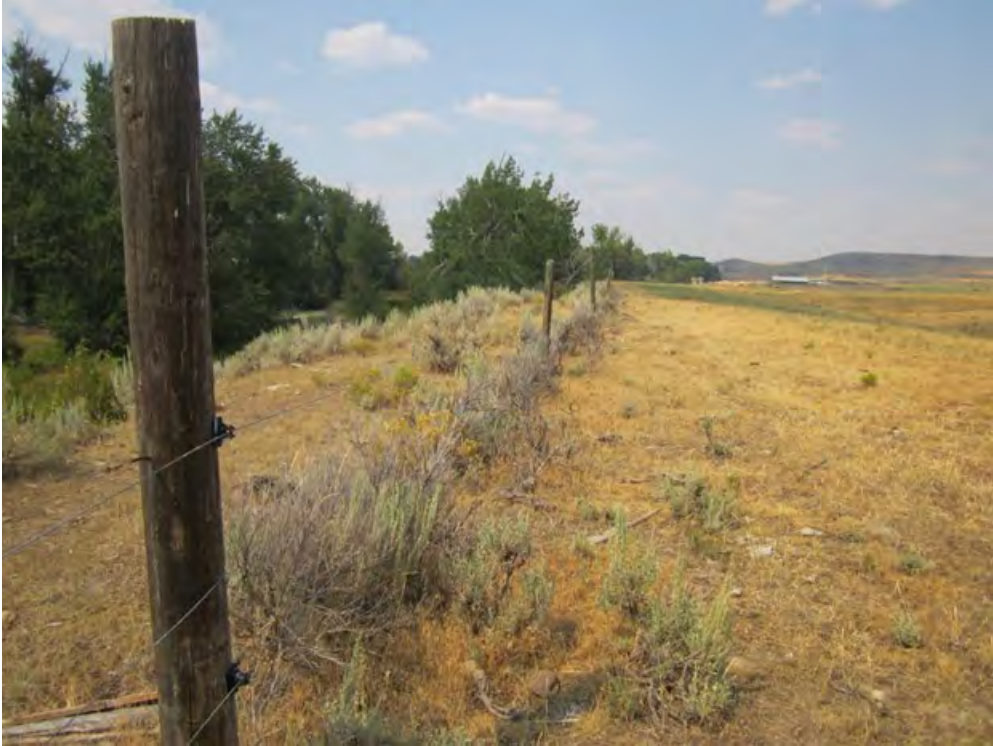
Figure 13

All fencing appears to be in good condition. Some areas in the riparian zone had fence posts with no wires, but they appeared to be part of the FFIP project. Cattle had access to the river, as evidenced by light trampling, manure, and hoof prints. The west side of the river is not fenced, but appears to be hay fields rather than pasture. Land owner said he had about 20 heifers "down there", which were heard but not seen. Riparian area looks relatively healthy with little grazing, although the hillside above the river does have some heavy grazing and a worn path (Images 12-15). Riparian are could still use slight improvement though.
