A STREAM HABITAT AND FISHERIES ANALYSIS FOR SIX TRIBUTARIES TO THE BIG BLACKFOOT RIVER

A cooperative project between the Bureau of Land Management
and the Montana Department of Fish, Wildlife and Parks

Reported by
Ron Pierce, Fisheries Division, MTDFWP

October 1991

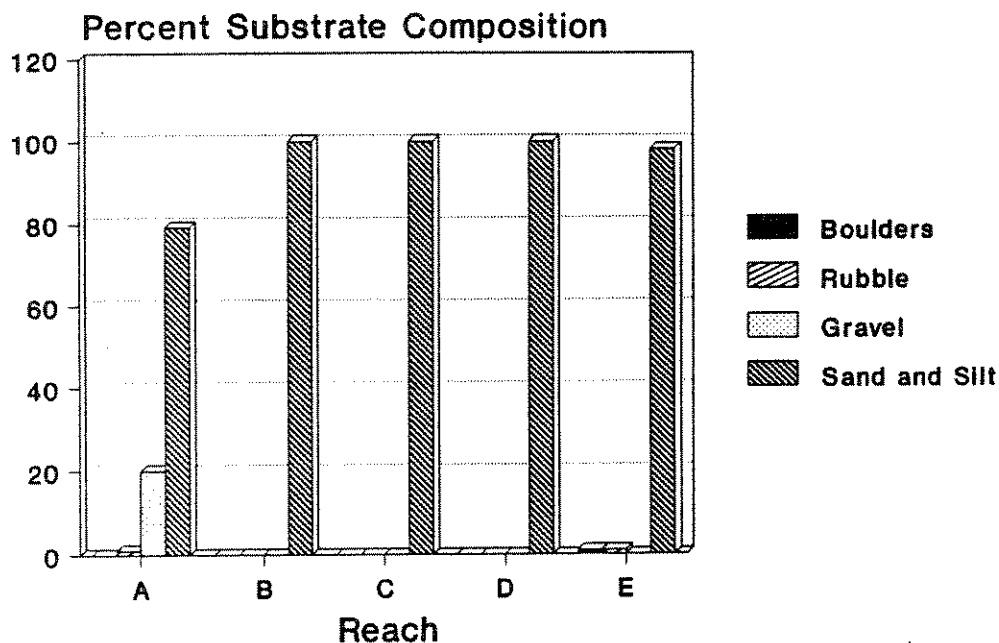
Figure 8 Percent substrate composition for 5 reaches of Nevada Spring Creek.

Substrates were comprised primarily of sand and silt (Fig. 8). Sand and silt increased from a mean of 79% in reach A to 99-100% in downstream reaches. Substrates in Reaches B and C were estimated

to be 100% sand and silt. Beginning in Reach B, depth of sediment increased downstream to reach D where a rock dam and culvert structure that is situated above stream base level. The device impounds water and causes sediment deposition upstream.

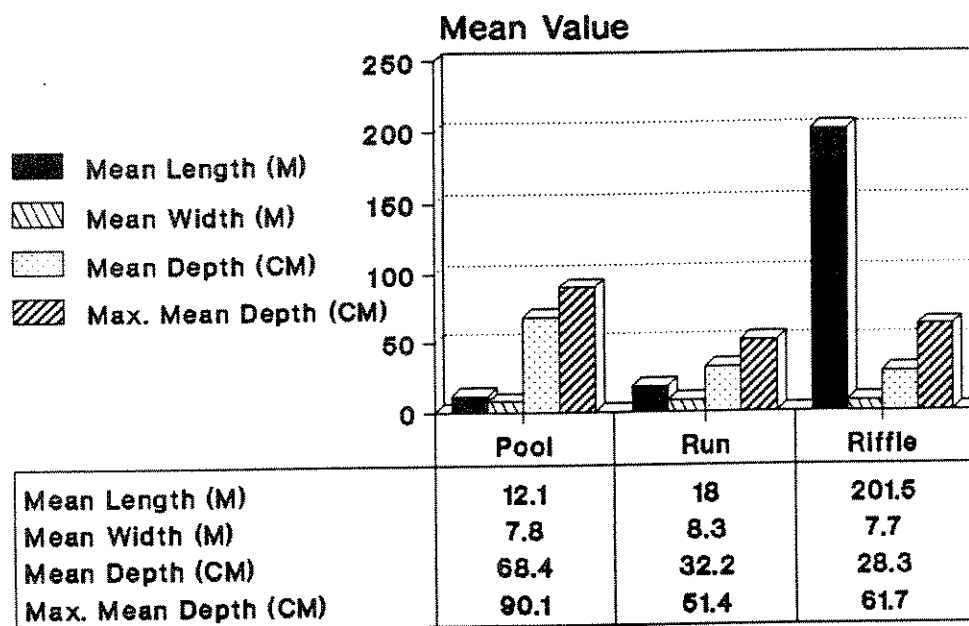
Figure 10 Mean length, width and depths for Gold Creek habitat types.

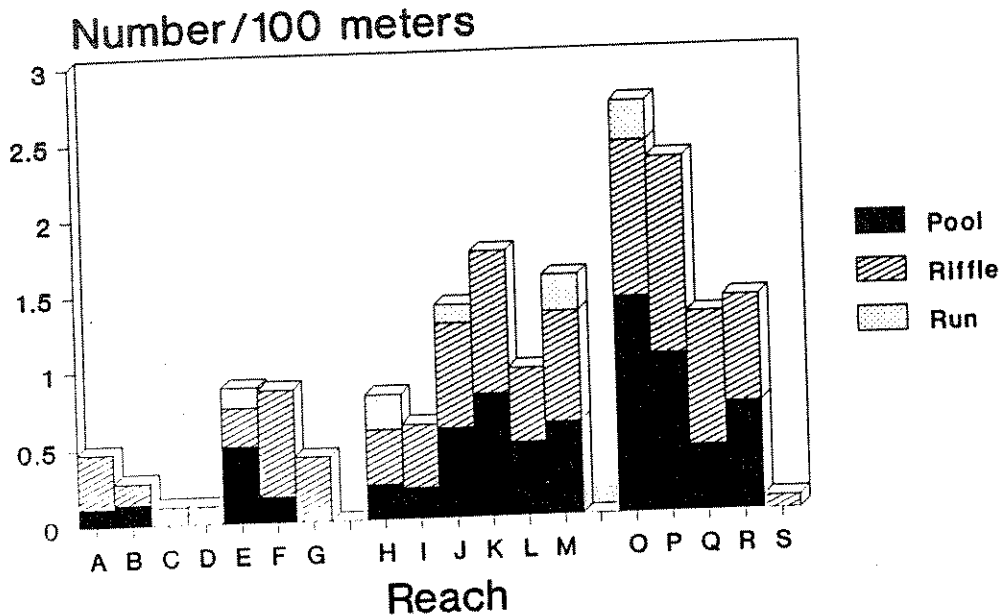
Figure 11 Sampled frequency of stream habitat types for Gold Creek stream reaches.

Forty two percent of the all habitat units were pools. Pools comprised however only 5% of the sampled surface area. Eight runs comprise the remaining 7% of the sampled units, and covered 8% of the sampled area. Of the 47 sampled pools there were 14 trench pools, 11 plunge pools, 8 lateral scour pools, 7 dammed pools and 7 back water pools. Like riffle types, pool diversity and frequency was highest in middle to upper reaches (fig. 11)

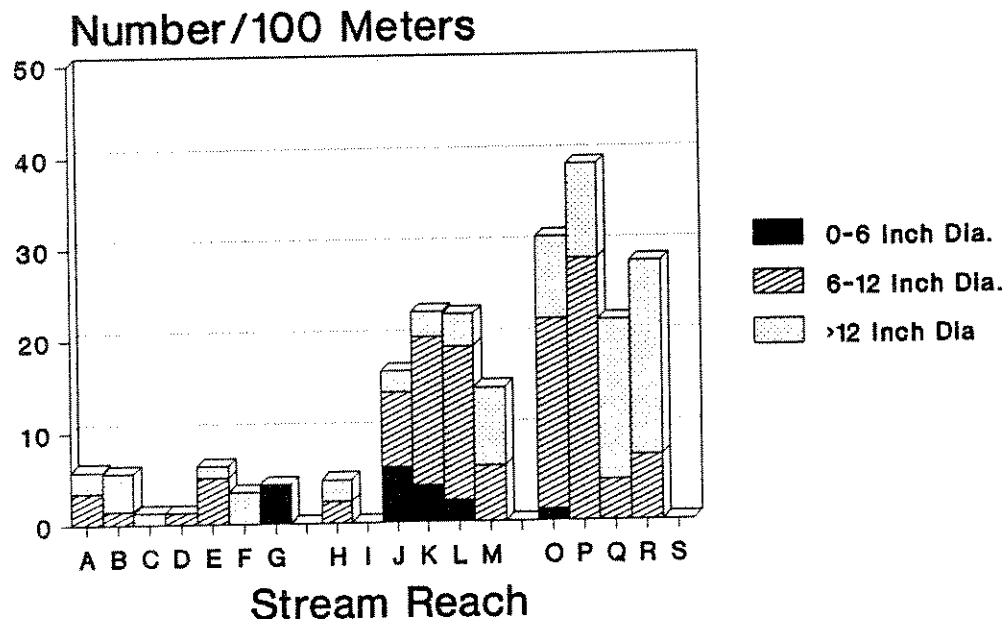
Figure 12 Amount of Organic debris for Gold Creek stream reaches.

Trends in the organic debris sample show a reduced amount of organic debris in lower stream reaches. The amount of organic debris increased significantly in the middle and upper stream

segments (fig. 12). The amount of organic debris in Gold Creek shows high degree of similarity with the frequency of habitat units in the Gold creek channel.

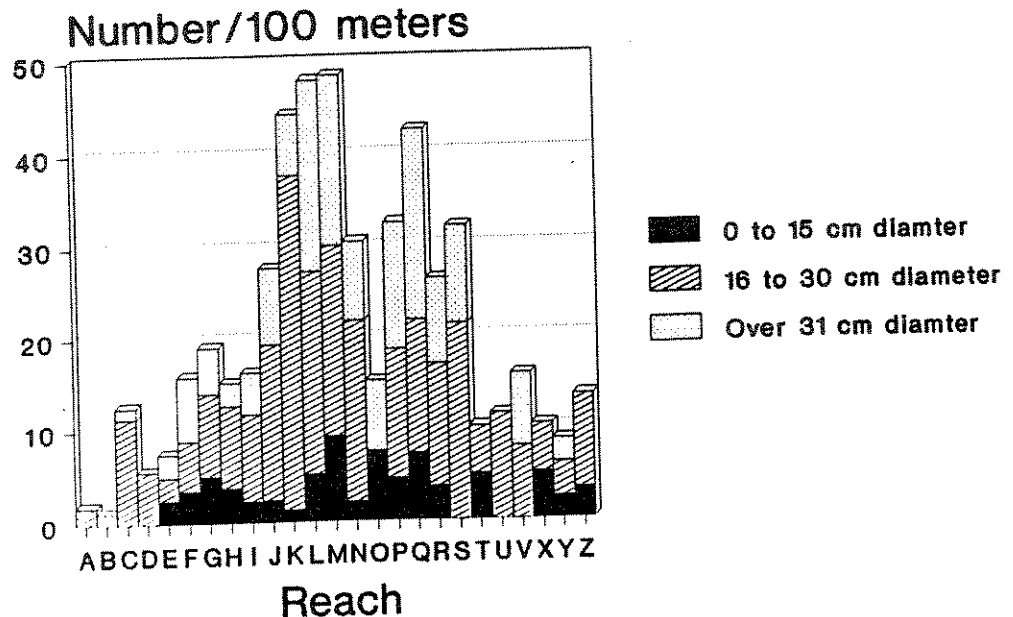
Figure 16 Amount of organic debris for individual stream reaches of Chamberlain Creek.

The amount of organic debris for individual stream reaches was highest in between reaches J and S (fig. 16).
