Stream Surveys in the Big Hole River Drainage 2017-2020

December 2020

Fisheries Division Federal Aid Job Progress Report

Job Title: Big Hole River Drainage Fisheries Management

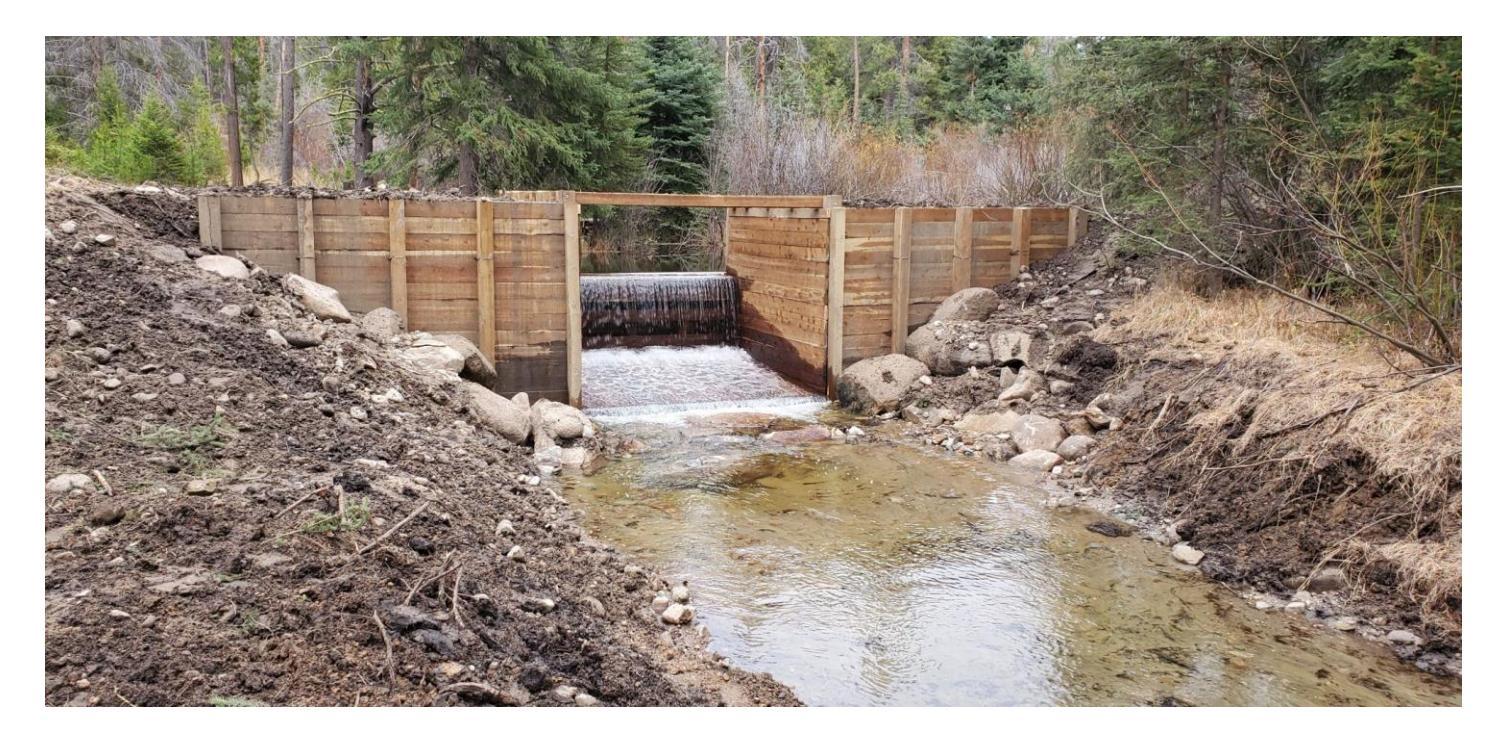
Figure 1. Fish barrier on Doolittle Creek below the confluence of the North Fork constructed in the fall of 2020.

A permanent fish barrier was constructed on Doolittle Creek downstream of the confluence of the North Fork in the fall of 2020 (Figure 1) and isolates over 11 miles of stream. Removal of brook trout is scheduled to begin in 2021. Prior to removal, WCT will be salvaged and held in non-treated water while the stream is treated with rotenone. Once the rotenone is neutralized, the WCT will be released back to Doolittle Creek. Unlike the previous treatment in the North Fork when EDNA technology did not exist, Doolittle Creek will be EDNA tested to determine if brook trout have been completely removed.

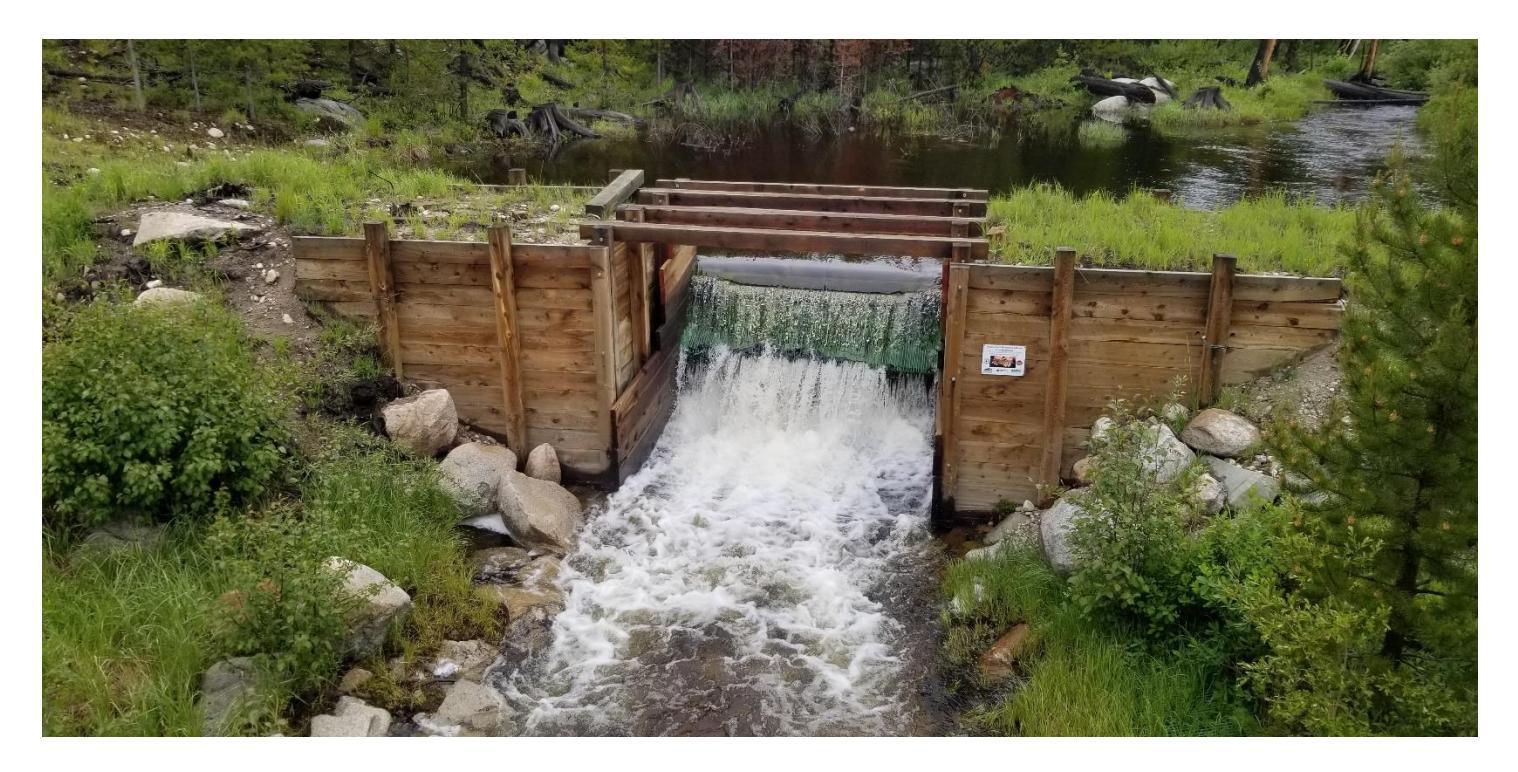
Figure 2. Bender Creek fish barrier in June 2020. Barrier was constructed in 2017.

Bender Creek, similar to Schultz Creek, is a tributary to Johnson Creek draining out of the Pintler Mountain Range. The headwaters of Bender Creek contain a non-hybridized population of westslope cuthroat trout. When the headwaters of the stream were last sampled in 1995, cutthroat trout were isolated in the upper ½ mile of stream. WCT from Bender Creek were used in the founding of the Big Hole WCT brood in the Cherry Creek drainage. A fish barrier was constructed on Bender Creek in 2017 at the crossing of Forest Road 1203 (Figure 2). Barrier construction on Bender Creek also required a barrier be placed on a separate culvert approximately ¼ mile from the bridge crossing. During high water, a secondary channel in Bender Creek from the meadows above becomes active and flows overland and down a separate channel and under Road 1203. The culver was fitted with a screened drop structure on the inlet to prevent fish passage for the few weeks in June when the channel is active. Bender Creek was treated with rotenone to remove brook trout in 2018. Prior to brook trout removal the WCT in the headwaters were salvaged using electrofishing and kept in Bender Creek upstream of the treatment area. Roughly 60 WCT were held during the treatment. EDNA testing occurred the following year in early summer in the upper 1.5 miles of the stream to determine if a second salvage of WCT would be necessary prior to retreatment of the stream. EDNA indicated that brook trout remained in the headwaters of the stream in 2 locations so WCT were once again salvaged and held and the stream was treated a second time. Only 32 WCT were captured during the 2nd salvage event in 2018. In 2019, the entire stream upstream of the fish barrier was EDNA tested and there were positive hits for brook trout near the fish barrier and approximately 3 miles upstream near an unnamed tributary. The stream was treated a 3rd time focusing on the areas where EDNA indicated brook trout presence. Two brook trout were found immediately upstream of the fish barrier but no brook trout were observed farther upstream during the treatment. No additional EDNA testing has been performed to date and the WCT in the headwaters will be allowed to reproduce and begin to fill the habitat downstream. Additional EDNA testing is warranted to determine if fish removals produced complete brook trout removal.

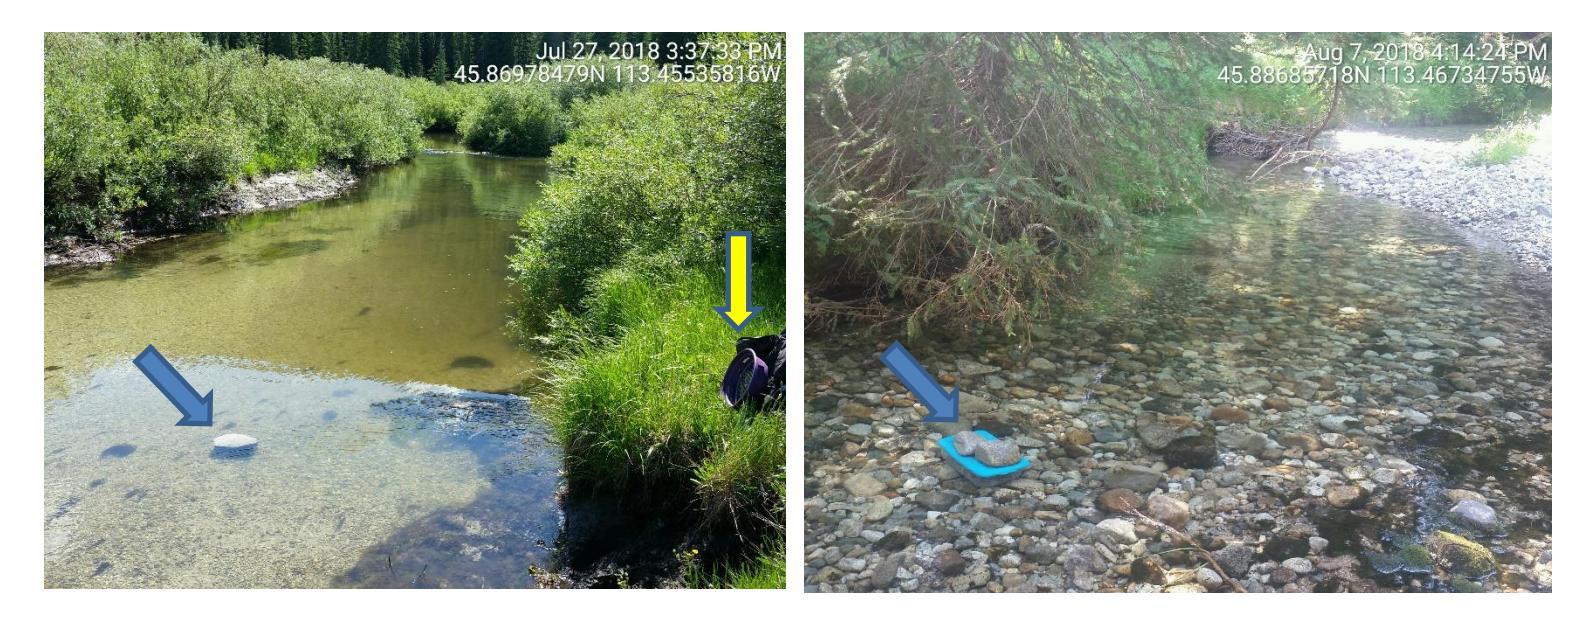
Figure 3. Egg containers used to restock Pintler Creek in 2018. Blue arrows indicate the incubator and yellow arrow is the sieve used to filter fines from gravels added to egg containers. All equipment and eggs could be carried in one backpack.

eggs from Van Houten with M012 genes would only be stocked into Pintler Creek. In 2018, 25,000 eggs were stocked into Pintler Creek and Beaver Creek using containerized incubators as described above. Incubators were installed in July and August and stocked with eyed eggs. Roughly 2,000-5,000 eggs were stocked in each container. In 2019, construction of an isolation facility at the Washoe Park hatchery was completed and eggs from the same sources listed above were incubated and hatched in this facility. In 2019 and 2020 9,872 and 27,136 juvenile cutthroat trout were stocked into Pintler Creek respectively. Because of its wilderness designation fish were transported to the stream either via backpack or a 20-gal cooler fitted with and oxygen tank and loaded onto a game cart. In 2019, livestock were also used to distribute fish up to within 1 mile of Oreamnos Lake. In 2018 Oreamnos Lake was stocked with 1,000 fertile fish from York Pond via helicopter.

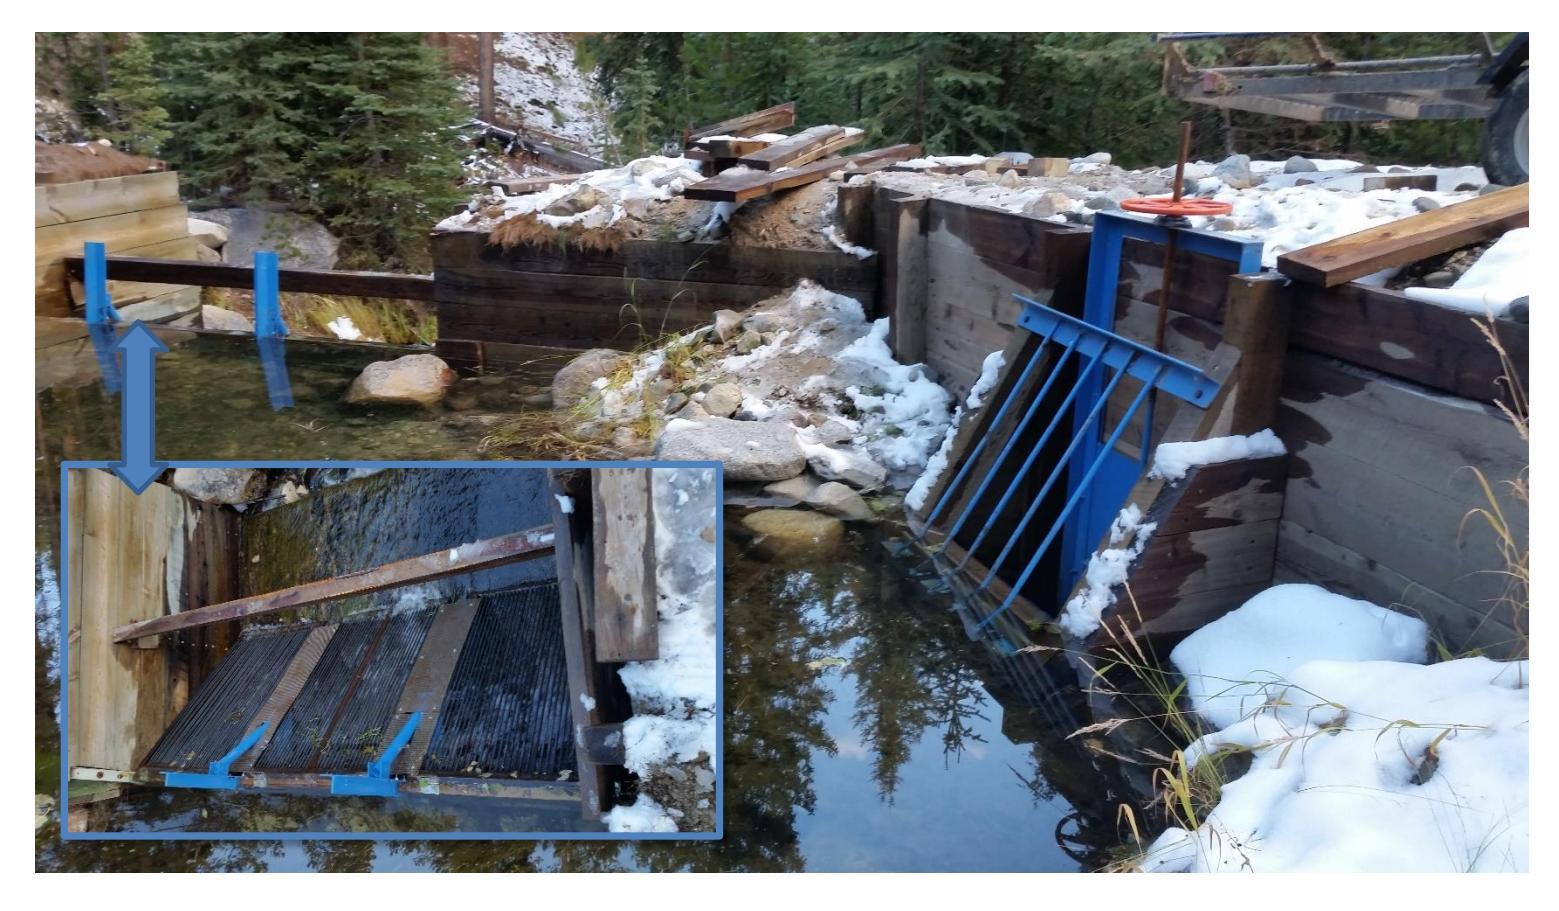
Figure 4. York diversion on the West Fork of Mudd Creek after modifications in 2019. Inset photo is of the barrier drop and screen.

Additional modifications were made to the W Fk Mudd Creek fish barrier in 2019 following a disagreement about how water was allocated between the West Fork of Mudd Creek and York Gulch. The initial conflict resulted in the boards in the fish barrier/diversion structure being removed by a downstream rancher. These board provided the extra height necessary to preclude upstream fish passage in the stream. After meeting with the owners of the 2 ranches it was determined that the solution to the problem would be to raise the inlet elevation to the headgate to match the elevation of the fish barrier to deliver a roughly 2/3 to 1/3 delivery of water to West Fork Mudd Creek and York Ditch respectively (Figure 4). Flows into the ditch are not closely monitored so this alteration to the configuration of the structure will apportion water with little maintenance.

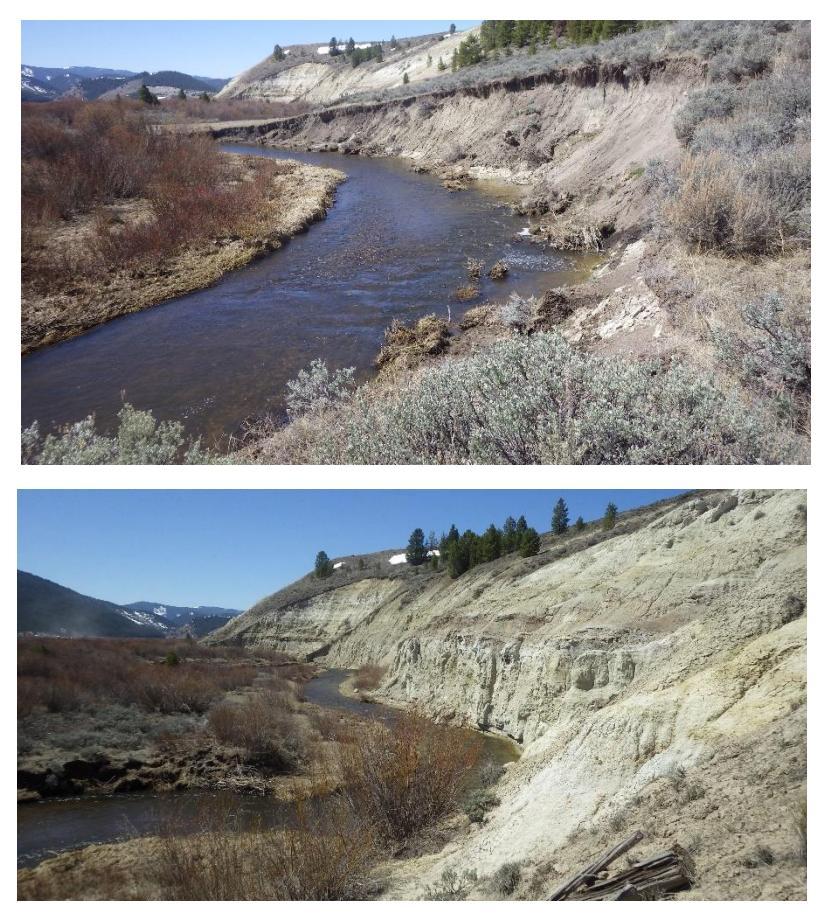
Figure 5. Eroding bands of French Creek upstream of Highway 569 crossing in 2016

Upstream of the Highway 569 crossing on Mount Haggin, French Creek flows against high, chalky banks which are actively eroding (Figure 5). These chalky banks are frequently calving into the stream causing annual deposition of an estimated 400+ tons of sediment per year. The cause of this erosion appears to be, at least in part, related to past mining activity in the area. French Creek has a very wide and well vegetated floodplain through this reach; however, it appears that the stream has been forced against the bluff so the floodplain could be mined. There is also a historic dredge channel that may have been used to convey water to the mining site. To restore this reach and reduce the chronic erosion

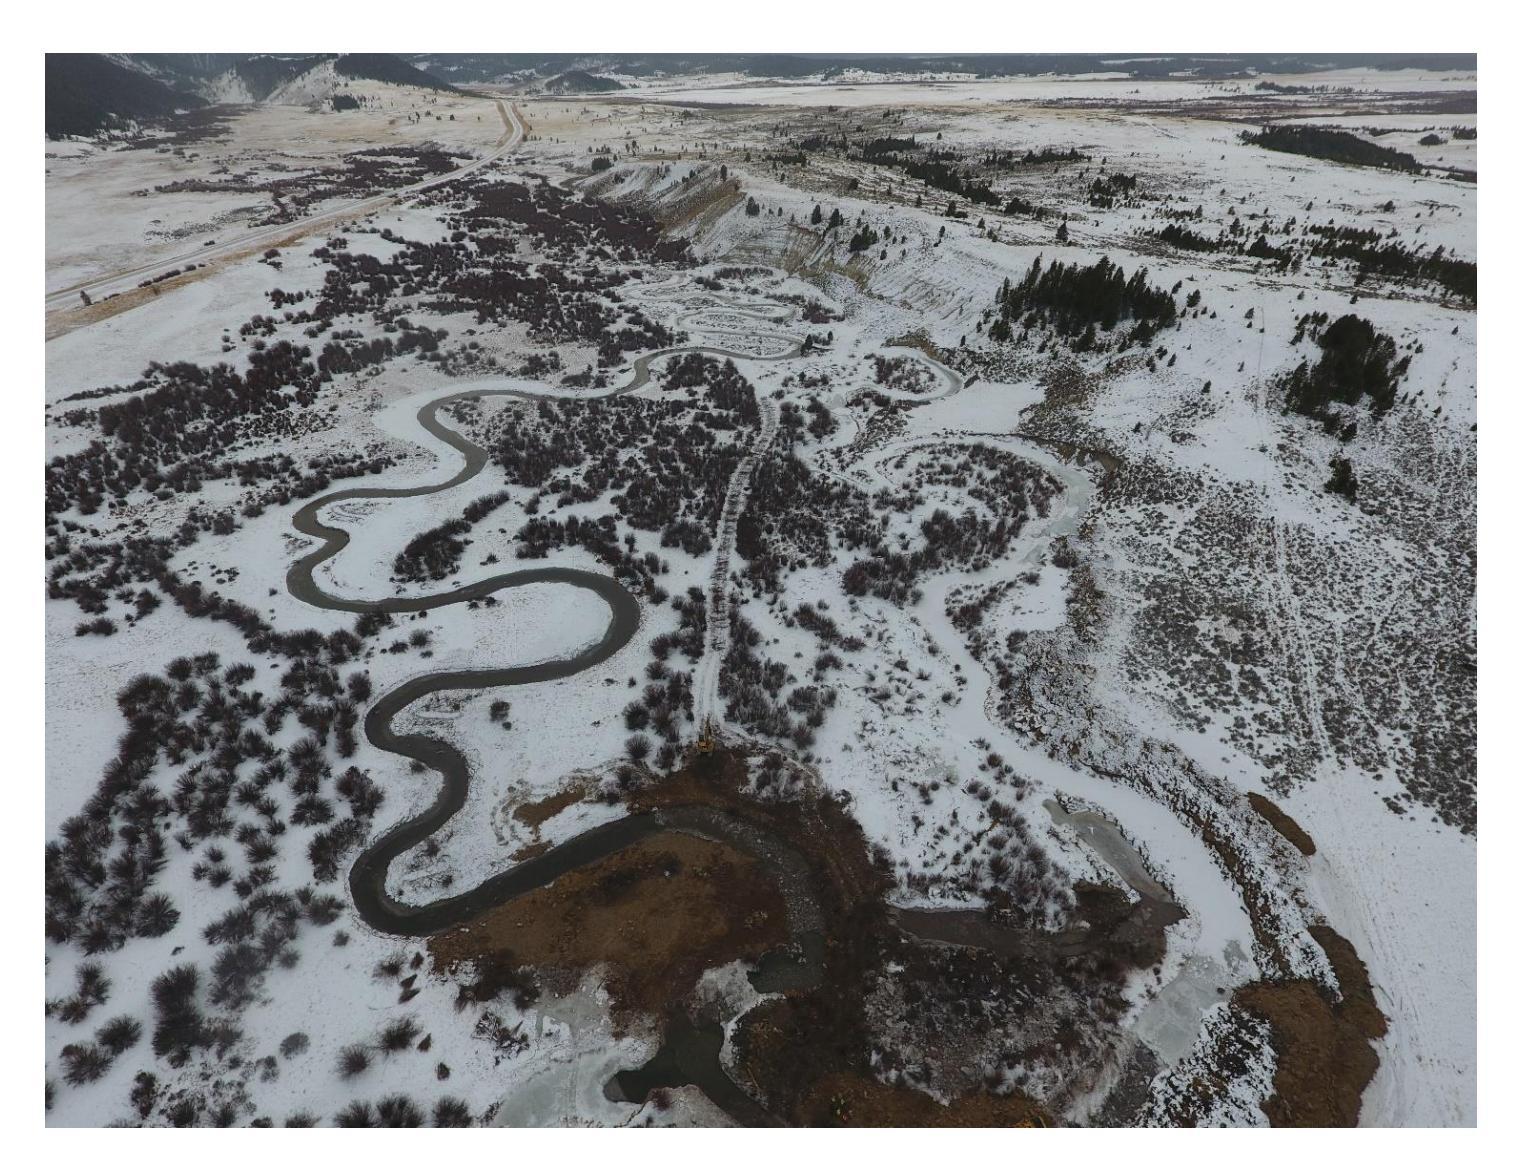
Figure 6. New stream channel on the left and the historic stream channel on the right (frozen) of French Creek in November of 2019 immediately after construction.

problem, a design was developed to construct a new stream channel in the wide floodplain located to the southeast of the existing stream and also restore the mined reach and create a functioning floodplain and riparian area. Approximately 2,700 ft of lineal feet of new stream channel were constructed in the floodplain away from the eroding hillslope (Figure 6). The upstream portion of the new stream channel was located in an area of healthy riparian vegetation. Native sods and existing willows and willow transplants were used to construct the banks of the new stream channel. Because of the intact floodplain and vegetation in this reach, less floodplain work was necessary. The lower reaches of the new channel flow through the formerly mined area. Bioengineered meander bends with added log jams and root wads were constructed in the in this area. Excess fill generated from construction was disposed of against the eroding terrace. The steep slopes of the terrace and bench on top contain potential important prehistoric artifacts and by stabilizing the toe of the eroding slope, losses of these resources will be greatly diminished. Construction of the project took place in the late fall of 2019 and was completed in roughly 2 months. The

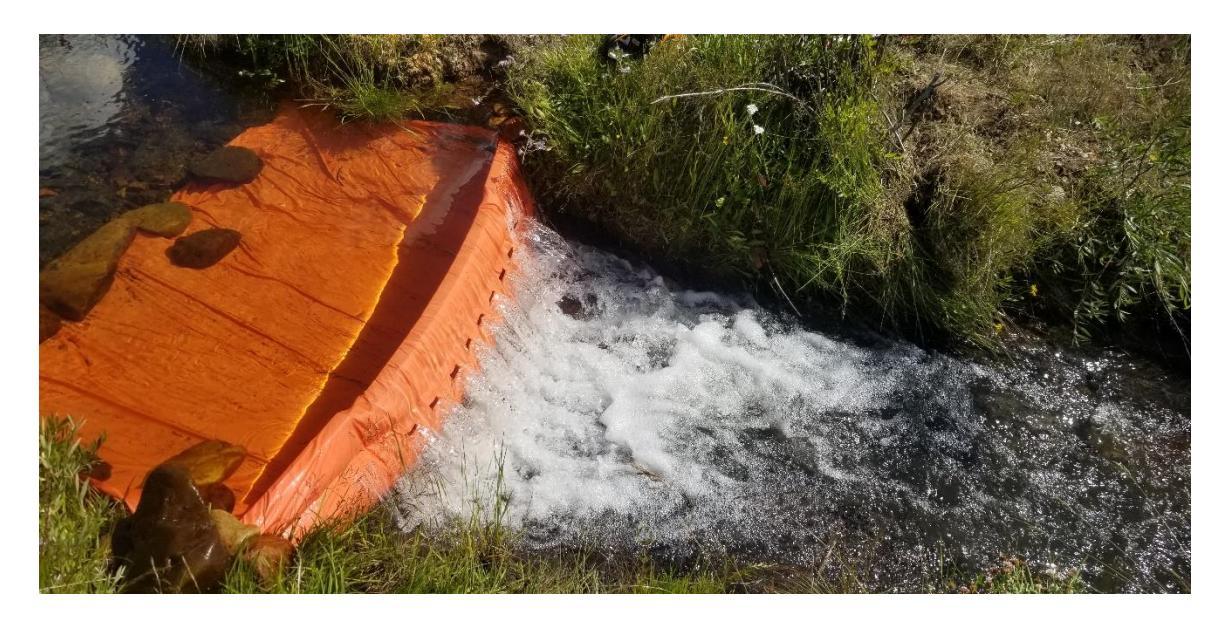
Figure 9. Temporary fish barrier on French Gulch which was similar to the temporary barriers placed on all tributary streams with the exception of American Creek.

With the fish barrier completed, French Creek and all its tributaries upstream of the fish barrier were treated with rotenone for the first time in 2020. Treatments began in the tributary streams on July 20. As tributaries were individually treated, small, temporary fish barriers were erected near the confluence with French Creek to prevent upstream fish passage until the mainstem stream could be treated in mid-August. These barriers generally consisted of placing a canvas dam across the stream and placing rocks on the downstream side of the dam to prevent a scour pool from forming (Figure 9). Once the tributaries were treated, the mainstem creek was treated beginning at the headwaters of California Creek on August 17. In each tributary stream encountered as the treatment progressed downstream, a rotenone drip station was placed 2 hours travel time upstream of the temporary fish barrier to ensure that if any fish ascended the fish barrier they would be killed. No fish were observed above these fish barriers in any of the tributary streams, so it was assumed that they were successful at keeping fish from moving upstream. The progress of the treatment was monitored daily using sentinel fish placed in cages in the stream at predetermined locations. Fish 4 hours upstream of the fish barrier (near the Highway 569 crossing) were checked at least twice daily for signs of rotenone. If these fish showed signs of being affected by rotenone, detoxification with potassium permanganate at the fish barrier was initiated. Detoxification was initiated on August 13 when fish at the 4-hour mark showed signs of rotenone sickness. This was due to the treatment that occurred in American Creek the previous day. Detoxification was run for 24 hours after which time it was discontinued because the fish at the 4-hour mark recovered. No fish at the fish barrier shows signs of rotenone sickness. The mainstem creek was treated to the fish barrier from August 17-August 20. Detoxification was imitated again on August 19 as treated waters from above caused sickness in fish at the 4-hour mark.

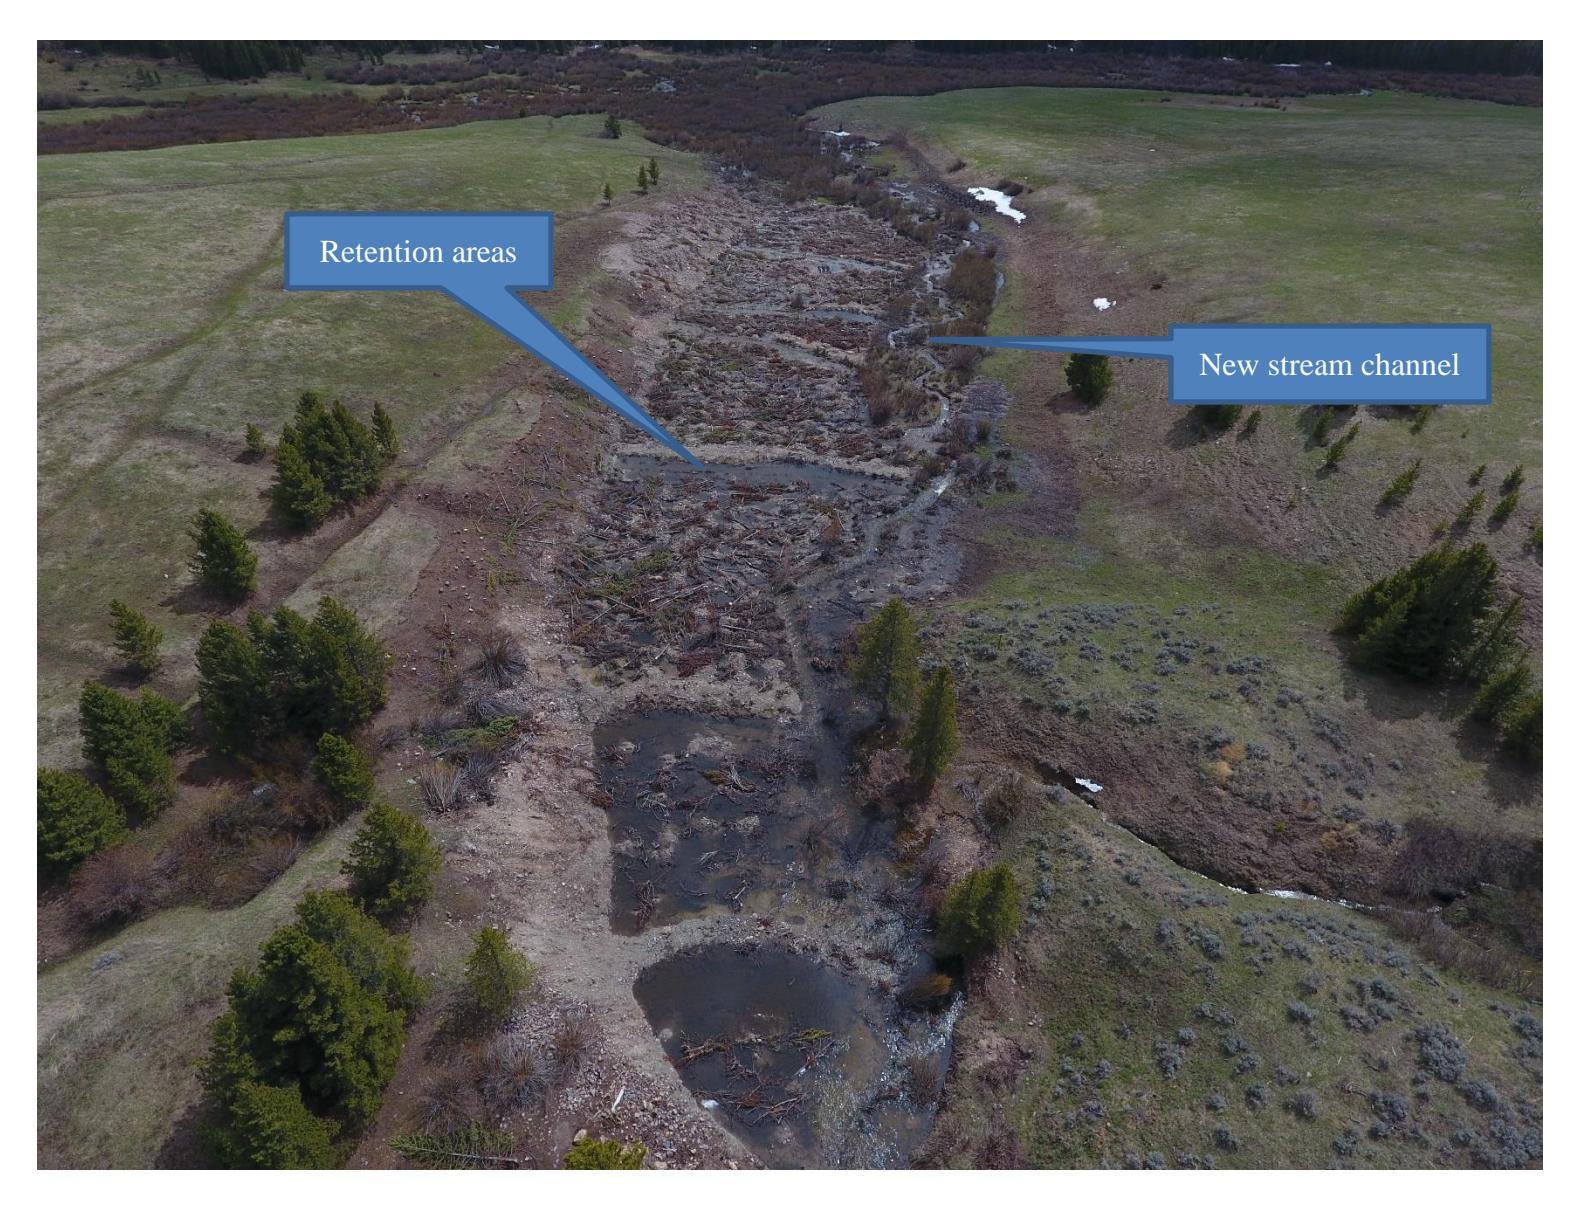
Figure 10. Restored reach of Oregon Creek downstream of Highway 569 constructed in 2019 with the new stream channel on the right side (west) and the retention areas on the left (east) in spring of 2020.

The lower ¹/₂ mile Oregon Creek was placer mined from roughly the Highway 569 crossing to the confluence with California Creek. The post mining stream was very incised and straight and isolated from its former floodplain. Large gravel piles flanked the eastern side of the stream and there was no access of the stream to its former floodplain. The aquatic habitat in Oregon Creek was limited due to the straight nature of the stream channel and limited riparian vegetation. A project was initiated to restore the impacts of past placer mining in this area and potentially increase late season flows and construction occurred in 2019. The goal of the stream restoration was to create a sinuous stream channel with a functioning riparian area and floodplain. An area west of the stream had an intact willow community and appeared to contain relic stream channels. It was likely that this was the former floodplain elevation before mining. The new Oregon Creek stream channel was constructed in this area to take advantage of an intact floodplain and robust riparian vegetation (Figure 10). The adjacent willows had to be trimmed to allow for machine access, but the roots were not disturbed. These trimmed willows are expected to survive sprout new shoots. The new channel has increased sinuosity which should facilitate the deposition of spawning gravels and increase available spawning habitat. The former stream channel and adjacent placer mined area to the east were leveled and converted into a series of water retention areas. The purpose of these retention areas is to capture over bank flows from Oregon Creek during spring runoff and saturate the floodplain. Then, as flows recede later in the summer, these saturated soils should slowly drain and add late season flow to the stream. Willow trenches were made with willow whips to accelerate riparian vegetation establishment within and adjacent to these retention areas. The stream channel was excavated into the existing willow riparian area.

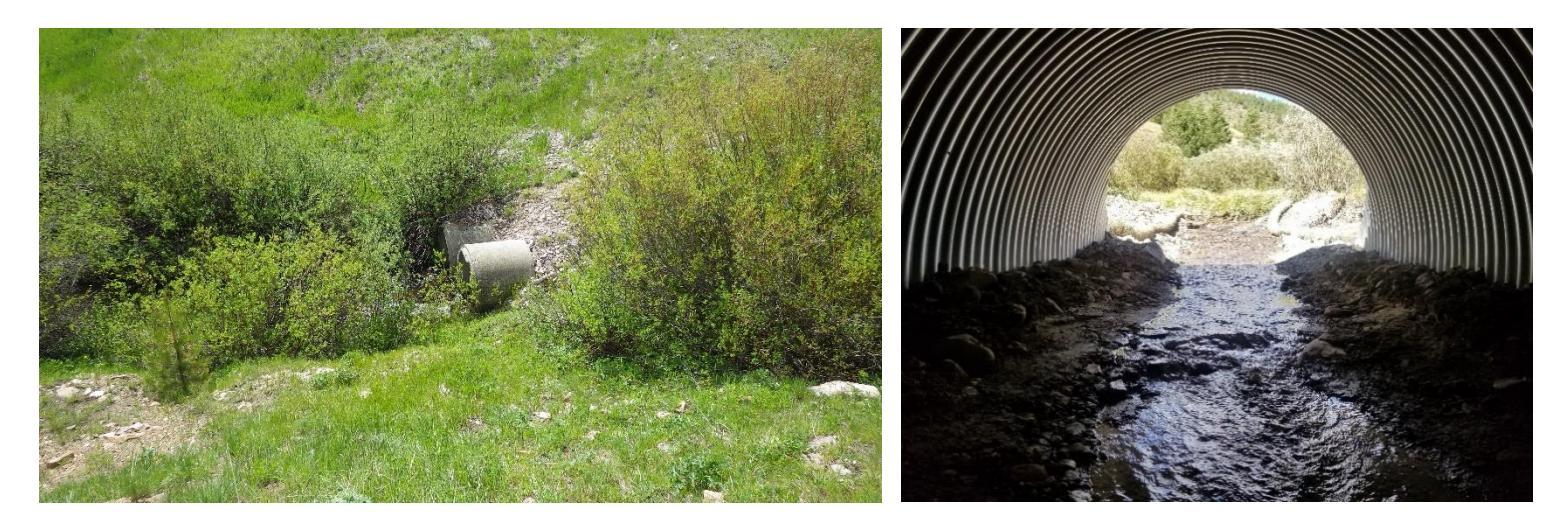
Figure 11. Highway 569 crossing over Oregon Creek before reconstruction (left) and after reconstruction (right) in 2019.

In the summer of 2019 highway reconstruction was performed on Highway 569 from the French Gulch Road turn off to the Sugar Loaf Lodge. This construction included the replacement of the crossing over Oregon Creek. The crossing over Oregon Creek was greatly improved to provide for sediment transport and fish passage. The previous crossing consisted of twin, 30-inch, cement culverts (Figure 11). The culverts were replaced by a single 10-ft metal culvert with a constructed stream channel inside (Figure 11). Because of aggradation of sediment upstream of the undersized twin-culvert crossing, 2 small rock weirs had to be placed to prevent downcutting.

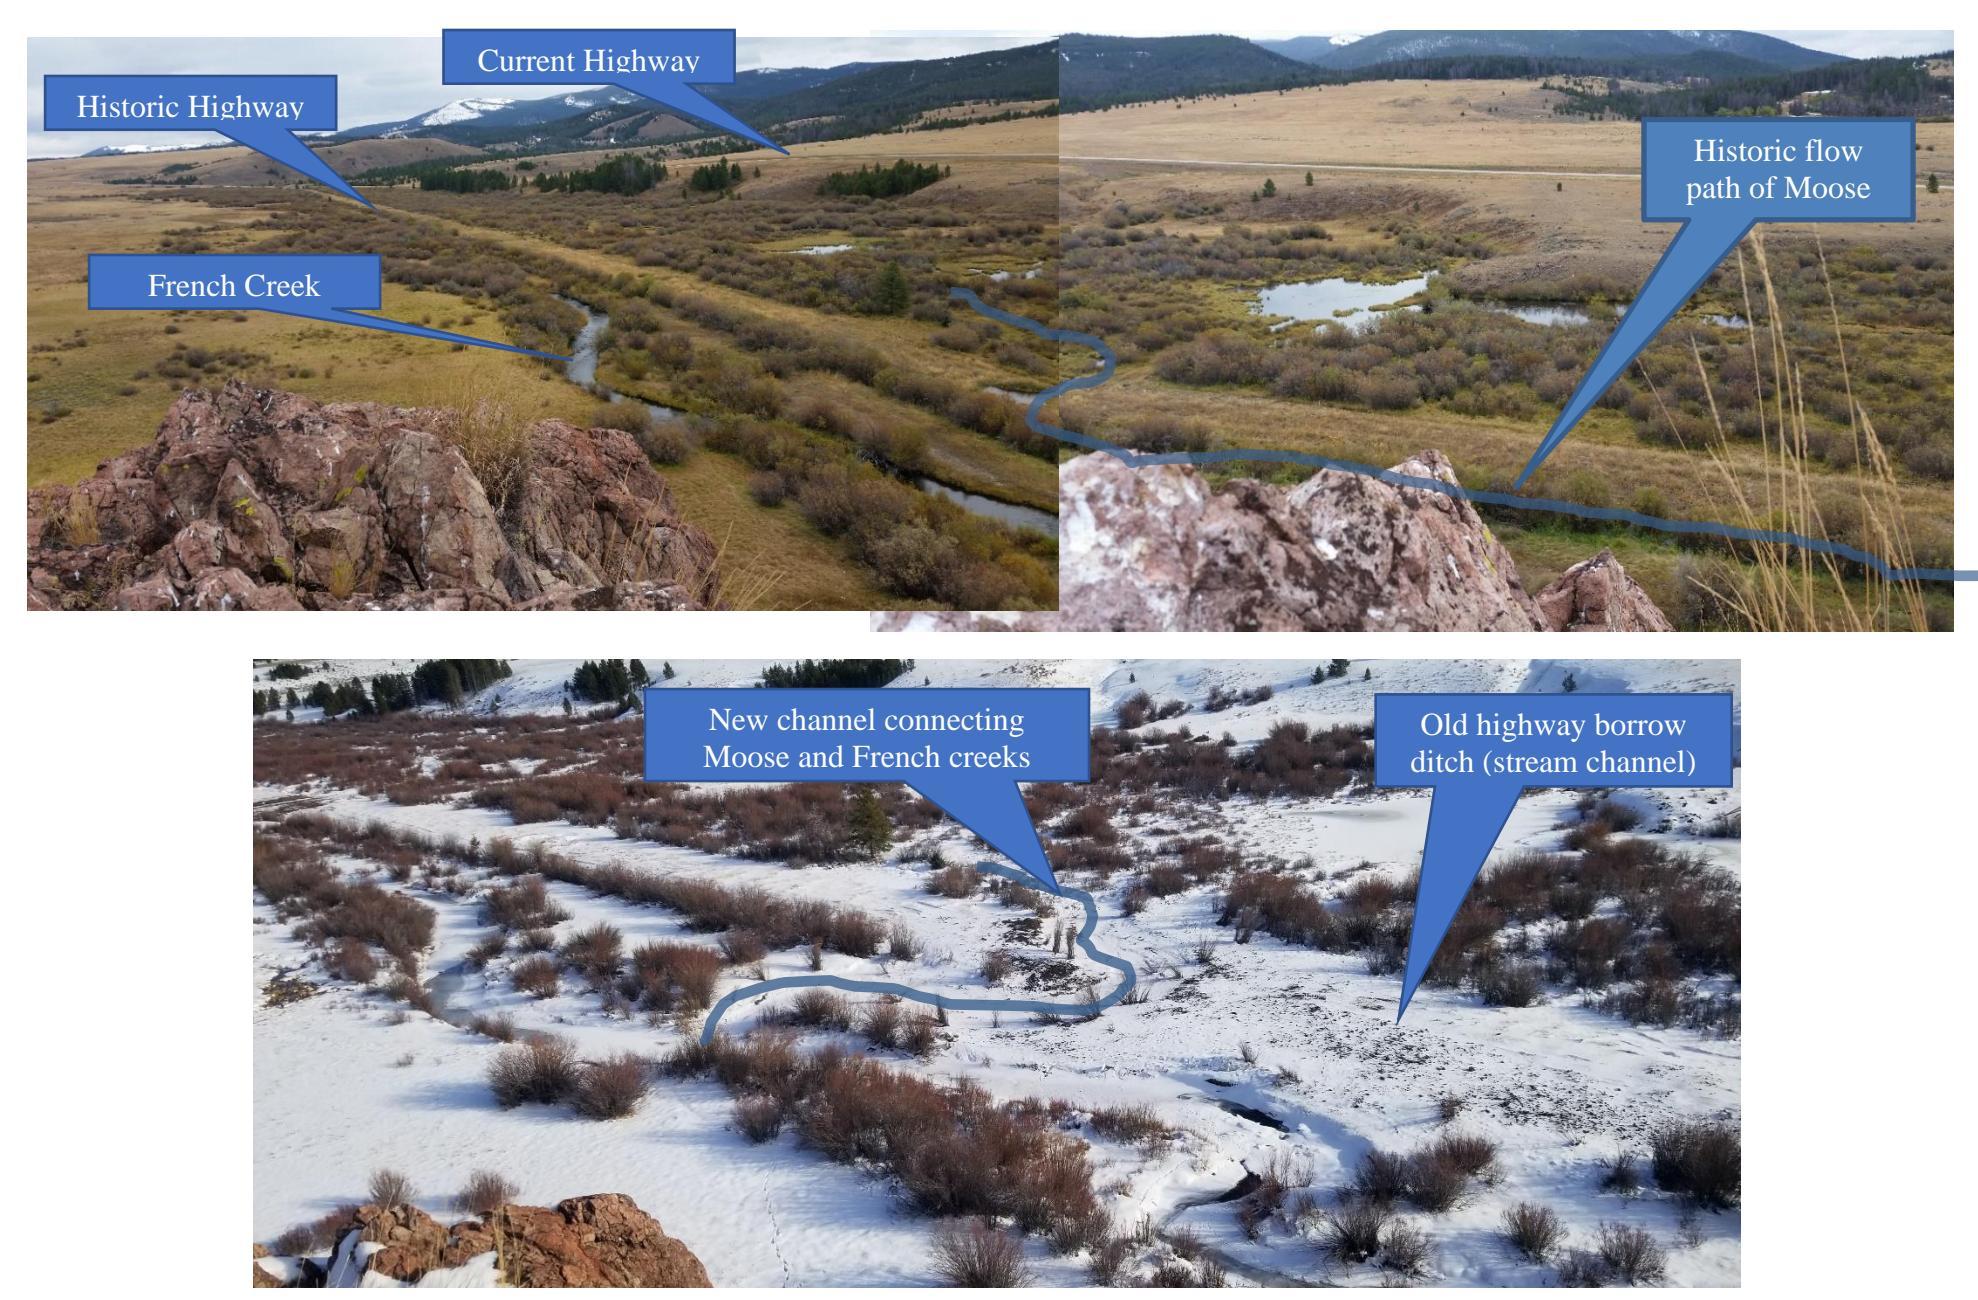
Figure 12. Figure above shows historic flow path of Moose Creek prior to restoration (note the stream flowed down the borrow ditch of the old highway. Photo below shows restored flow path between Moose and French creeks

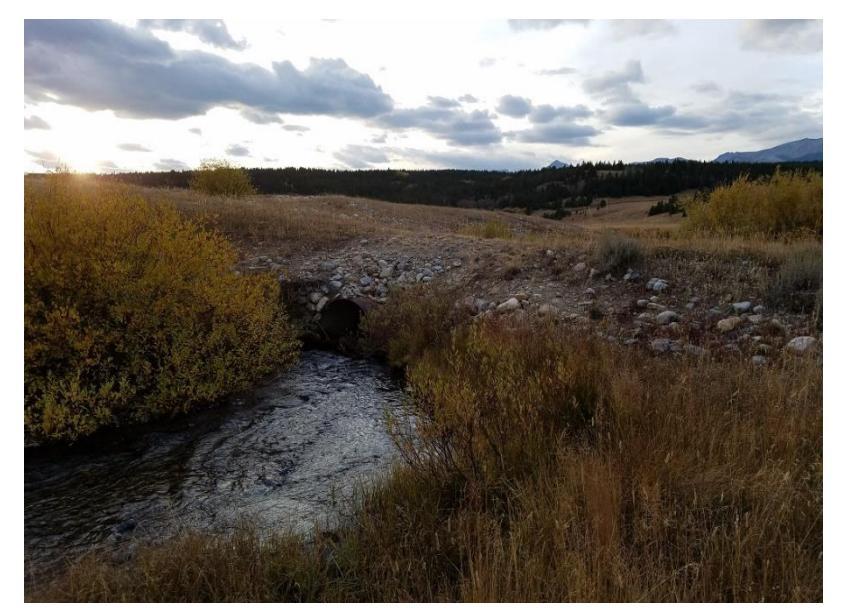
Figure 13. American Creek culvert before removal in 2019.

As part of the reconstruction of Highway 569 in 2019, the twin, concrete culverts on American Creek were replaced with a single 15-ft wide rectangular box culvert that was filled partway with stream sediments. In exchange for using the remaining waste rock from the placer mining restoration on French Gulch, the construction company for the highway project also agreed to remove a 4-ft culvert and associated road fill on American Creek downstream of the highway crossing (Figure 13). This culvert crossing in not used for access and while not a fish barrier, it

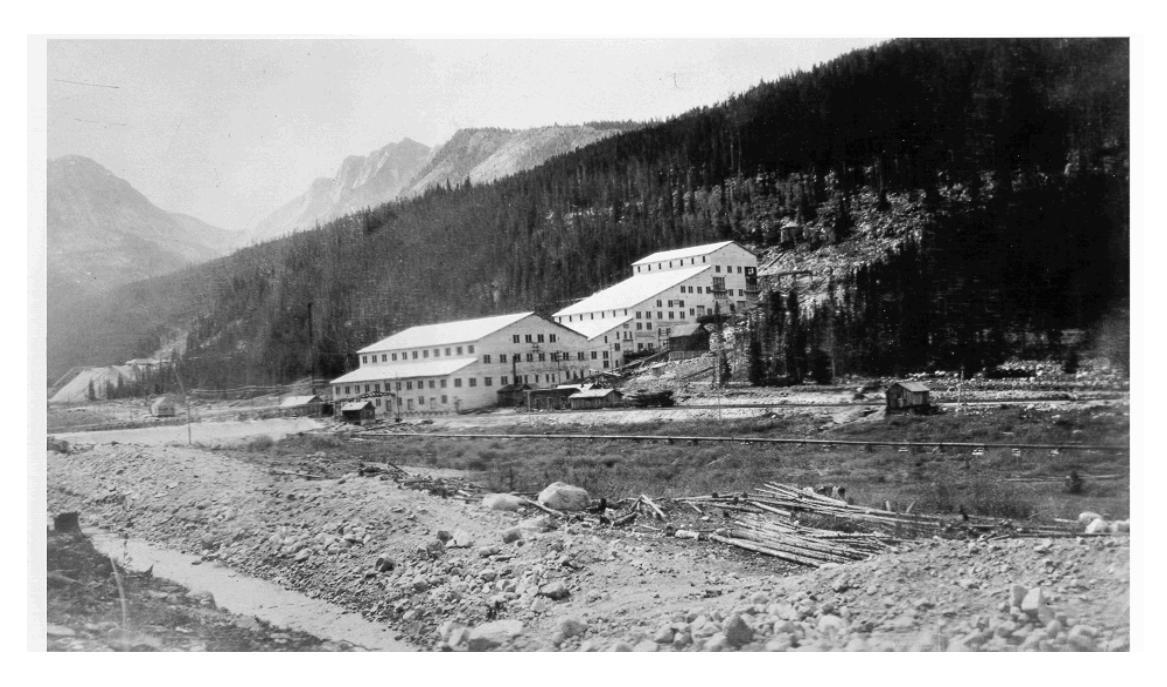
Figure 14. Mill site at Coolidge with the tailings pile visible on the left-center of the photo and Elkhorn Creek in the foreground.

The mining activity in the drainage has lead to the contamination of the site with elevated levels of arsnic, lead, copper and zinc. Several cleanup operations have taken place at the Coolidge site and much of the mill structure itself has been removed. In the late 1990's and early 2000's the tailings at the mill were removed including tailing in the floodplain of Elkhorn Creek and the waste was hauled to a repository 2 miles away. At the same time the mine waste dump at the adit was capped and measures taken to reduce infiltration of water (Wintergerst 2019). Water flowing out of the main mine adit was diverted around the tailings. In Elkhorn Creek a sinuous stream channel and floodplain were reconstructed and a diversion was created to maintain some flow through the historic ditches adjacent to the town of Coolidge while directing the main flows of the creek to the new stream channel.
