Emigrant Spring Creek Monitoring

Redd Counts 2007

August 14, 2007

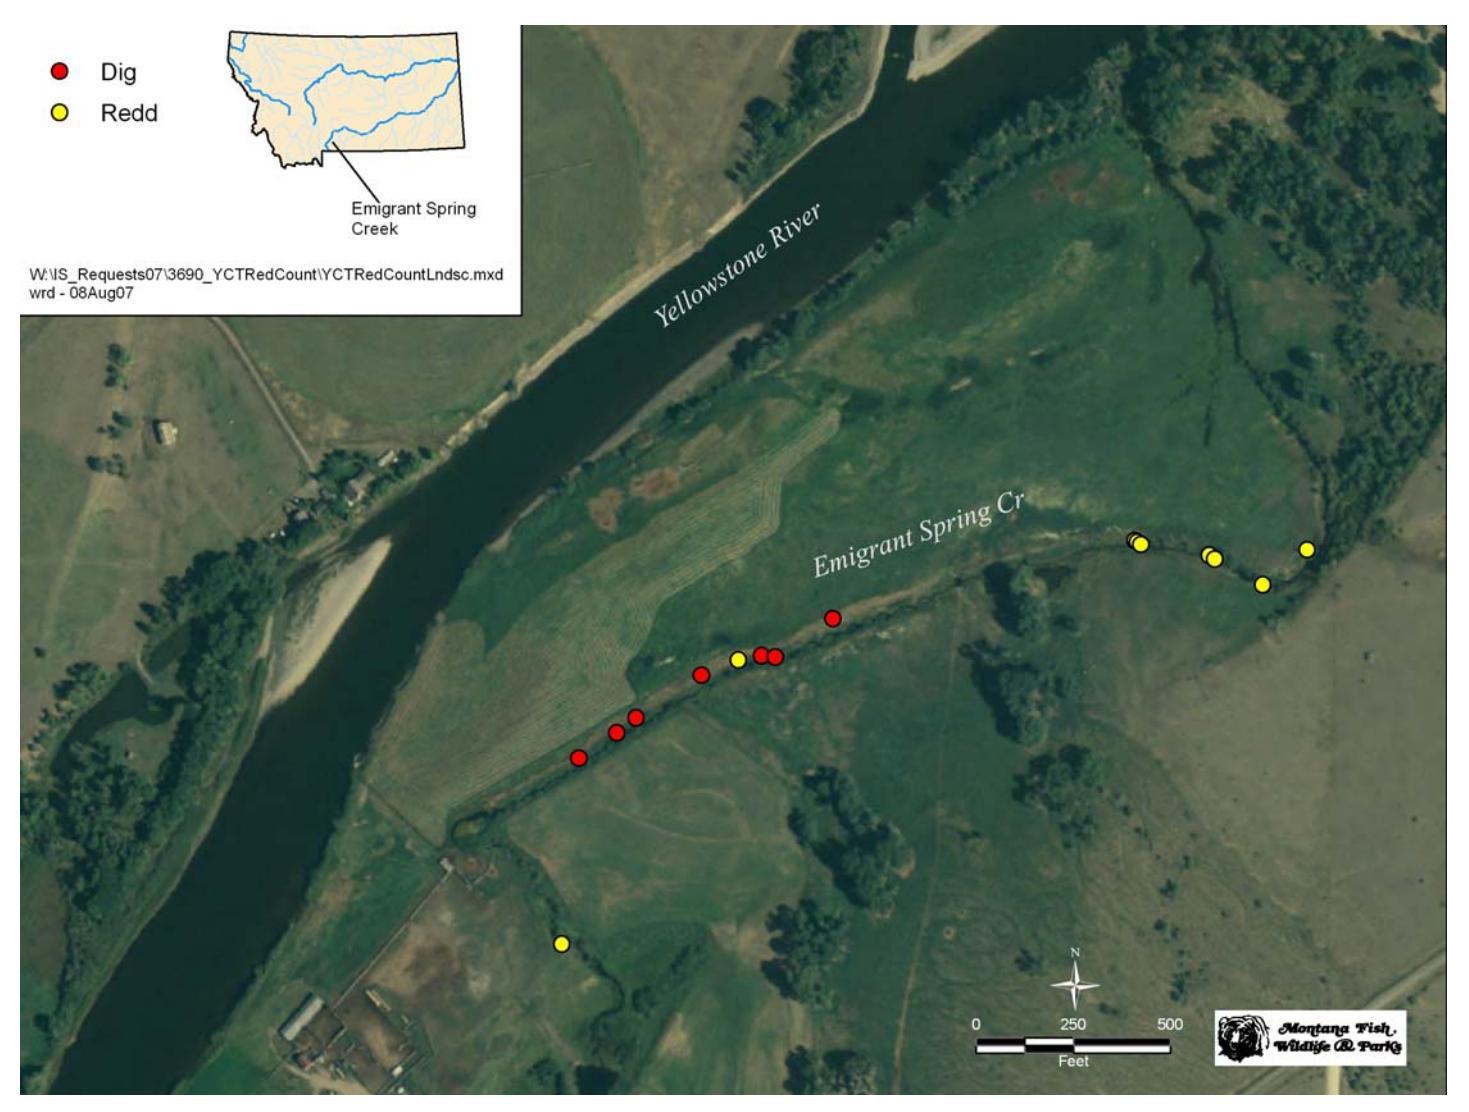
Figure 3-1: Distribution of redds and digs, apparent attempts at redds, identified on Emigrant Spring Creek, June 19, 2007.

Nine redds and seven digs were apparent on June 19, 2007, with most redds clustered within a small reach of stream (Figure 3-1). Although only nine distinct redds were observed, these probably reflect the activity of considerably more spawning fish. Several redds were large, with lengths and widths sometimes exceeding eight feet (Figure 3-2). By comparison, an investigation of Yellowstone cutthroat trout redds in Idaho found they averaged 5 by 2 feet (Thurow and King 1994). Large dimensions of some redds in Emigrant Spring Creek suggest superimposition of several redds at one location.

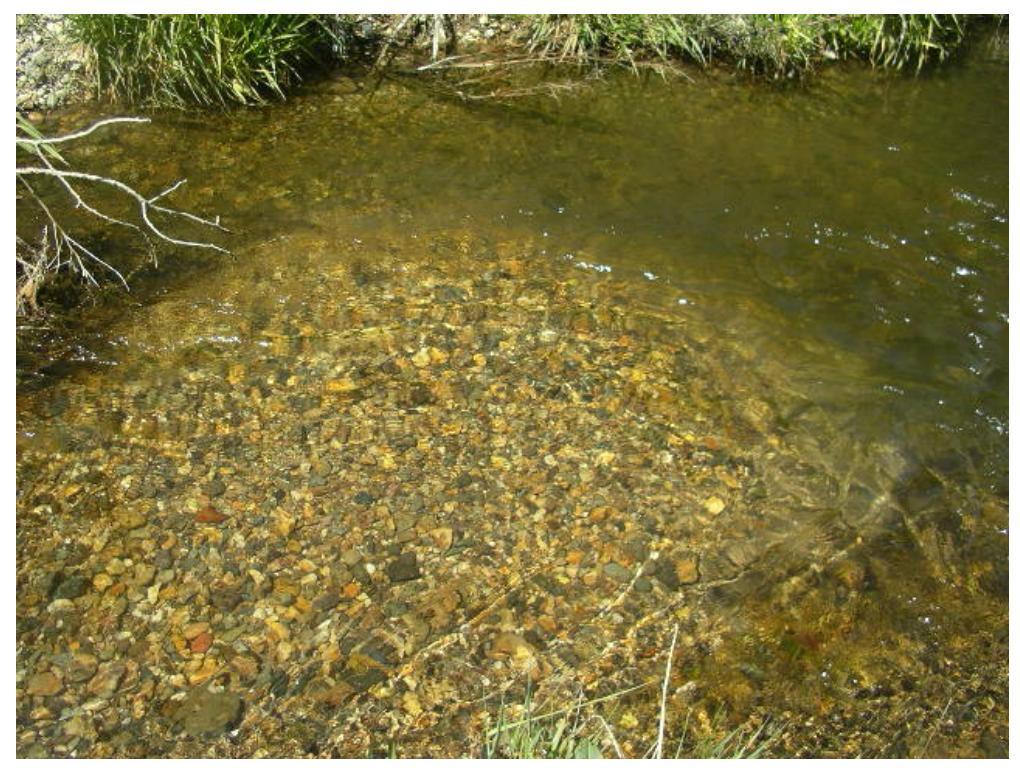
Figure 3-2: Large redd on Emigrant Spring Creek, which is likely the result of more than one spawning pair.

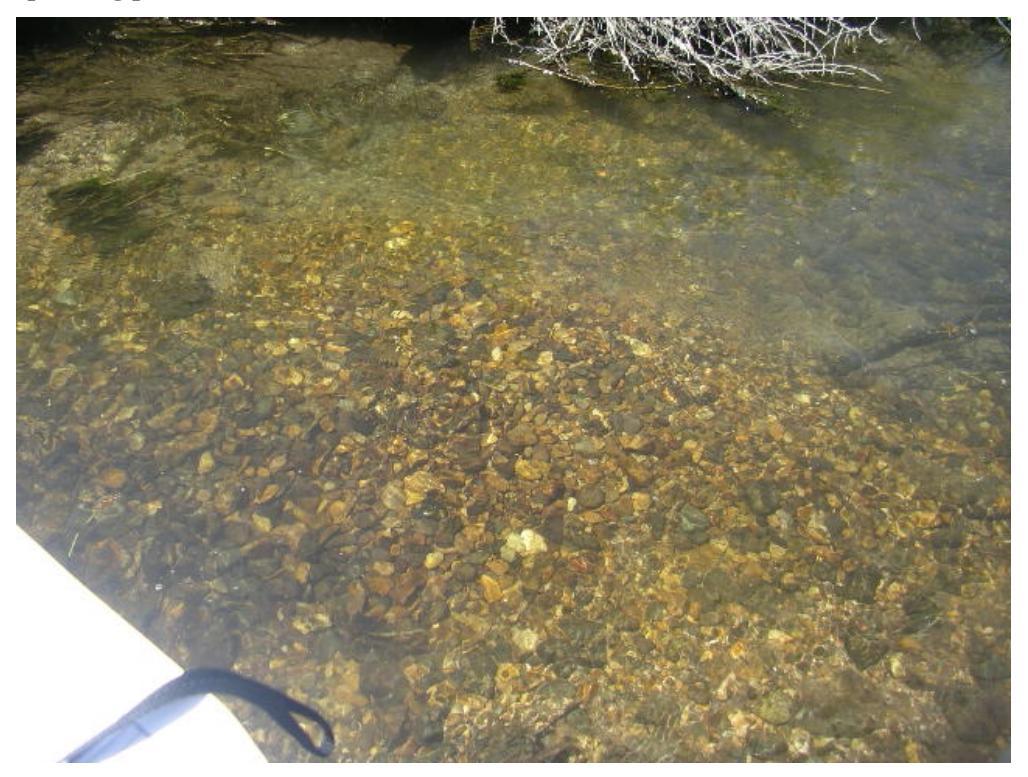
Figure 3-3: Older redd with less recently disturbed gravel.

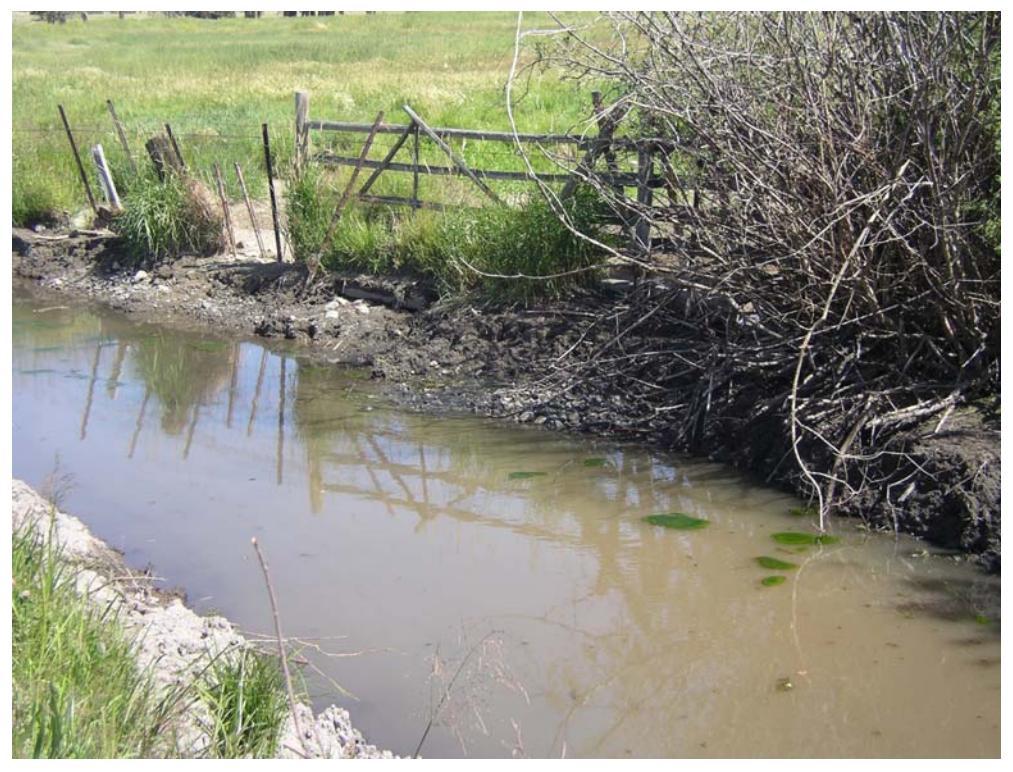
Figure 3-4: View of riparian condition, stream morphology, and suspended sediment in Emigrant Spring Creek before restoration (2004).

Observations of current habitat condition, combined with review of pre-project photos, indicate marked improvements in riparian health and vigor, and instream habitat on Emigrant Spring Creek. Pre-project photos show a wide and shallow stream channel with poor sediment transport capabilities and impaired riparian health and function (Figure 3-4 and Figure 3-5). Conditions in June of 2007 were in marked contrast to pre-restoration conditions (Figure 3-6). Riparian vegetation was robust with herbaceous and woody vegetation providing shade and overhead cover. The stream channel was narrow and deep, which provided better habitat to resident fish. The improved sediment transport capacity of the restored channel prevented accumulation of fine sediment on the streambed increased the suitability of this stream for spawning by trout, including the sensitive Yellowstone cutthroat trout.

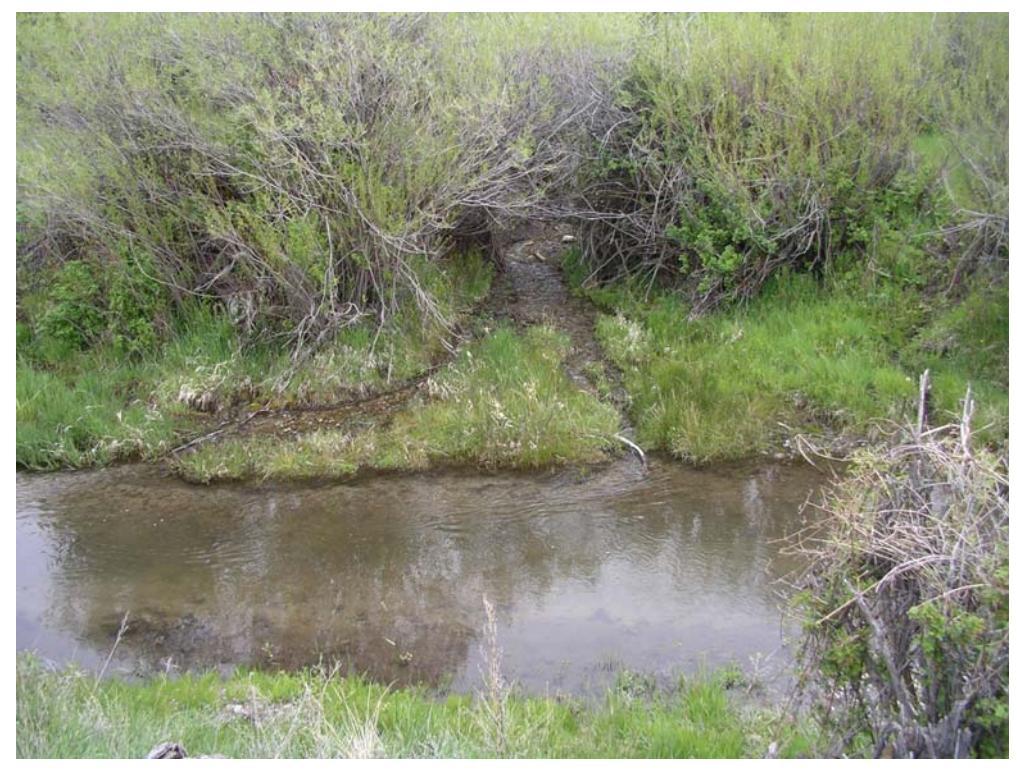
Figure 3-5: Wide and shallow stream channel typical of much of Emigrant Spring Creek before restoration (2004).

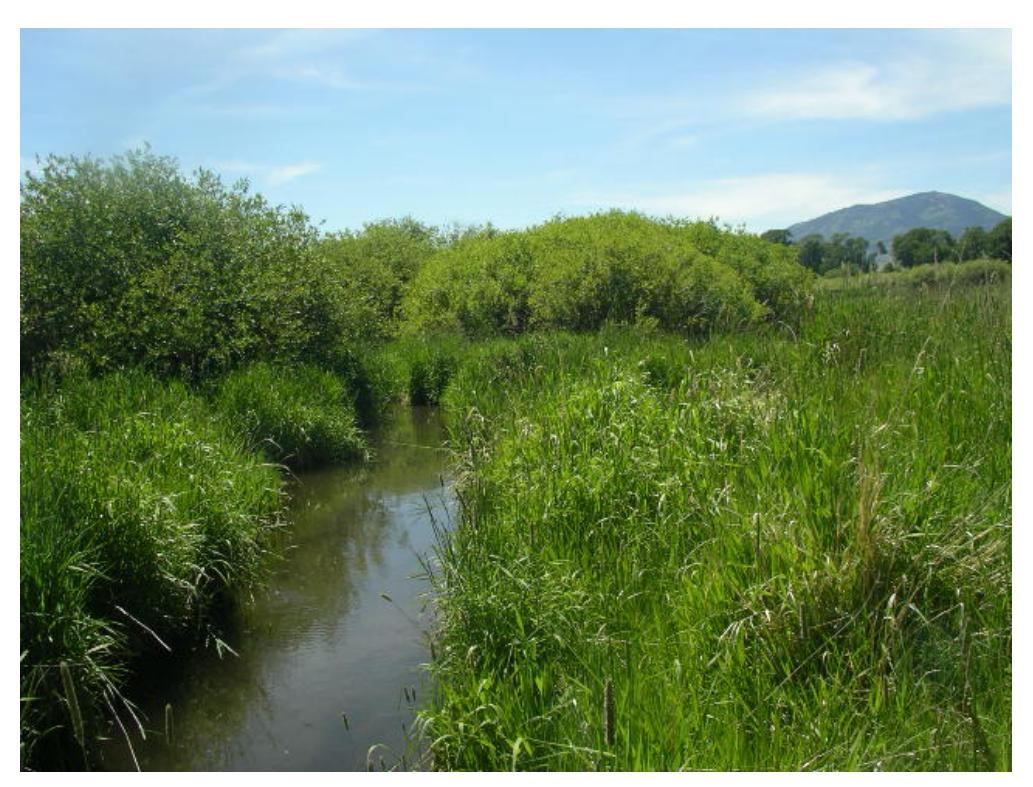
Figure 3-6: Post-restoration view of Emigrant Spring Creek showing well vegetated banks and recovering shrub community on June 19, 2007.
