Elbow Creek

Initial Project Assessment

March 30, 2009

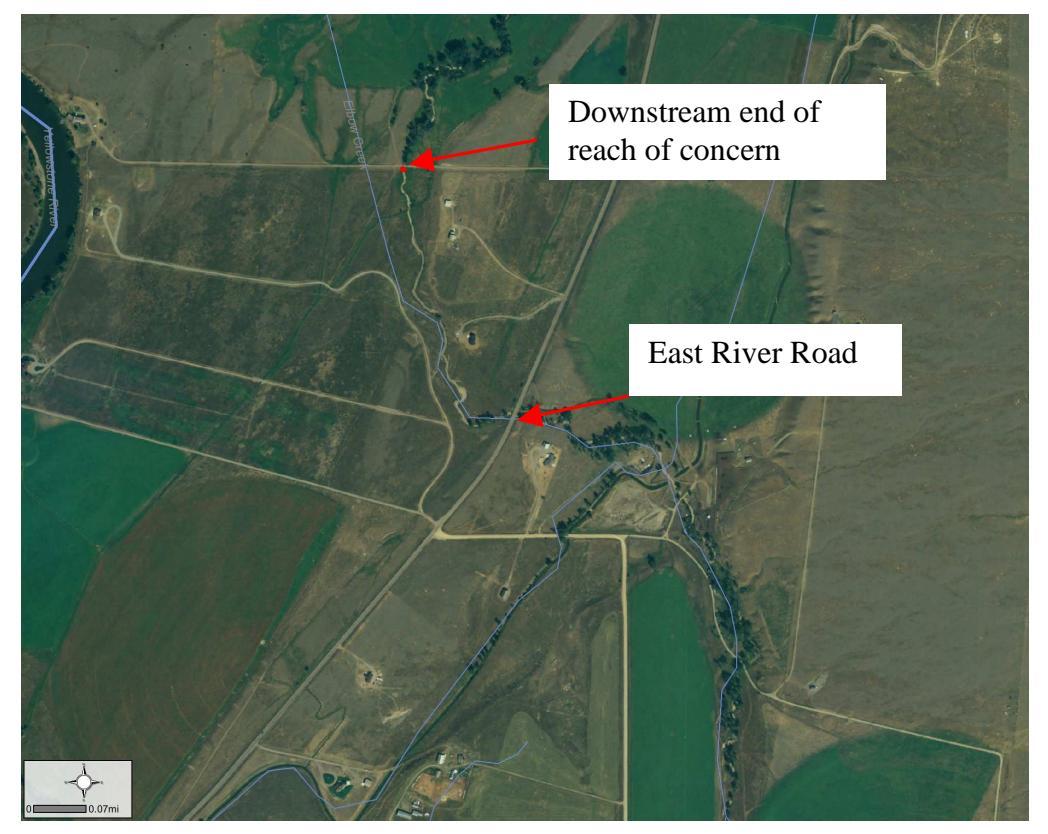
On March 13, 2009, Carol Endicott, FWP's Landowner Incentive Program biologist visited Elbow Creek. Landowners Meredith Allen and Dan Hull were present, and provided history and associated information on status and trends of the stream. The primary area of interest was the reach upstream of an internal ranch bridge and below the East River Road crossing (Figure 4-1).

Figure 4-1: Aerial photo of lower Elbow Creek

A scarcity of woody riparian species is another dominant feature in the reach of concern, and the lack of mature cottonwoods or riparian shrubs is apparent in the aerial photo (Figure 4-1). Mr. Hull indicated cottonwoods had been removed years ago when an irrigation system was installed. He has planted several cottonwoods in order to reestablish a riparian stand. In addition to historic removal, livestock are probably limiting recruitment of woody vegetation along the stream margin.

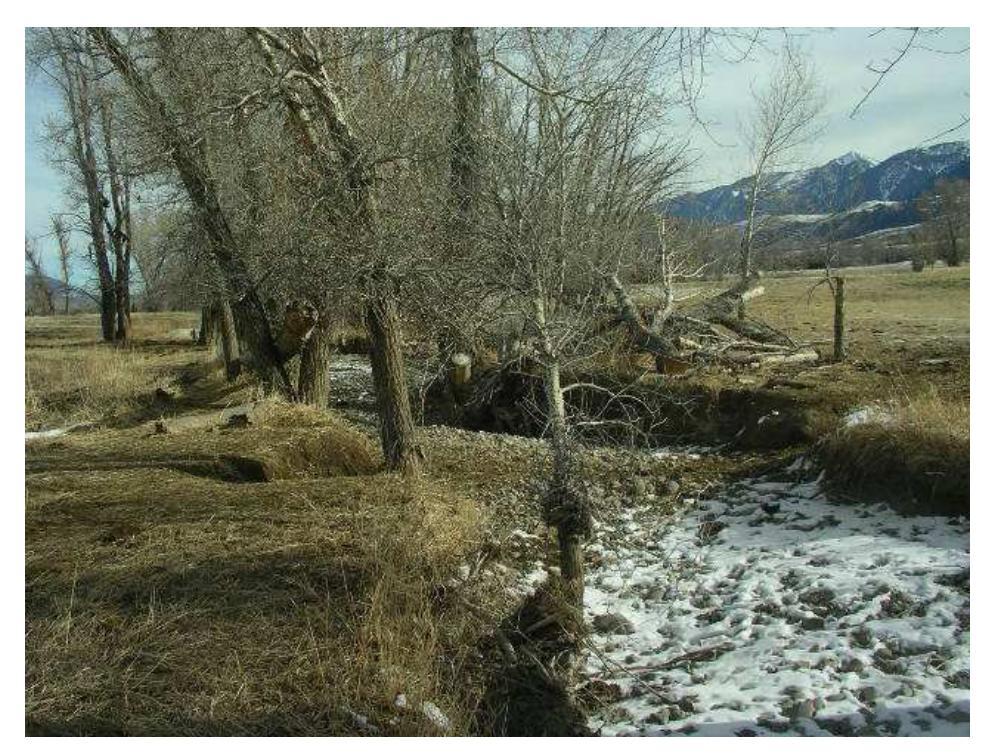
A striking feature of Elbow Creek on March 13, 2009 was a total lack of water (Figure 4-2). The glacial history of the east side of the Paradise Valley has resulted in a highly permeable landscape, and many streams lose water when they encounter the valley. A lack of water before onset of the irrigation season suggests water supply is naturally limited, which affects Elbow Creek's potential to support a resident fishery.

Figure 4-2: Cottonwood gallery downstream of ranch road crossing on Elbow Creek.

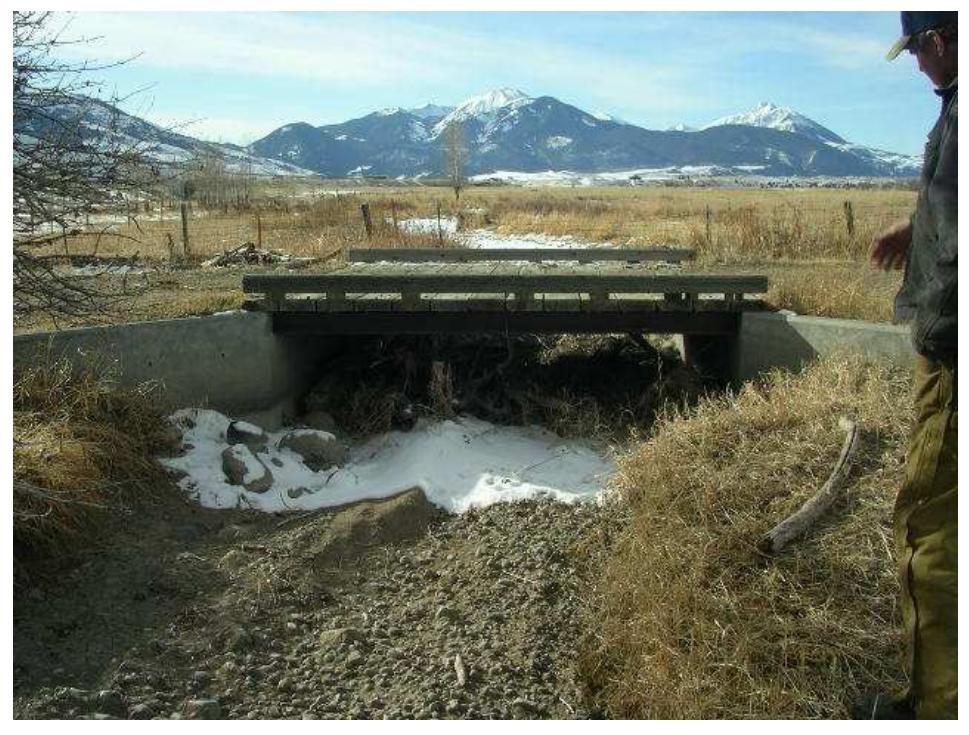
One of Mr. Allen's concerns was an area of aggradation upstream of the bridge crossing Elbow Creek (Figure 4-3). The upper Yellowstone River watershed had a greater than average snowpack in 2008, and many tributaries reached and remained flows at flood stage for an extended period. On Elbow Creek, the bridge trapped debris, which impounded flow. Bed load, mostly cobble size particles, fell out of transport, and accumulated upstream of the bridge (Figure 4-4). The resulting rise in the streambed elevation diverted flows out of the channel and across the floodplain, as evidenced by debris caught on a barbwire fence (Figure 4-5).

Figure 4-3: Ranch bridge which impounded flows during spring runoff of 2008.

This reach of Elbow Creek has numerous constraints that negatively influence fluvial processes and its ability to support fish. Water supply is considerably less than water demands in most years, so insufficient water is available to transport bed load and provide suitable habitat for fish. An undersized bridge traps debris, which further adds to reduced sediment transport capabilities. Dominance of shallow rooted grasses, to the near exclusion of riparian woody vegetation, has made banks susceptible to erosion during high flows.

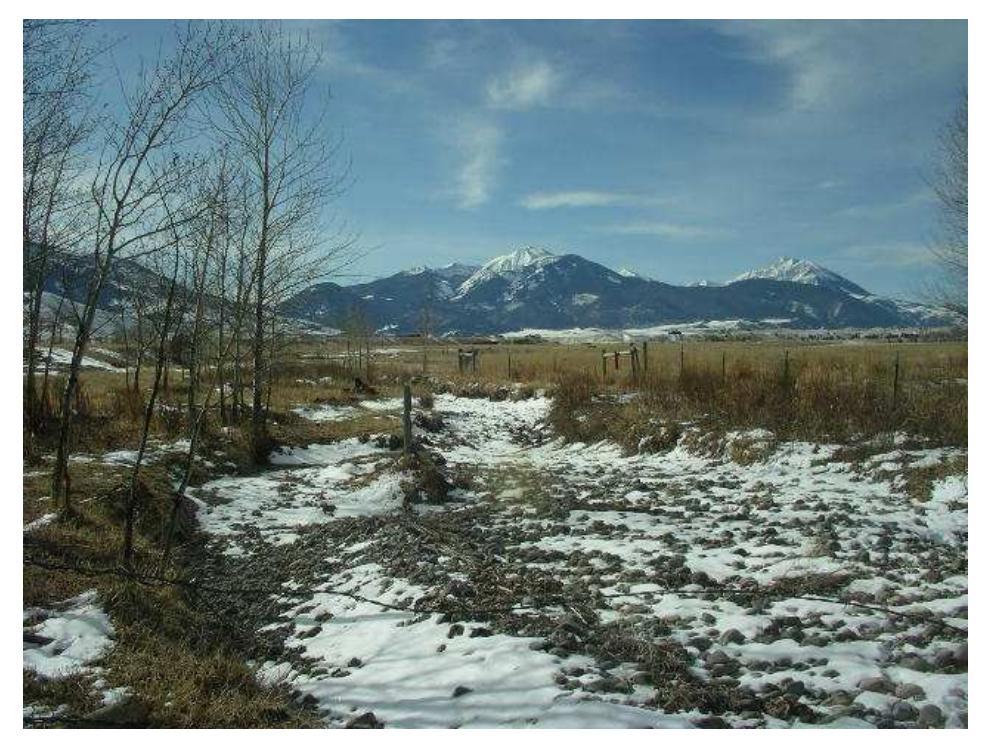
Figure 4-4: Area of aggradation upstream of the ranch bridge where bed load deposited when high flows became impounded by the bridge in spring of 2008.

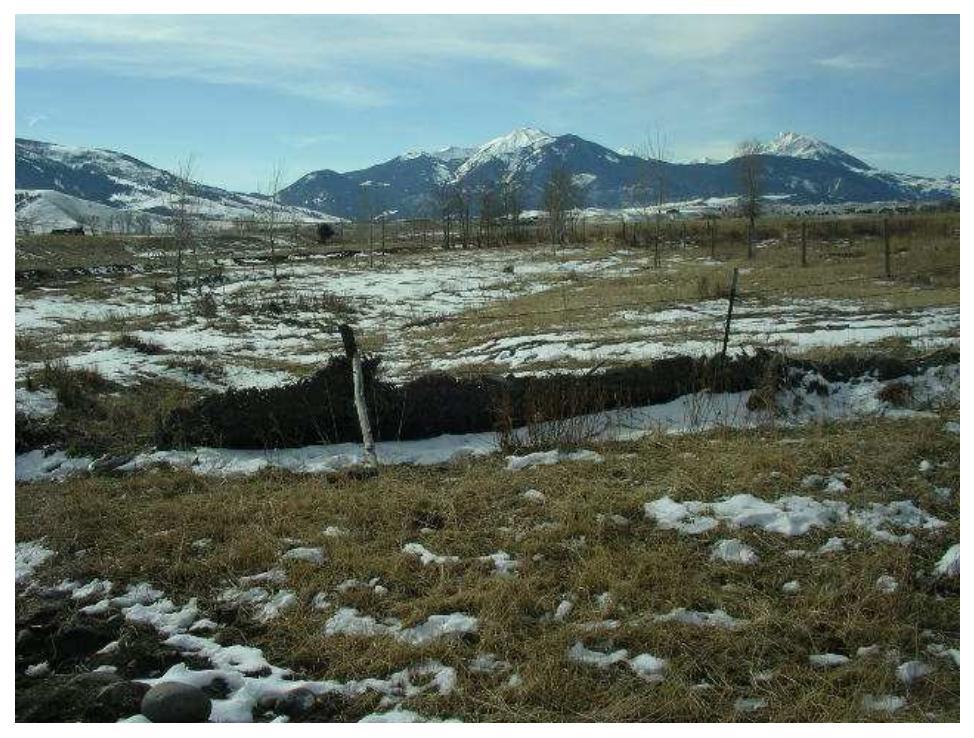
Figure 4-5: Debris caught on fence where Elbow Creek's flows were diverted across the floodplain because of a rise in bed elevation.

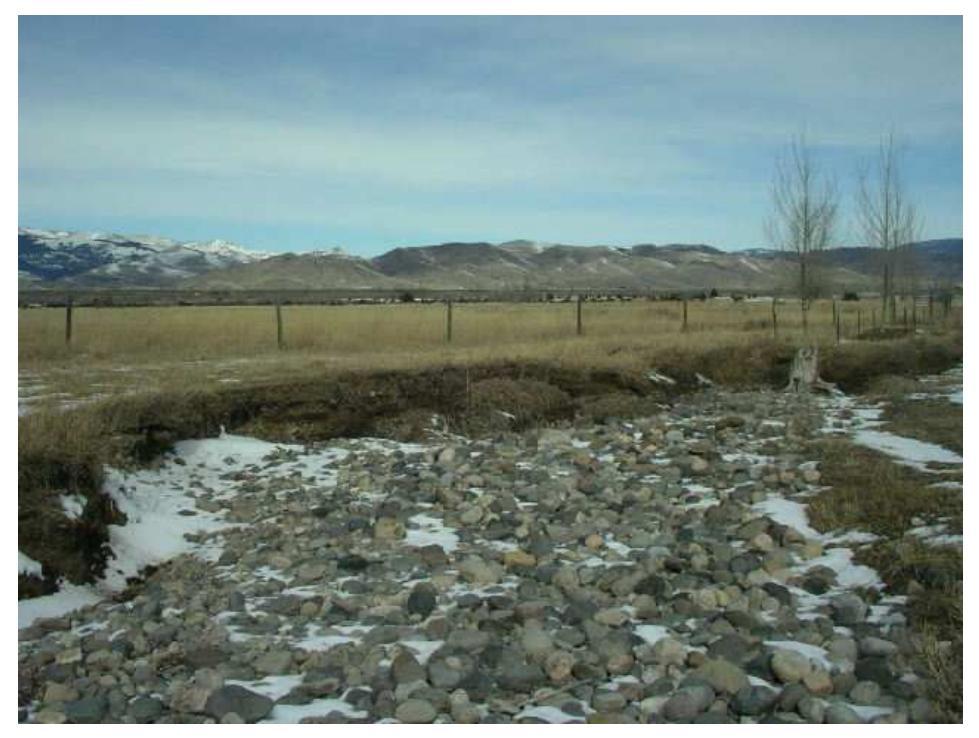
In addition to changes in bed elevation, flooding in 2008 resulted in localized areas of bank erosion, which was another of Mr. Allen's concerns (Figure 4-6). Shallow rooted grasses were the dominant vegetation type on these eroding banks. These closely cropped grasses do little to protect banks during high flows.

Figure 4-6: Sloughing of stream banks associated with flooding in 2008.

Recommended approaches to remedying eroding banks involve several actions aimed at reducing erosion and restoring riparian function, and preventing future damage by controlling livestock adjacent to the stream. Montana stream permitting guidelines (DNRC 2001) emphasize the use of soft, bioengineered approaches that replicate natural channel stability. Restoring banks through bioengineered approaches typically involves re-sloping the eroding banks, applying erosion control fabric, and revegetating the bank with plantings and seeding (see Figure 5-1 for a conceptual approach).

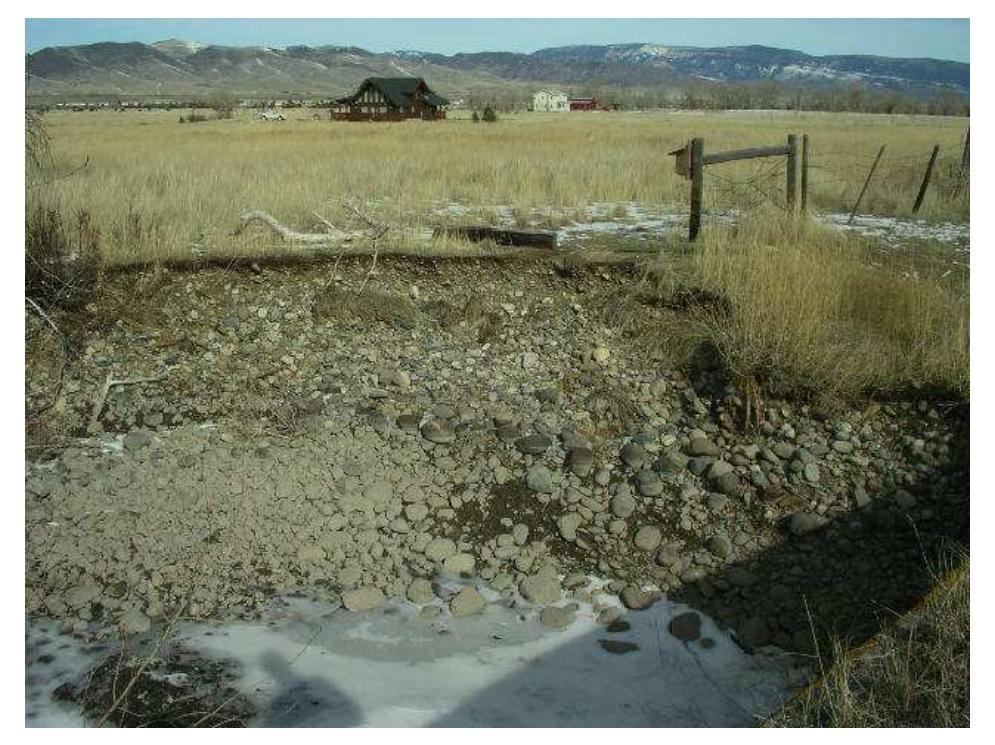
A final feature of concern on Elbow Creek was a large scour just downstream of the East River Road crossing. This is a source of cobble and gravel sized particles, and likely contributes to an over supply of bed load in Elbow Creek. In addition, this erosion may put the bridge abutment at risk. The Park Conservation District recently approved application of bank armor to reduce sourcing of sediment, and protect the bridge structure.

Figure 4-7: Bank scour immediately downstream of the East River Road crossing.

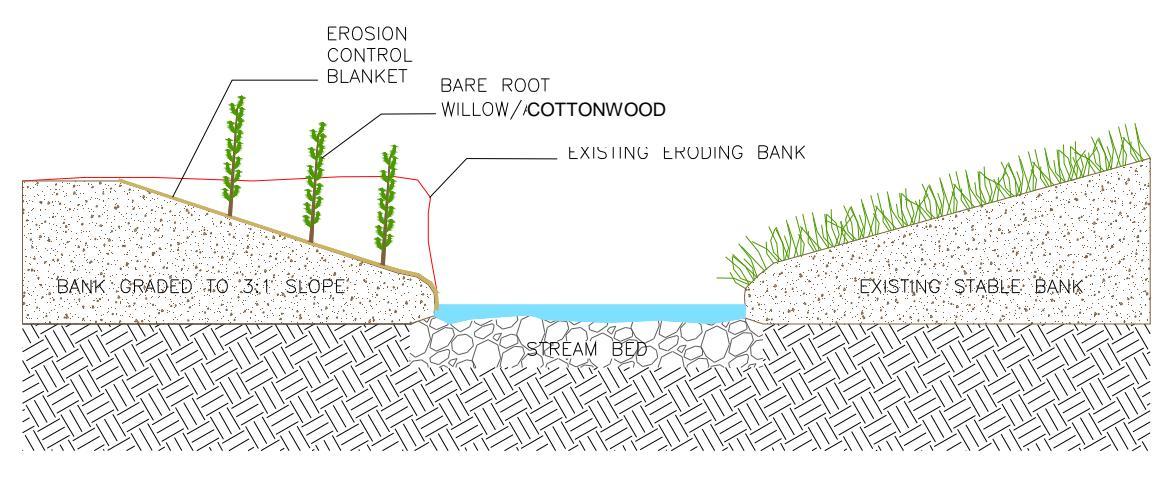
Bank Stabilization Section, Typical

Figure 5-1: Conceptual approach to bioengineered bank stabilization.
