Willow Creek

Initial Project Assessment

October 30, 2009

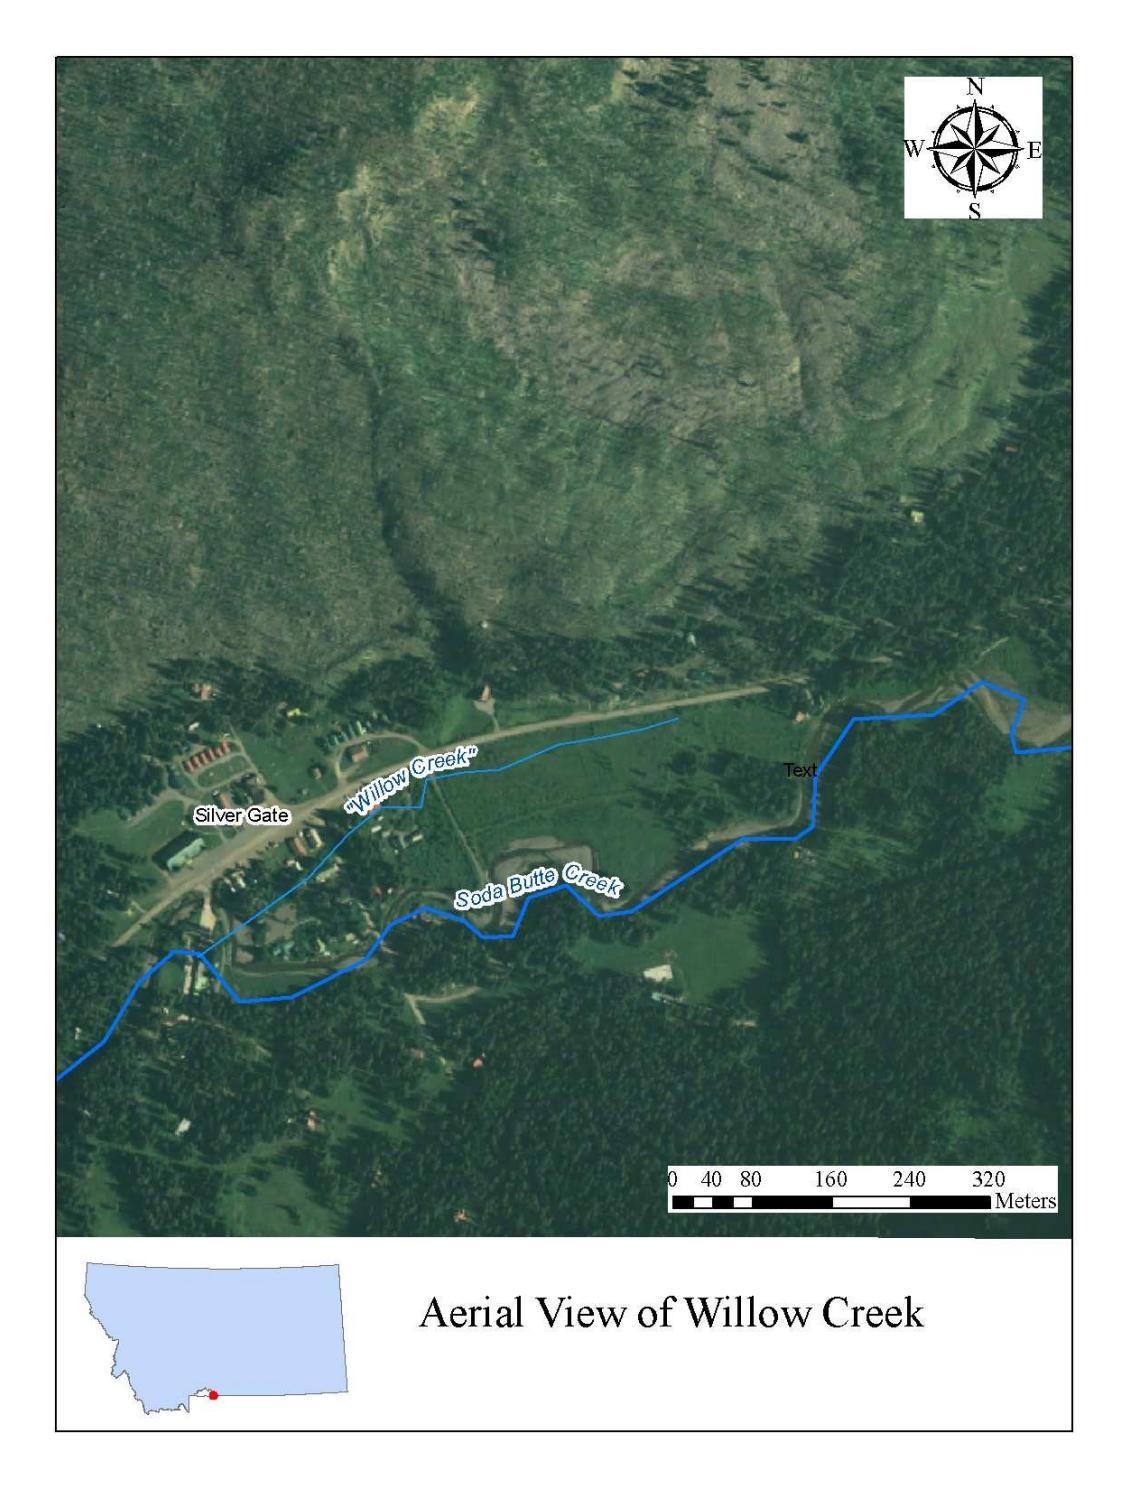
Willow Creek is in the Yellowstone headwaters hydrologic unit (hydrologic unit code [HUC] 10070001) in south central Montana, just north of the border of Yellowstone National Park (Figure 2-1). This stream is unmapped and lacks an official name; however, local residents refer to it as Willow Creek. Willow Creek originates in a sedge (*Carex* sp.) and willow-dominated (*Salix* sp.) wetland on the north and south sides of Highway 212, and flows through the small town of Silver Gate, for about 1/3-miles until its confluence with Soda Butte Creek. The surrounding watershed is mountainous, and dominated by lodgepole pine (*Pinus contorta*) forest. The area burned in the 1988 fires, and standing, dead timber still occupies the surrounding hillslopes (Figure 2-2).

Figure 2-2: Aerial view of Willow Creek.

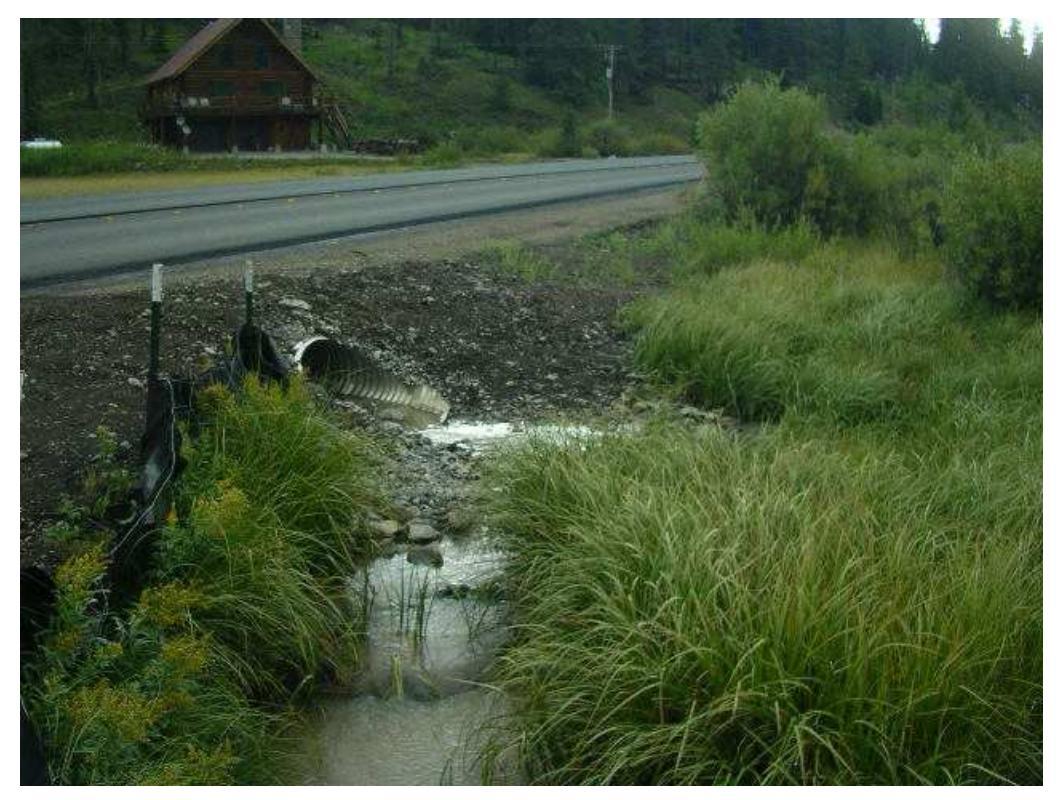
Although hillslope erosion following the 1988 fires likely contributed considerably to the impaired habitat and water quality in Willow Creek, other factors are preventing Willow Creek from recovering from this disturbance. Road construction on the adjacent Highway 212 has been ongoing for at least three years, and is a source of fine sediment. Although some erosion control best management practices (BMPs) are in place, substantial gaps are present that allow for delivery of fines (Figure 3-1). Periodic thunderstorms were rolling through during the field visit, and an influx of sediment was readily apparent.

Figure 3-1: Erosion control BMPs and gaps allowing delivery of fine sediment.

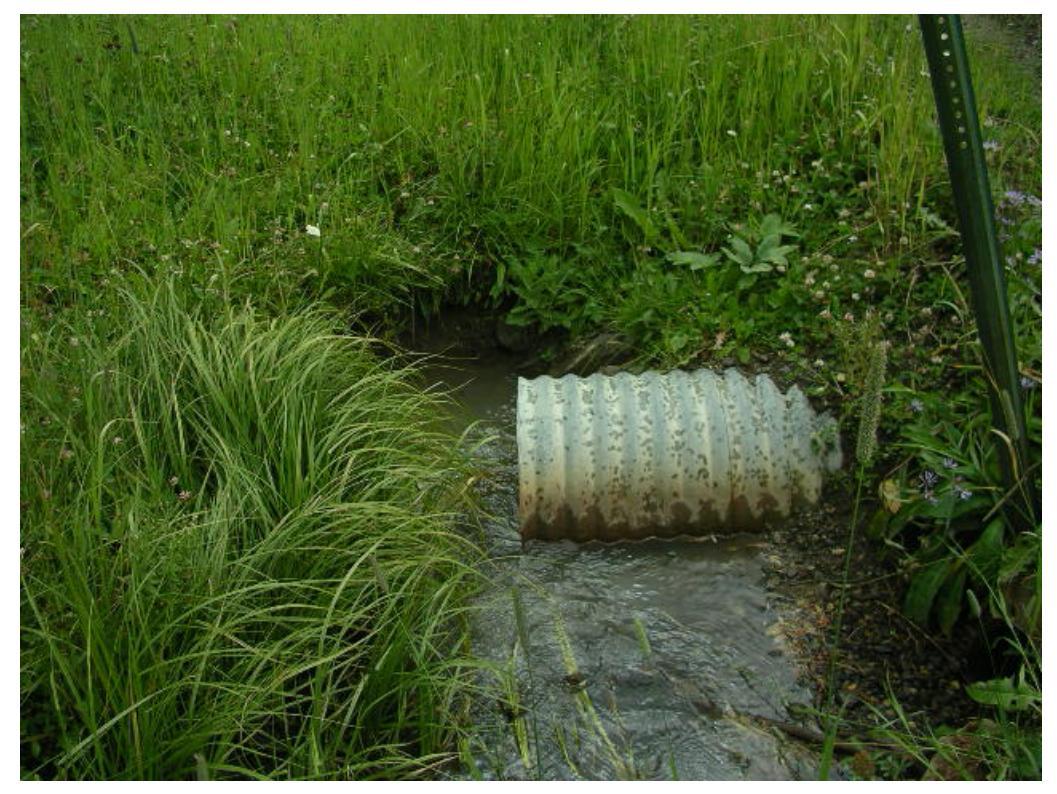
Undersized and improperly placed culverts present another factor limiting habitat quality, and Willow Creek's ability to transport sediment contributed from burned hillslopes and road construction. For example, one road culvert place perpendicular to stream flow is likely inefficient in conveying flow and transporting sediment and debris (Figure 3-2). Likewise, a number of stream crossings associated with residences impound flows, resulting in near lentic conditions, with deep accumulations of mud burying any gravel that may be present (Figure 3-3).

Figure 3-2: Improperly placed culvert on Willow Creek.

Replacing or modifying culverts associated with roads and residences would contribute to improving stream form and function. This component would require working with landowners to ensure the stream crossing option meets their requirements. In some cases, a footbridge may be sufficient. Bottomless arch culverts of sufficient size are likely appropriate for established road crossings or residential crossings that need to accommodate vehicles.

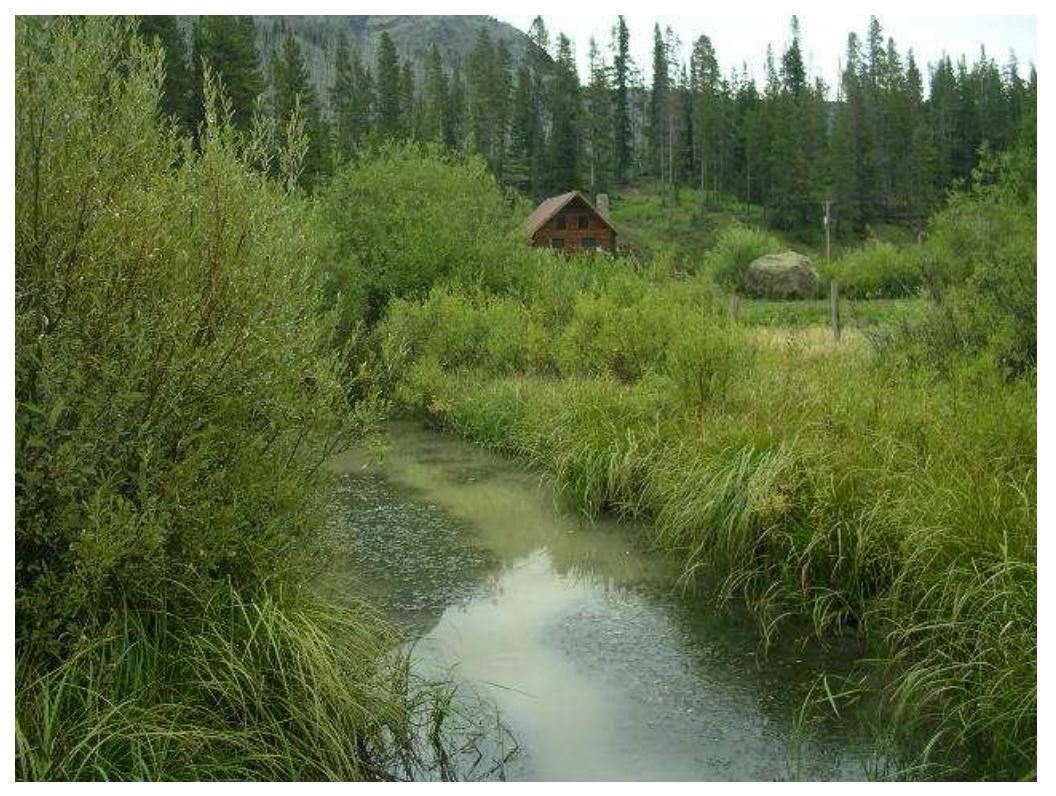
Figure 3-3: Portion of Willow Creek impounded by an improperly placed and undersized culvert.

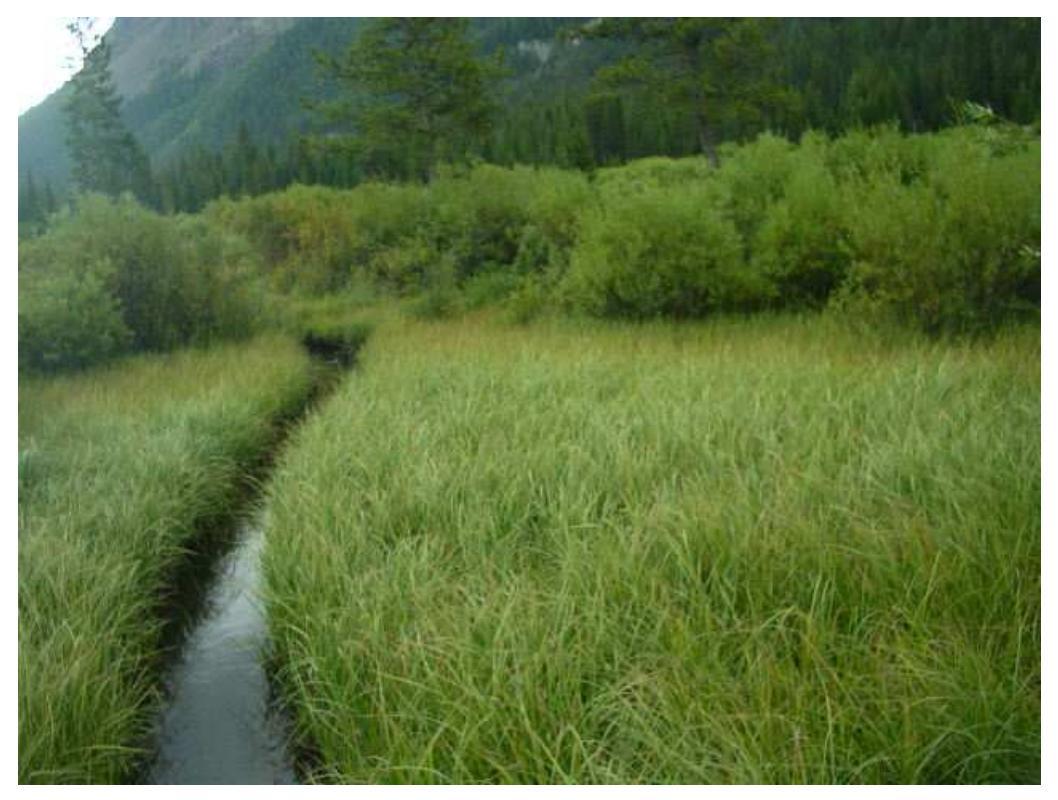
Upstream of the residential area, Willow Creek flows through a wet meadow dominated by sedges and willows (Figure 3-4). Before the highway construction, the channel consisted of a simple ditch next to the highway that lacked habitat features for fish (Jim Olsen, FWP, personal communication). Highway construction coincided with excavation of a new channel, located farther from the highway. Overall, this was beneficial to Willow Creek, as it likely reduced loading of fine sediment from the highway. Nonetheless, the channel constructed to convey flow does not have the form and function of a natural stream channel (Figure 3-5).

Figure 3-4: Newly constructed channel in wet meadow east of Silver Gate.

Construction of a new, functioning stream channel within the wet meadow upstream of Silver Gate would be beneficial in improving habitat and increasing Yellowstone cutthroat trout recruitment. The recommended actions involve excavating a new channel having cross-sectional channel dimensions and planform typical of natural spring creeks. The spoils from the new channel would be used to fill the channel created during highway construction to a depth that allows this channel to function as an emergent wetland.

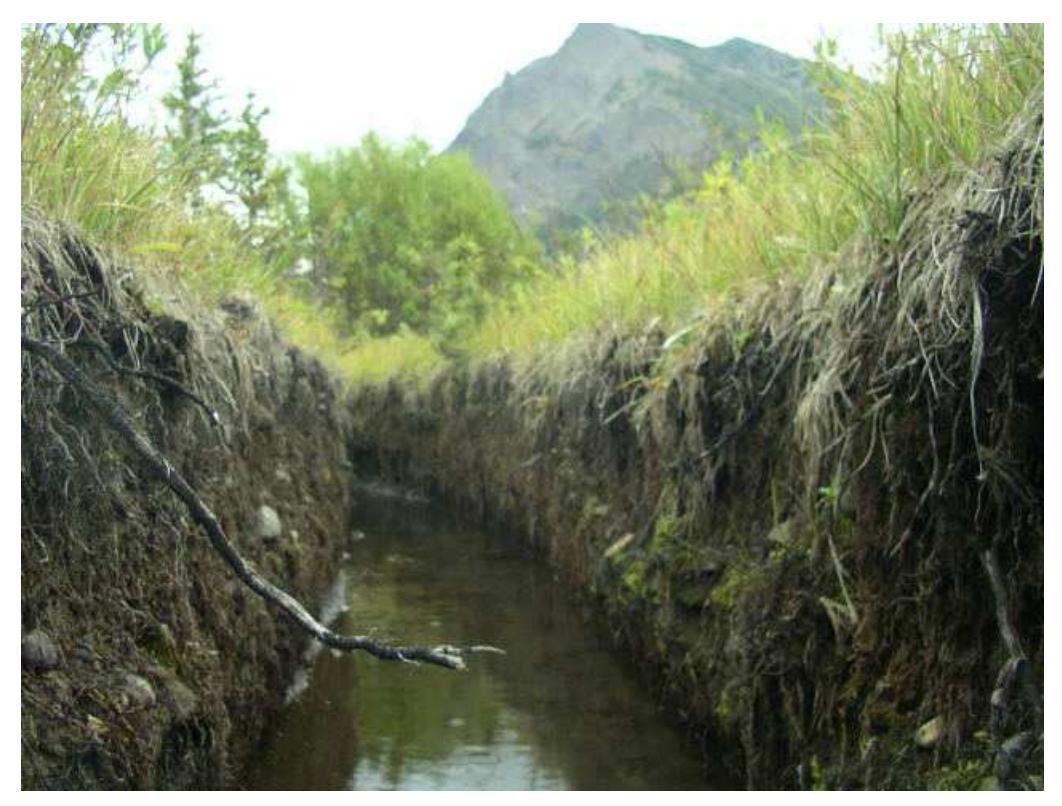
Figure 3-5: Excavated channel in the meadow reach of Willow Creek.

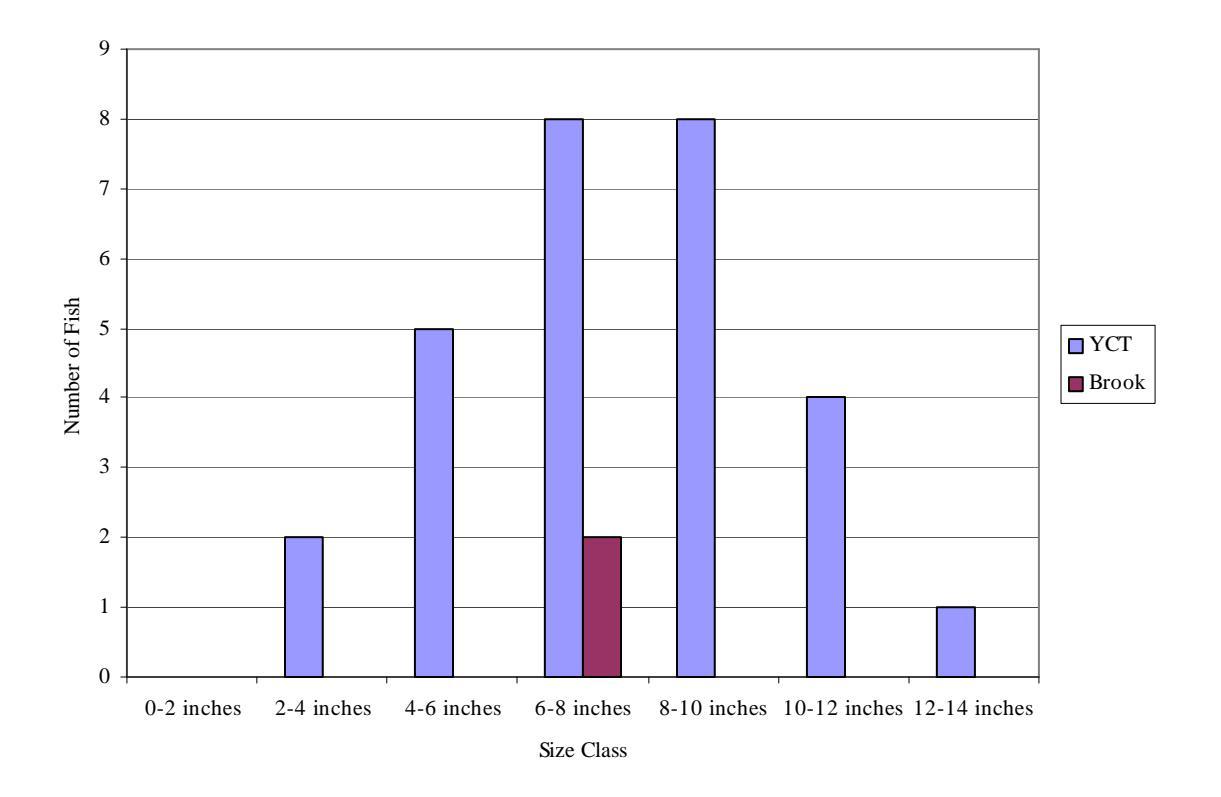
Electrofishing of the length of Willow Creek resulted in capture of 28 Yellowstone cutthroat trout and 2 brook trout. The brook trout were both ripe males, and were killed, consistent with the brook trout suppression project underway. Fish were typically not encountered in impounded reaches with deep muck bottoms, but were concentrated where stream form and function were largely intact. Despite its unnatural channel configuration, several cutthroat trout occupied the newly created channel, including some of the larger fish encountered. In general, Willow Creek had some relatively large fish for such a small stream (Figure 3-6). Electrofishing results suggest Willow Creek could support an impressive resident fishery with restoration of habitat and water quality.

Figure 3-6: Length frequency histogram of fish captured in Willow Creek.

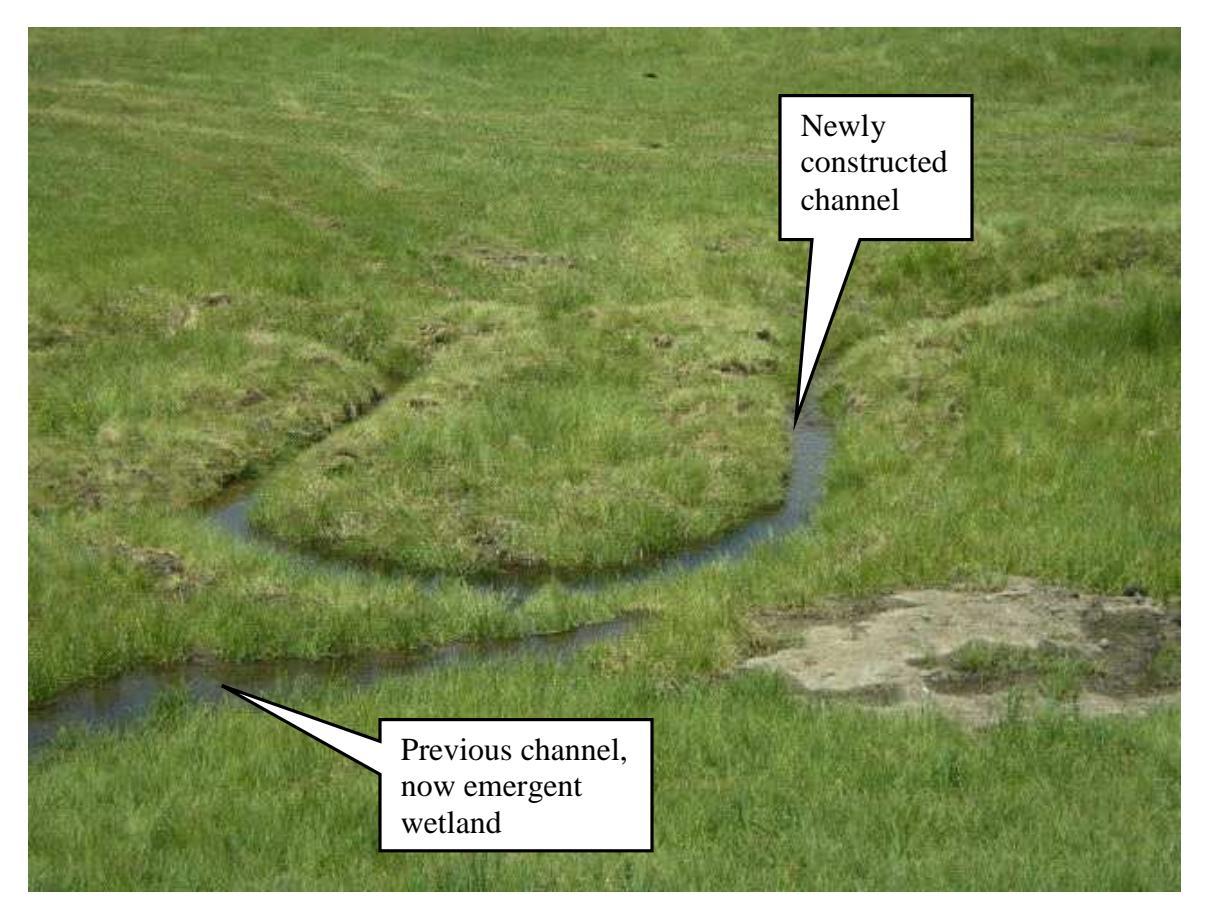
A recently completed spring creek project near Big Timber, Montana illustrates this approach (Figure 4-1). The original channel was relatively straight, and did not provide habitat features such as pools, overhead cover, or substrate suitable for spawning. The new channel was constructed within the wet sedge meadow, a setting very similar to Willow Creek. The constructed channel had greater sinuosity and its bed morphology

consisted of riffle/pool sequences, typical of natural channels. Spawning size gravel was imported to the stream to provide high quality spawning habitat.

Figure 4-1: Recent spring creek enhancement project

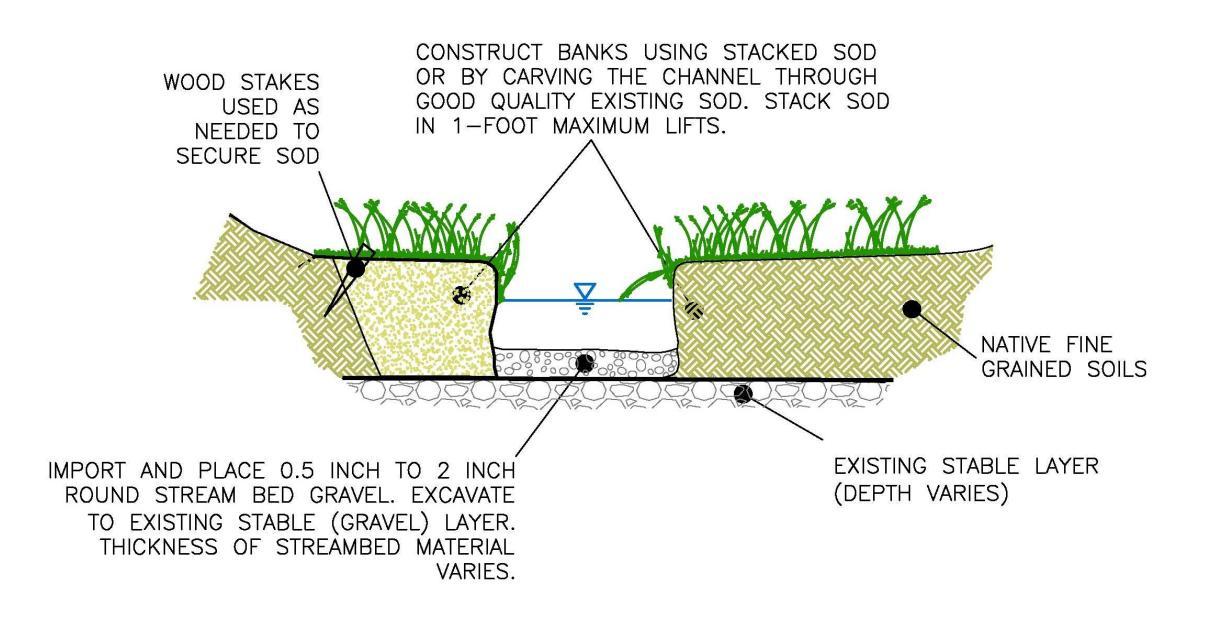
Ideally, channel construction would hit a layer of native gravels that would provide the streambed features required for spawning. The channel excavated during highway work did not encounter a gravel layer, suggesting these particles would need to be imported to the site. The new channel would be over-excavated to accommodate introduced gravel (Figure 4-2). Banks would be constructed of stacked sod mats salvaged during channel excavation, or borrowed from elsewhere on site.

Figure 4-2: Typical riffle cross-section of a constructed channel for Willow Creek (from OASIS 2008).
