An Assessment of Fish Populations and Riparian Habitat in Tributaries of the Upper Clark Fork River Basin – 2009 Report

Jason Lindstrom – Fisheries Biologist Montana Fish, Wildlife and Parks

January 2011

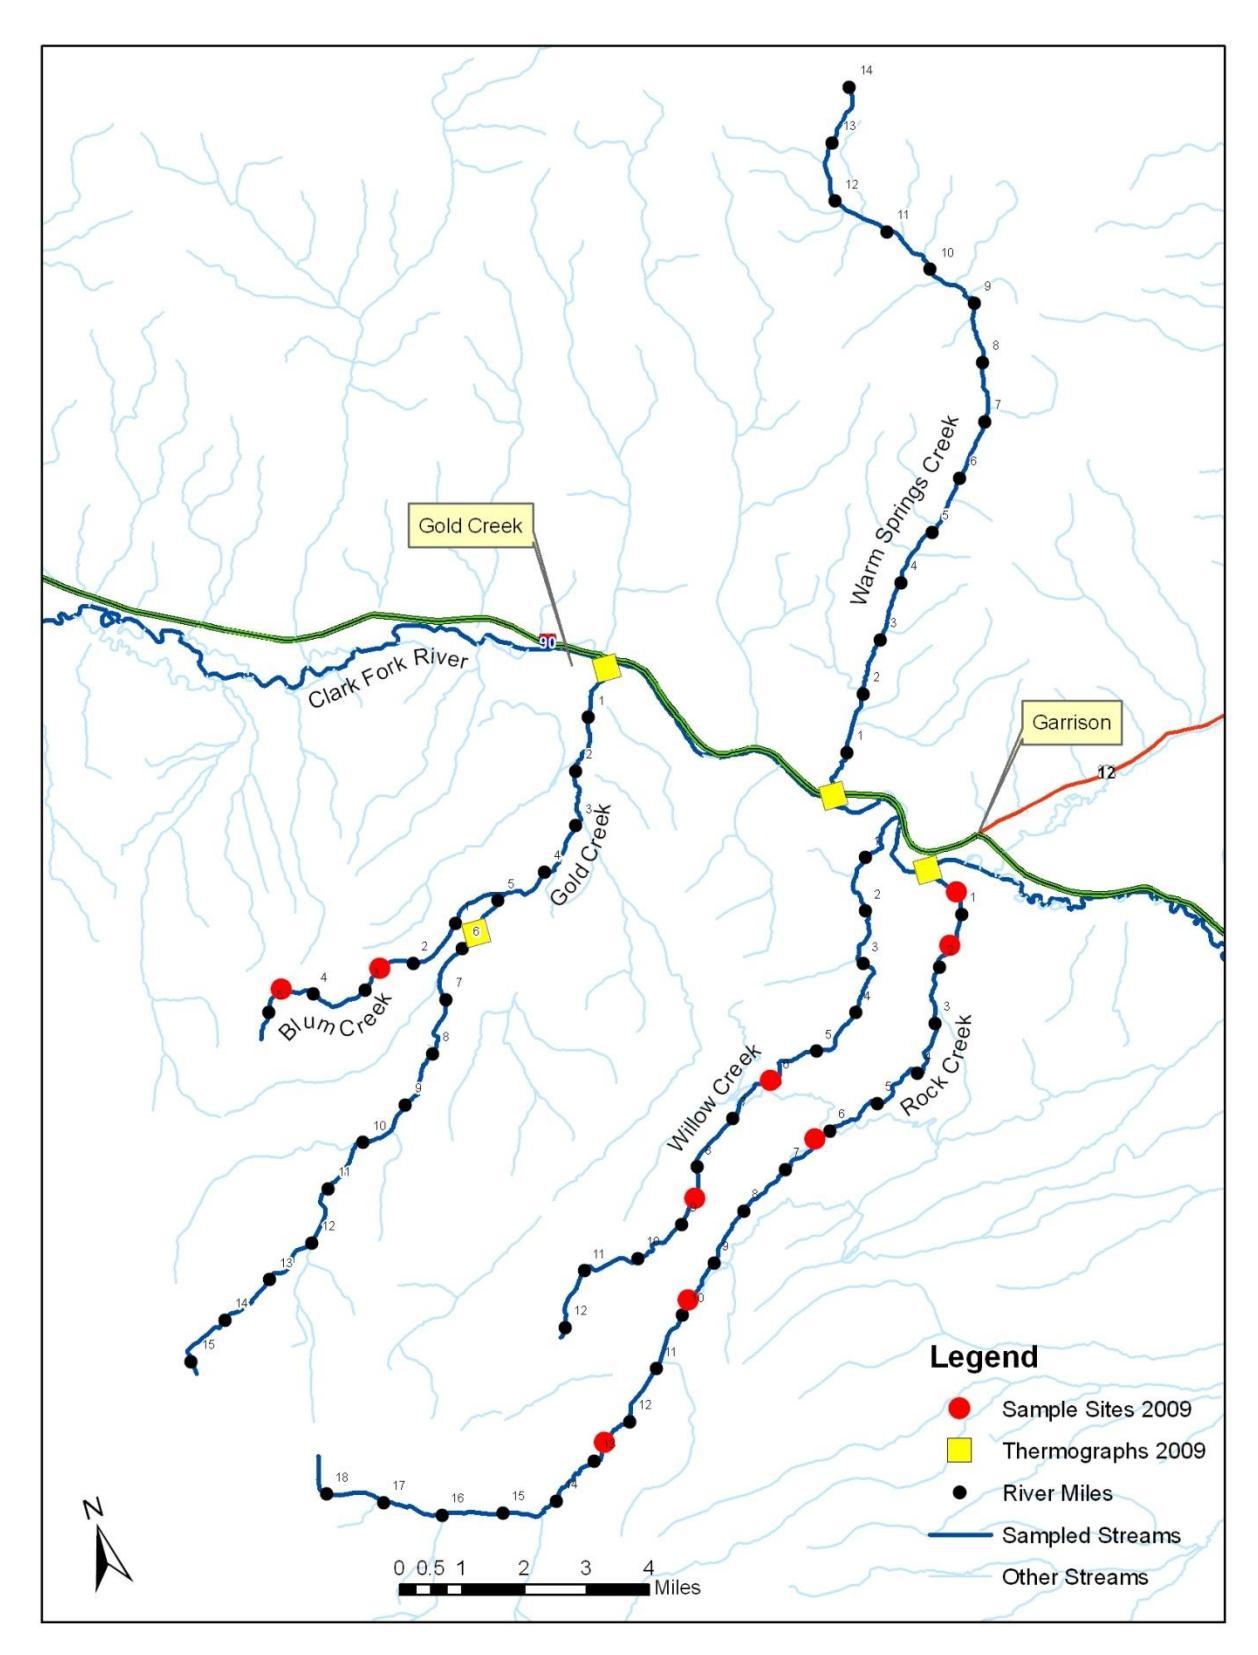
Figure 1. Map of the Clark Fork River drainage between Gold Creek and Garrison, MT showing sites of fish and temperature sampling conducted in 2009.

In 2009, water temperature was monitored in Gold Creek from June 25 through October 19 at RM 0.1 and 5.7 (Figure 1; Appendix B). At RM 0.1, maximum daily water temperature exceeded 15°C on 67 days. On no days did maximum daily water temperature exceed 20°C. The maximum-recorded temperature at RM 0.1 was 19.1°C on August 11. At RM 5.7, maximum daily water temperature did not exceed 15°C during the entire 2009 sampling period. The maximum-recorded temperature at this site was 12.9°C on August 21.

Fish surveys were completed at two sites on Blum Creek in late September of 2009. The sites were located on U.S. Forest Service land at RM 2.6 and 4.6 (Table 1; Figure 1). The fish community at both locations was comprised entirely of westslope cutthroat trout. Fish density was similar at each of the sample locations, and fish of multiple age/size classes were present in each of the sections (Table 1; Appendix A). While fish tended to be larger at the upper sample section, fish at both sample sites were relatively small overall (Table 1). The largest fish captured during 2009 sampling was 159 mm in total length. This fish was likely an adult with a resident life history. Genetic sampling conducted in 1996 indicates that the westslope cutthroat trout population in Blum Creek is genetically pure.

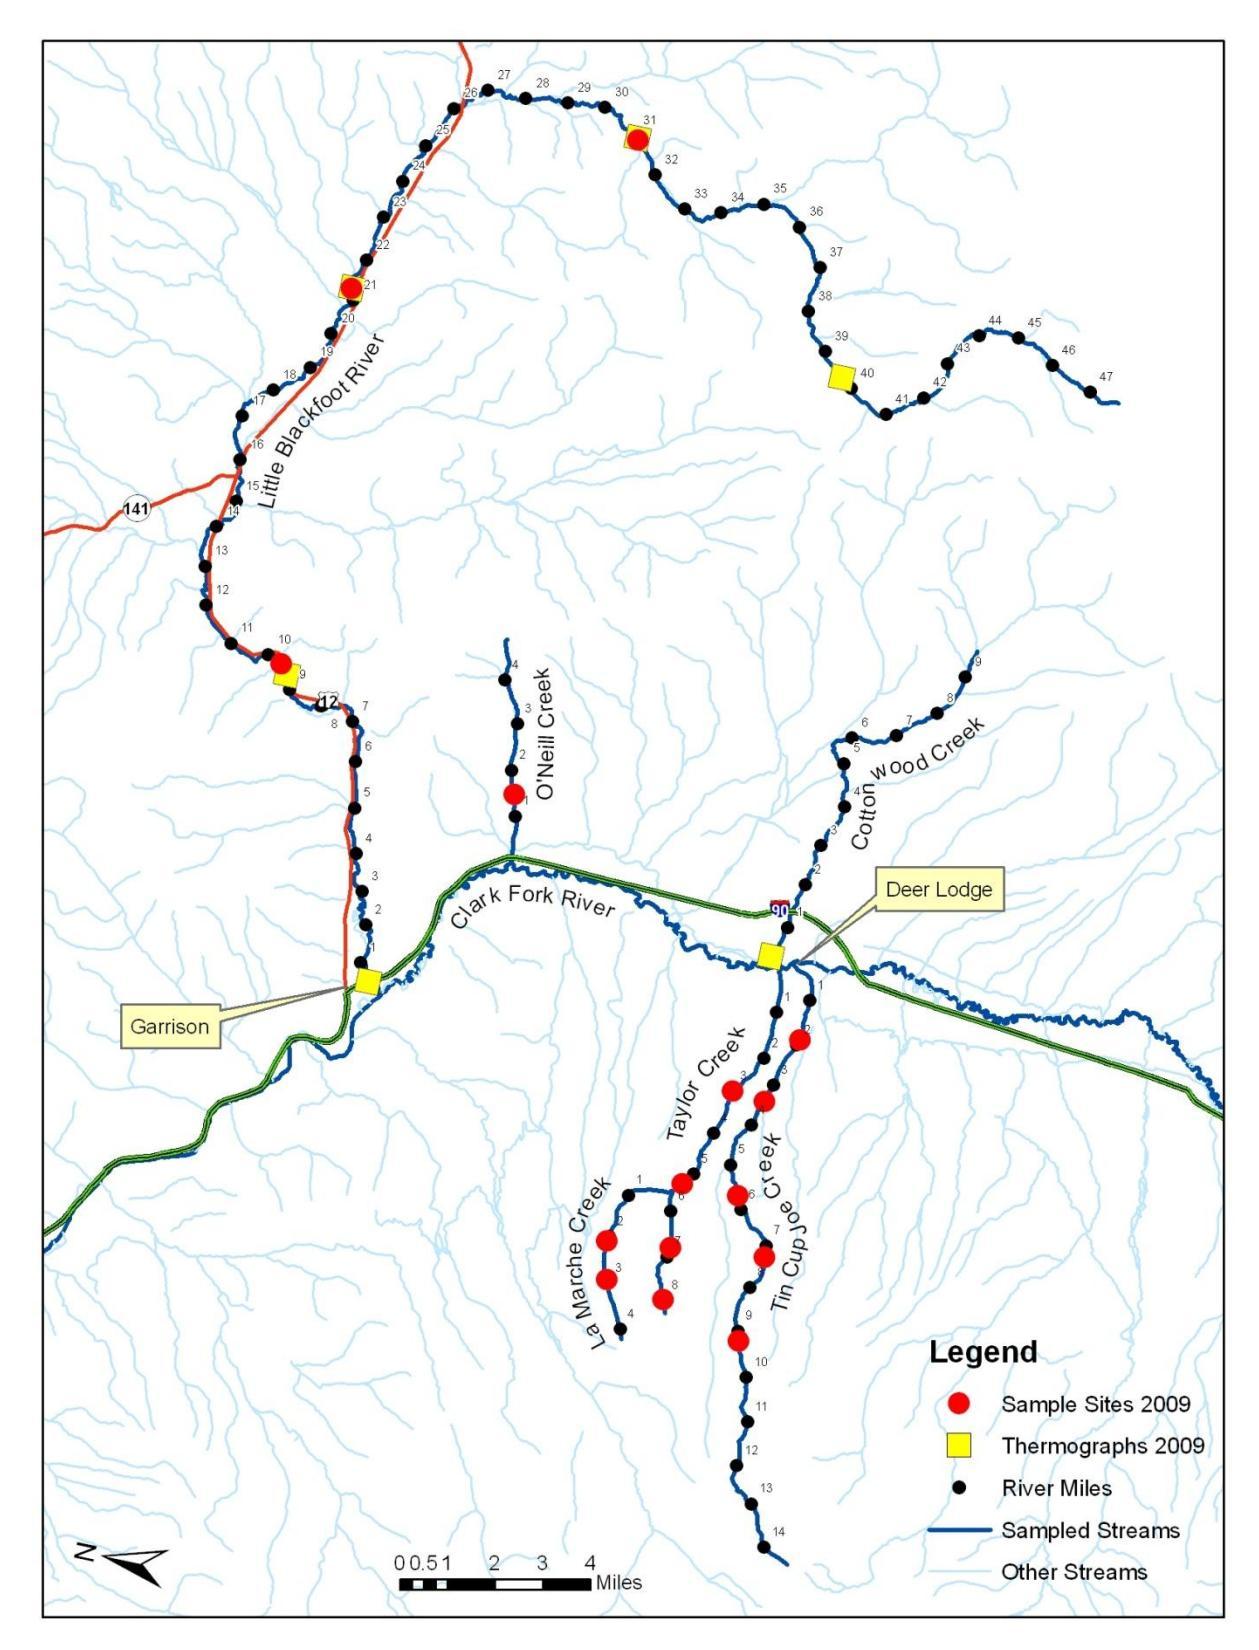
Figure 2. Map of the Clark Fork River drainage between Garrison and Deer Lodge, MT showing sites of fish and temperature sampling conducted in 2009.

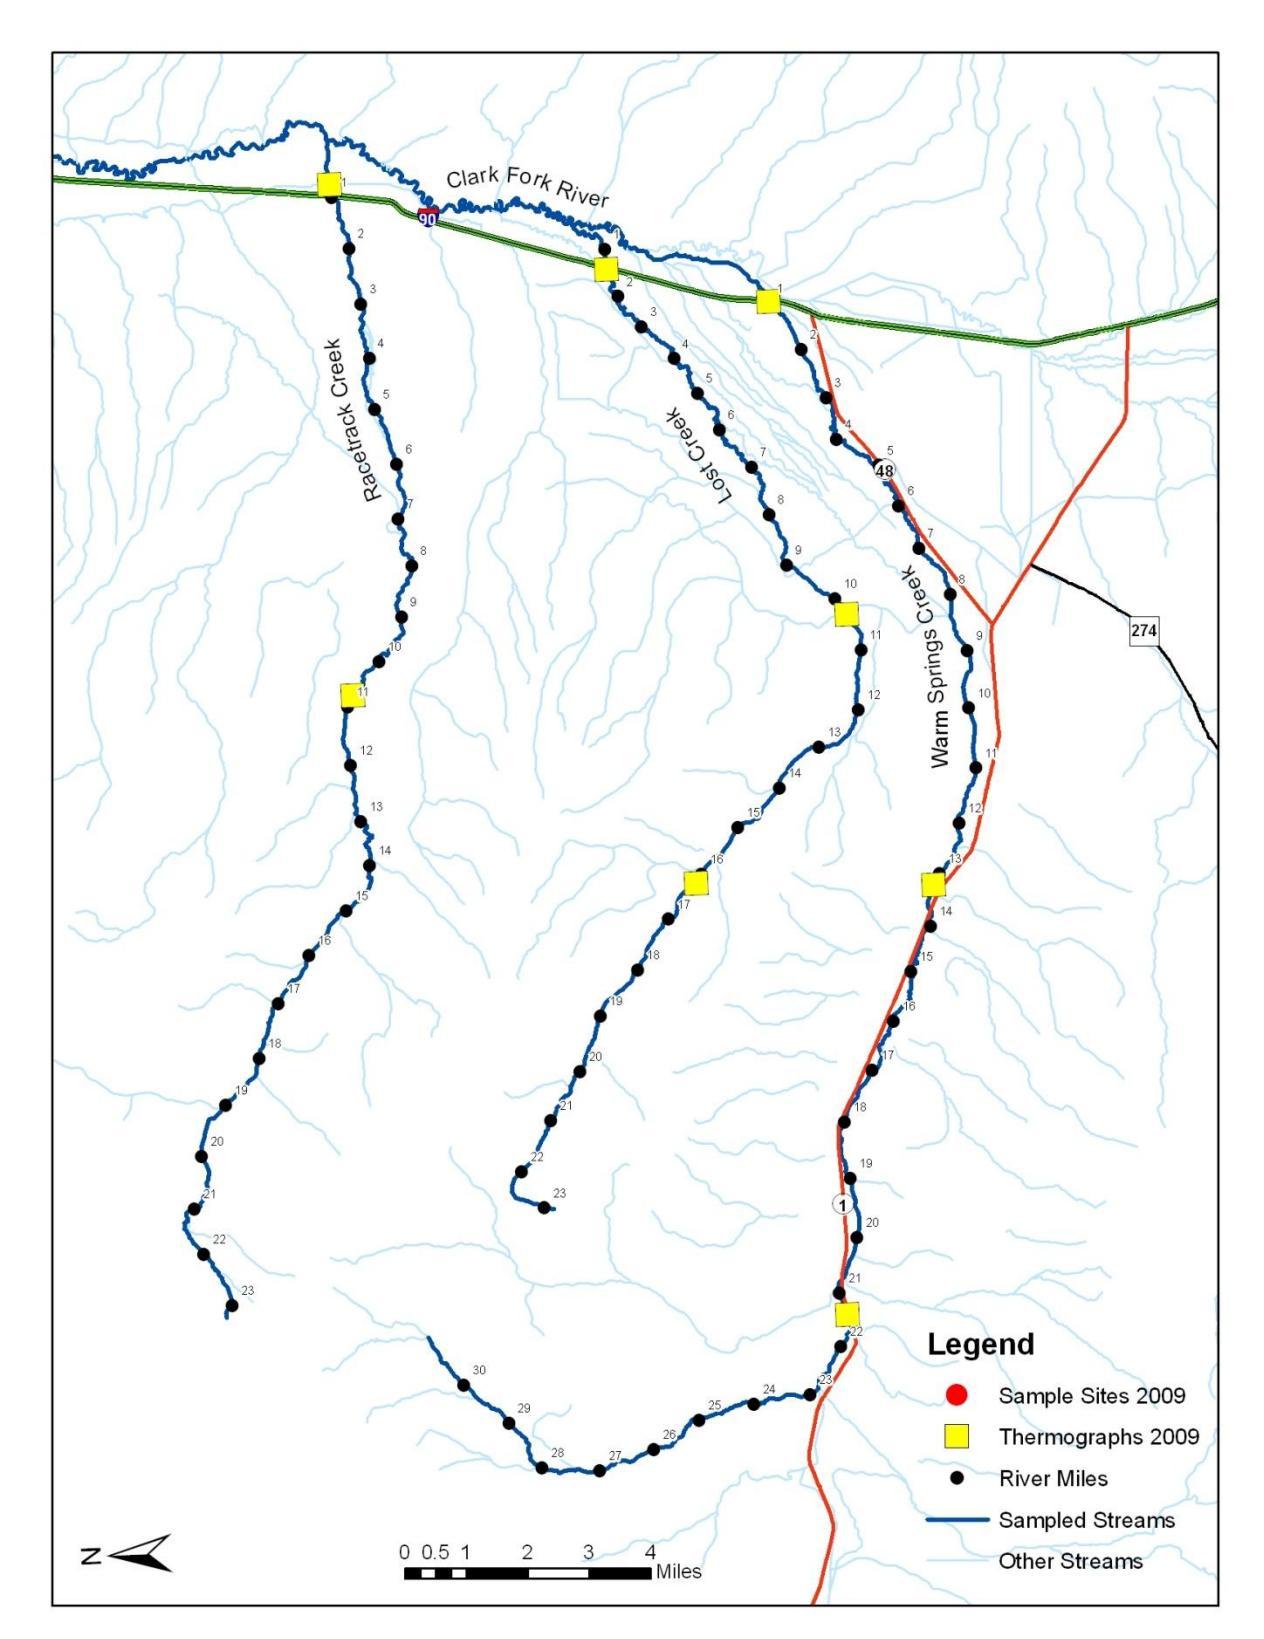
Figure 3. Map of Clark Fork River drainage between Deer Lodge and Warm Springs, MT showing sites of fish and temperature sampling conducted in 2009.

Water temperature was monitored in Racetrack Creek from July 1 through October 19, 2009 at RM 0.8 and 10.8 (Figure 3; Appendix B). At RM 0.8, maximum daily water temperature exceeded 15°C on 50 days. On no days did maximum daily water temperature exceed 20°C during 2009 monitoring. The maximum-recorded temperature at RM 0.8 was 17.9°C on July 24. At RM 10.8, maximum daily water temperature only exceeded 15°C on two days. The maximum-recorded temperature at this site was 15.1°C on July 22.

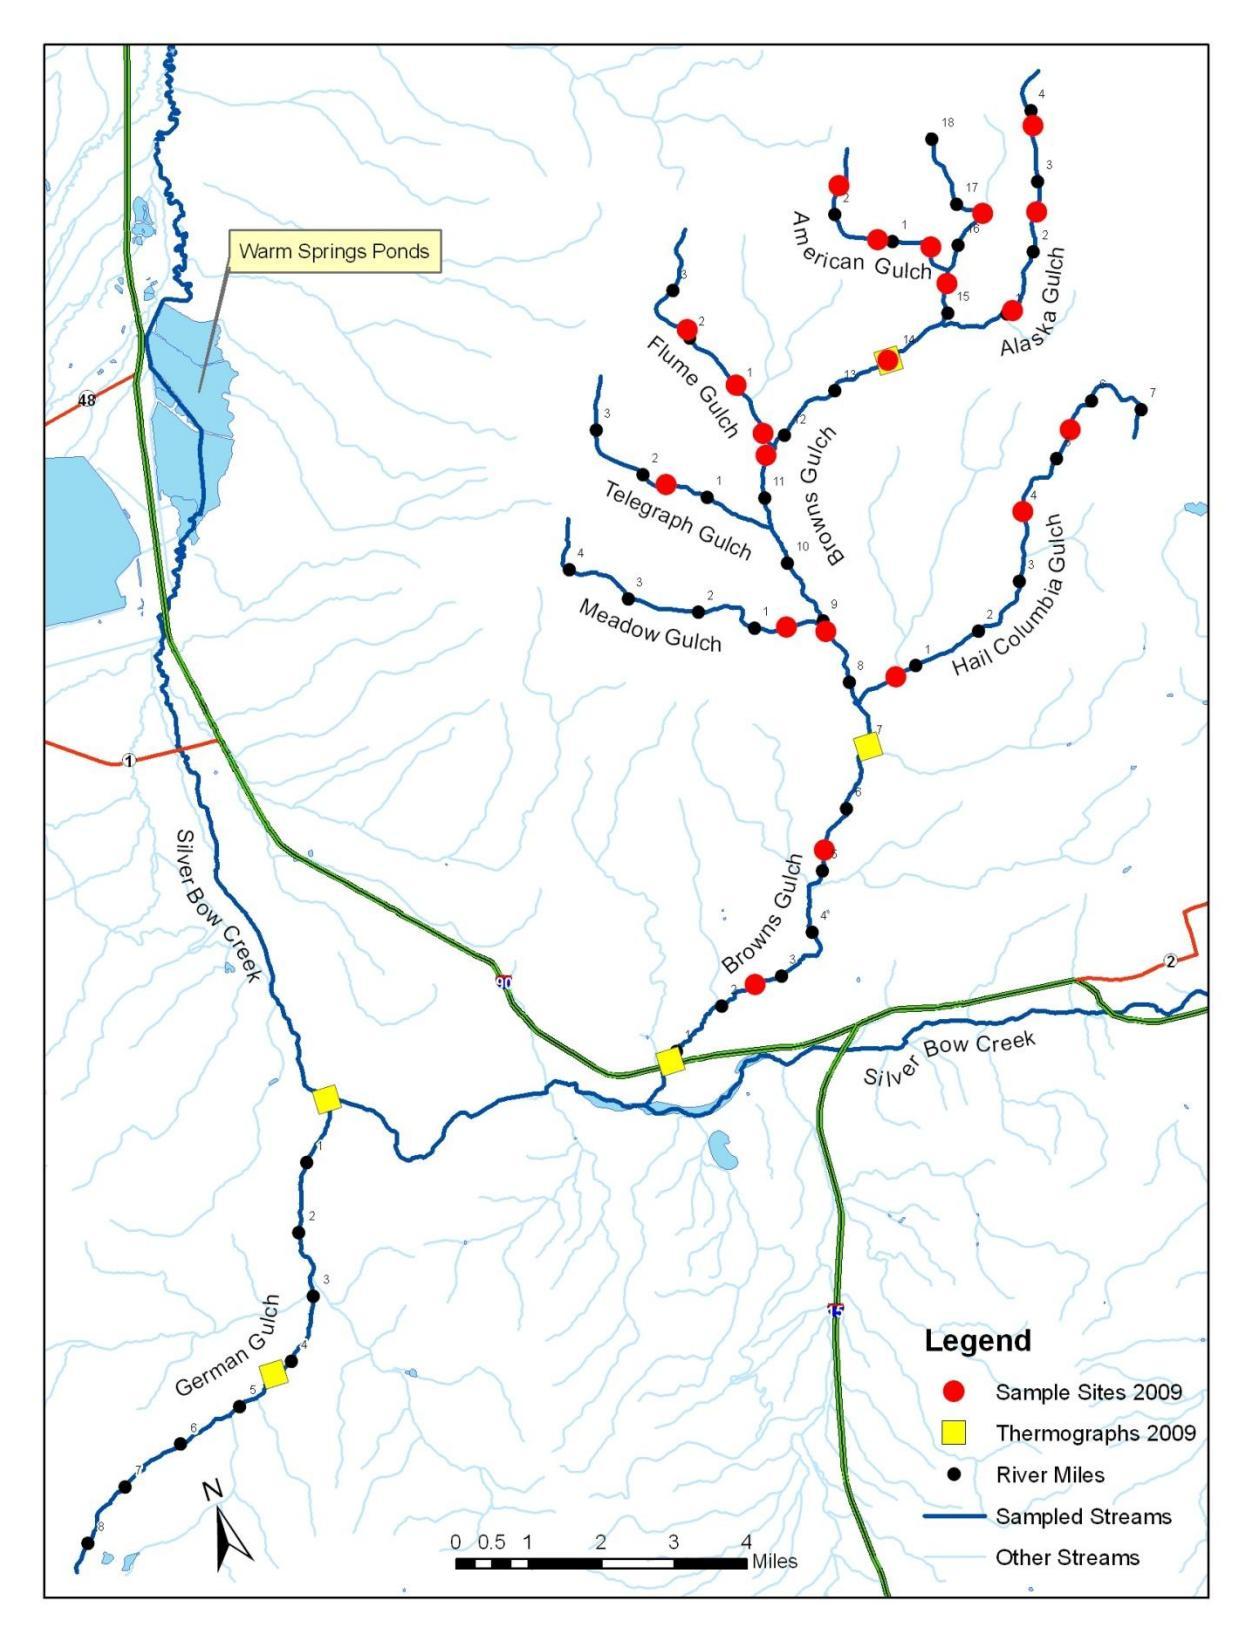
Figure 4. Map of the lower Silver Bow Creek drainage showing sites of fish and temperature sampling conducted in 2009.

Fish surveys were completed at three sites on Hail Columbia Gulch in 2009. The sites were located at RM 0.7, 4.0, and 5.4 (Table 18; Figure 4). The lowest site was situated on private land, while the remaining two sites were located on National Forest land. The fish community was dominated by brook trout at all of the sample locations (Table 18). Brook trout of multiple size classes were found at each of the electrofishing sections, and fish ranged in size from young-of-the-year to adults as large as 264 mm in total length (Table 18; Appendix A). Only one westslope cutthroat trout was captured in Hail Columbia Gulch during 2009 sampling. This fish was found at RM 0.7 and was a 114 mm (total length) juvenile. Although no westslope cutthroat trout could be found in the upper reaches of Hail Columbia Gulch in 2009, sampling conducted by the U.S. Forest Service
in 1999 turned up several fish. Genetic results from these fish indicated that the fish were genetically pure at that time.

Fish surveys were completed at three sites on Alaska Gulch in 2009. The sites were located at RM 1.1, 2.5, and 3.8 (Table 26; Figure 4). The fish community throughout the stream was comprised of both brook trout and westslope cutthroat trout, with brook trout being the more common species. At RM 1.1, brook trout comprised over 80% of the fish community (Table 26). Fish ranged in size from small juveniles to adults as large as 180 mm in total length (Table 26; Appendix A). Westslope cutthroat trout were relatively uncommon in the reach, but fish of several size classes were observed suggesting at least some limited recruitment has occurred (Table 26; Appendix A). At RM 2.5, fish density was very low, and most of fish captured in this reach were brook trout that ranged in size from 81 mm to 176 mm in total length (Table 26; Appendix A). Only one small, juvenile westslope cutthroat trout was observed at this survey site in 2009 (Table 26). At RM 3.8, no fish were captured in the sample section. Downstream of the section, a perched culvert was noted, and spot electrofishing below this site turned up two larger brook trout and one sub-adult westslope cutthroat trout. It appears likely that the perched culvert is a complete barrier to upstream fish passage under most flow conditions. It should be noted however, that there does not appear to be a significant amount of quality habitat above this location for fish to utilize. Genetic sampling conducted in 2004 indicates that the westslope cutthroat trout population in Alaska Gulch is genetically pure.

Fish surveys were completed at three sites on American Gulch in 2009. The sites were located at RM 0.4, 1.2, and 2.4 (Table 28; Figure 4). The fish community at RM 0.4 and 1.2 was relatively similar. At both sites, westslope cutthroat trout and brook trout were present, with brook trout being the more common species (Table 28). While multiple size classes of fish were observed for each species at each of the sites, it appears that juvenile brook trout between 80 and 90 mm in total length comprised a sizeable proportion of the total brook trout captured at each of the reaches (Table 28; Appendix A). Further upstream at RM 2.4, fish density was very low. No brook trout were observed at this location, and only five westslope cutthroat trout were collected in the section. The majority of these fish appeared to be sub-adults based on size (< 150 mm total length) (Table 28; Appendix A). Genetic sampling conducted in 2004 indicates that the westslope cutthroat trout population in American Gulch is genetically pure.

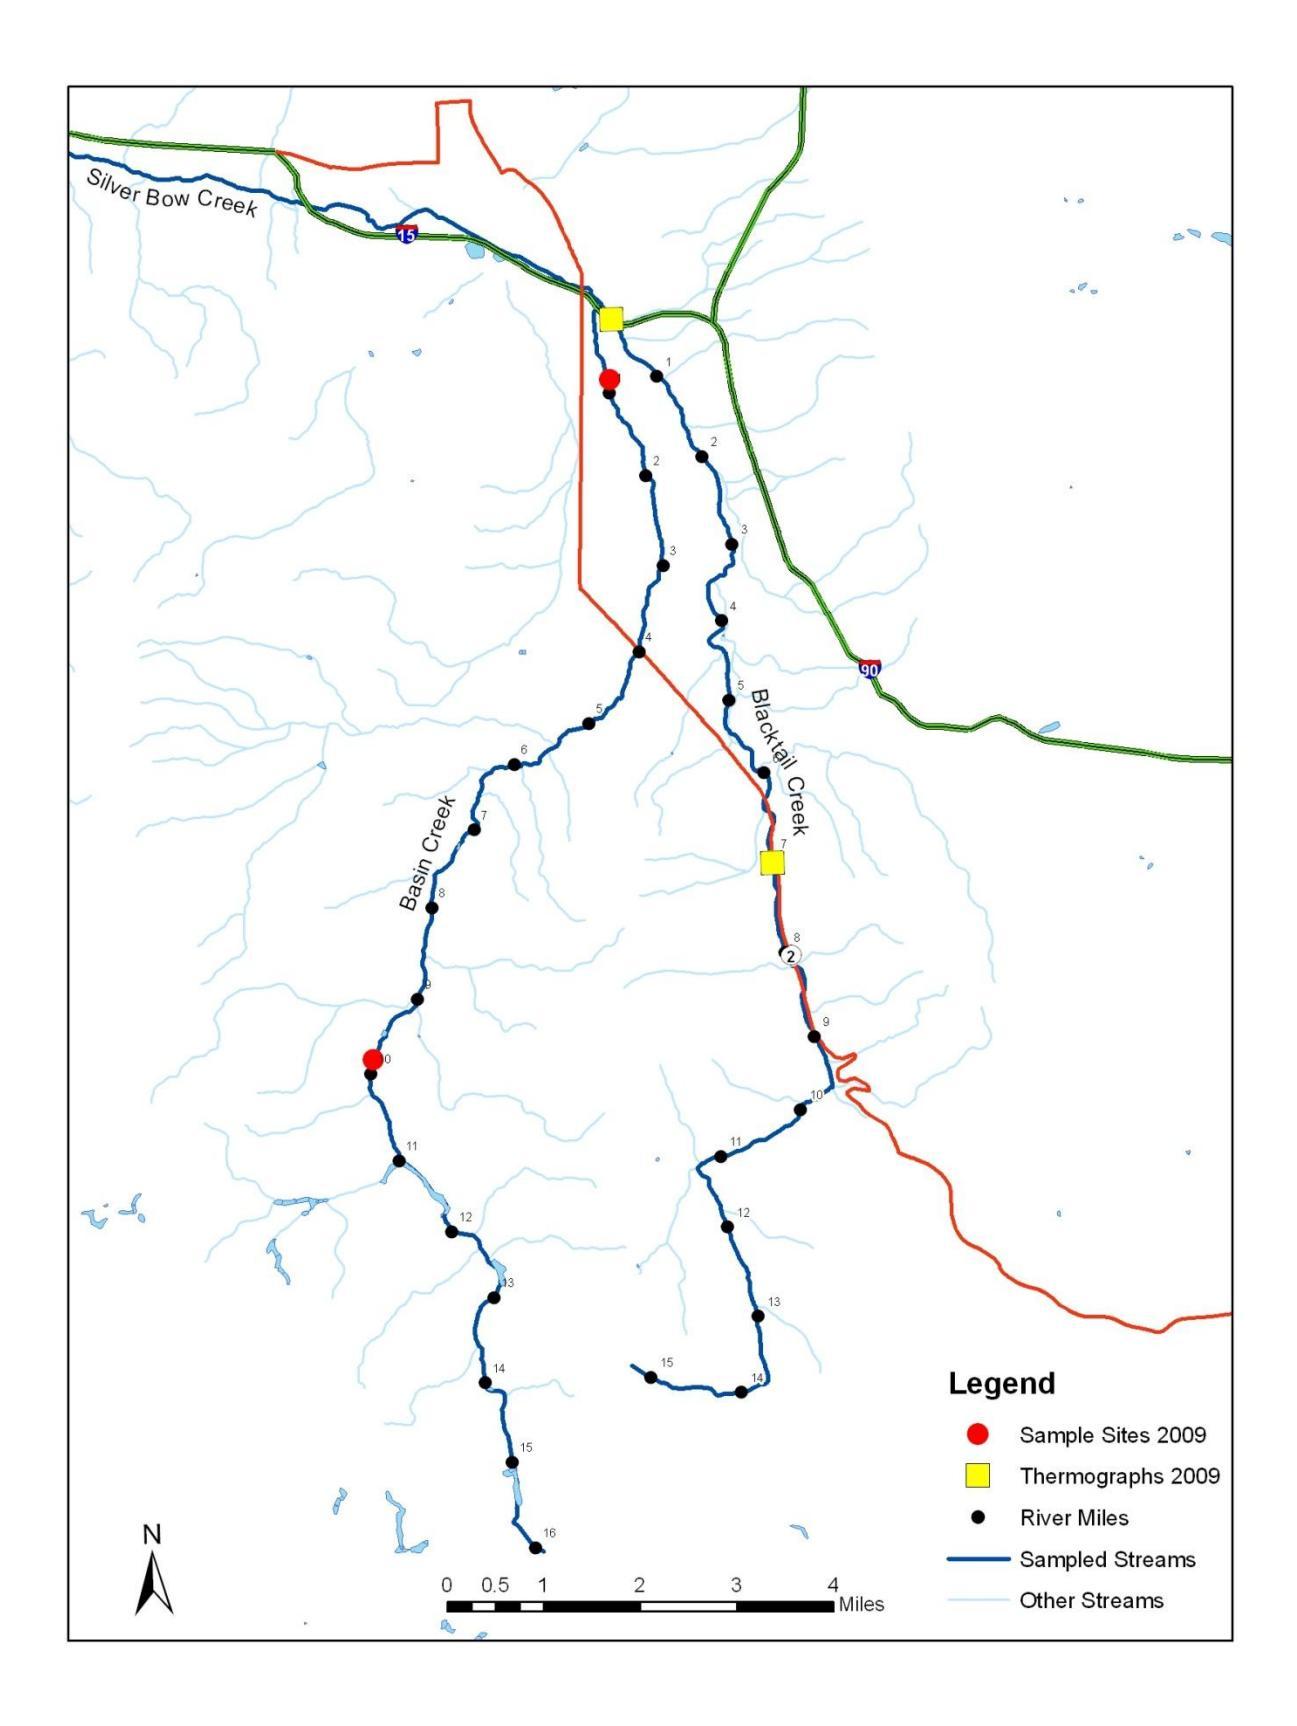
Figure 5. Map of the upper Silver Bow Creek drainage showing sites of fish and temperature sampling conducted in 2009.

Fish surveys were completed at two sites on Basin Creek in 2009. The sites were located downstream of Basin Creek Reservoir at RM 0.9 and 9.8 (Table 30; Figure 5). At RM 0.9, the trout community was comprised entirely of brook trout that ranged in size from 80 mm to 320 mm in total length (Table 30; Appendix A). Other fish captured at this sample site included 20 longnose suckers and five central mudminnow. At RM 9.8, no trout were captured in the reach. Flow and habitat was very limited, and only two longnose suckers were observed. Although no fish sampling was conducted upstream of Basin Creek Reservoir in 2009, past sampling in this reach documented the presence of an isolated population of westslope cutthroat trout. The species comprises the entire fish community in this segment of the stream, and occurs in fairly good numbers. Genetic testing conducted in 2001 indicates that this population is genetically pure.
