**FORT PECK FISHERY HABITAT EVALUATION
AND IMPROVEMENT STUDY**

Annual Milestone

Montana Department of Fish, Wildlife and Parks
1987

Funding Provided By:
U.S. Army Corps of Engineers
Missouri River Division

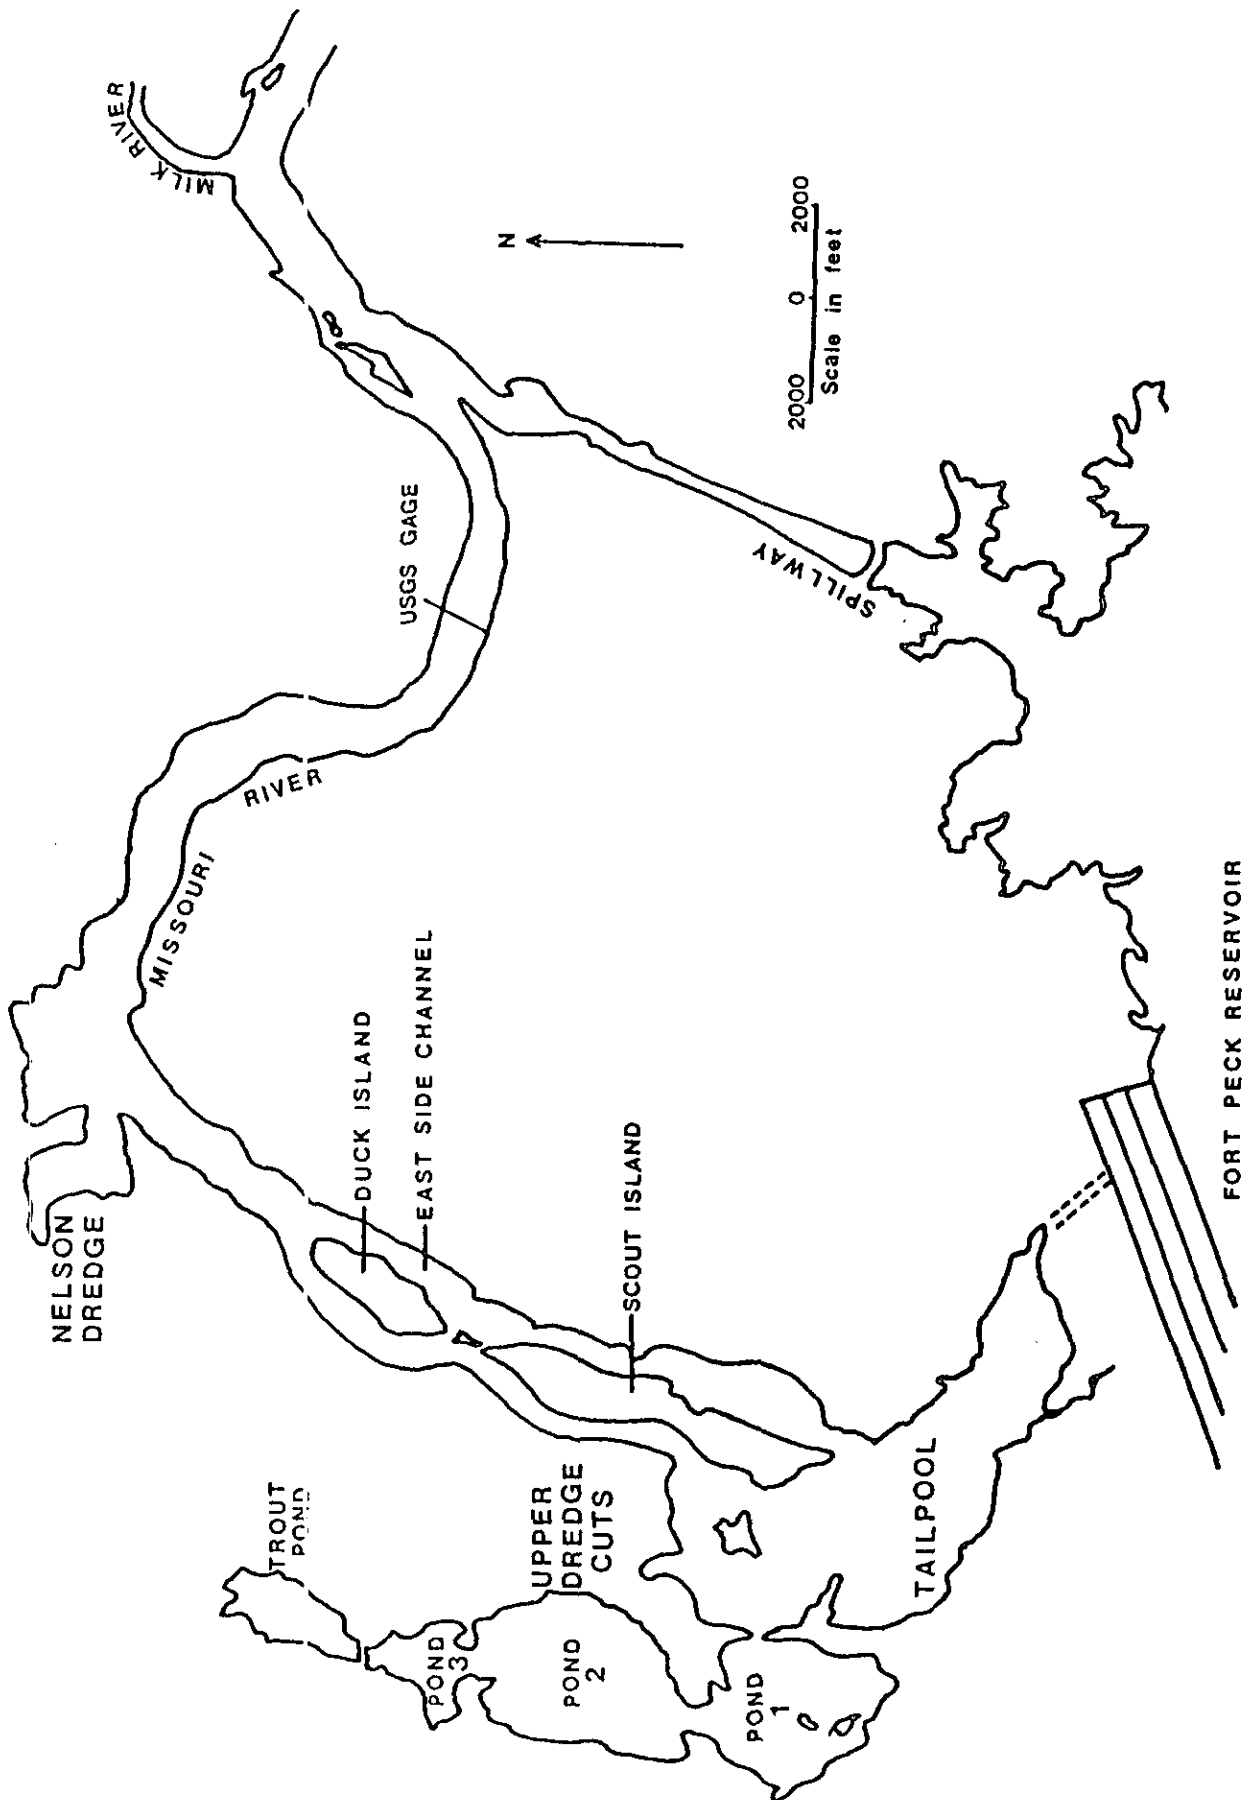
Figure 1. Study Area

There are two dredge cut areas. The upper one, 1.6 miles downstream from the dam, consists of three interconnected ponds with a single connection to the river (Figure 1). The ponds have a total surface area of approximately 650 acres and a maximum depth of approximately 31 feet. Their average depth is 15 to 20 feet. The banks and bottom of the ponds are composed of sand and silt. The banks are steep and very unstable with little shoreline cover. Two gravel points provide potential spawning habitat for walleye and sauger.

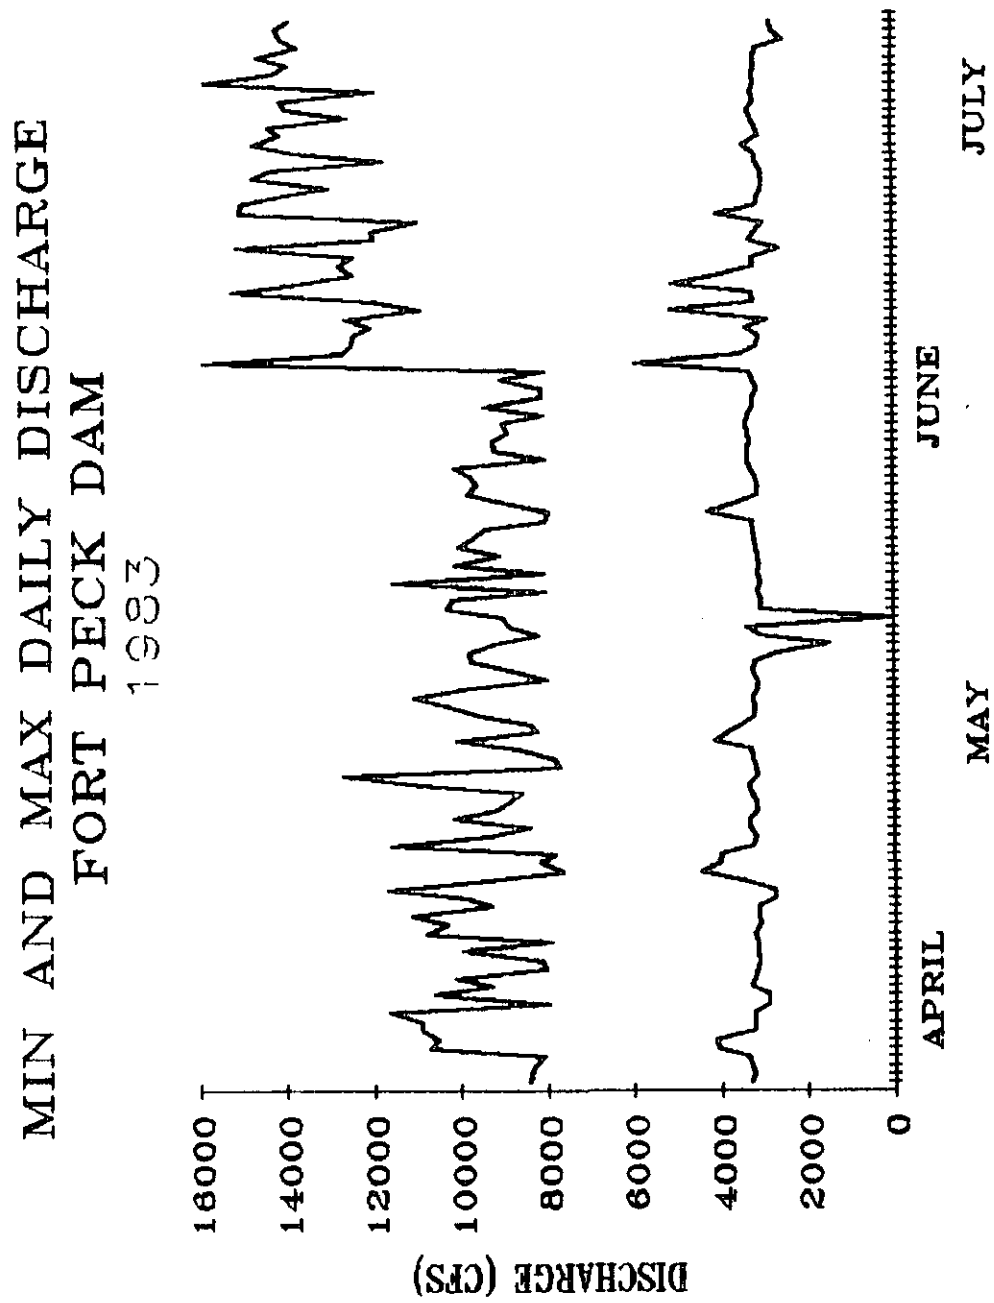
Figure 2. Minimum and maximum daily discharges from Fort Peck Dam during the spring and early summer, 1983.

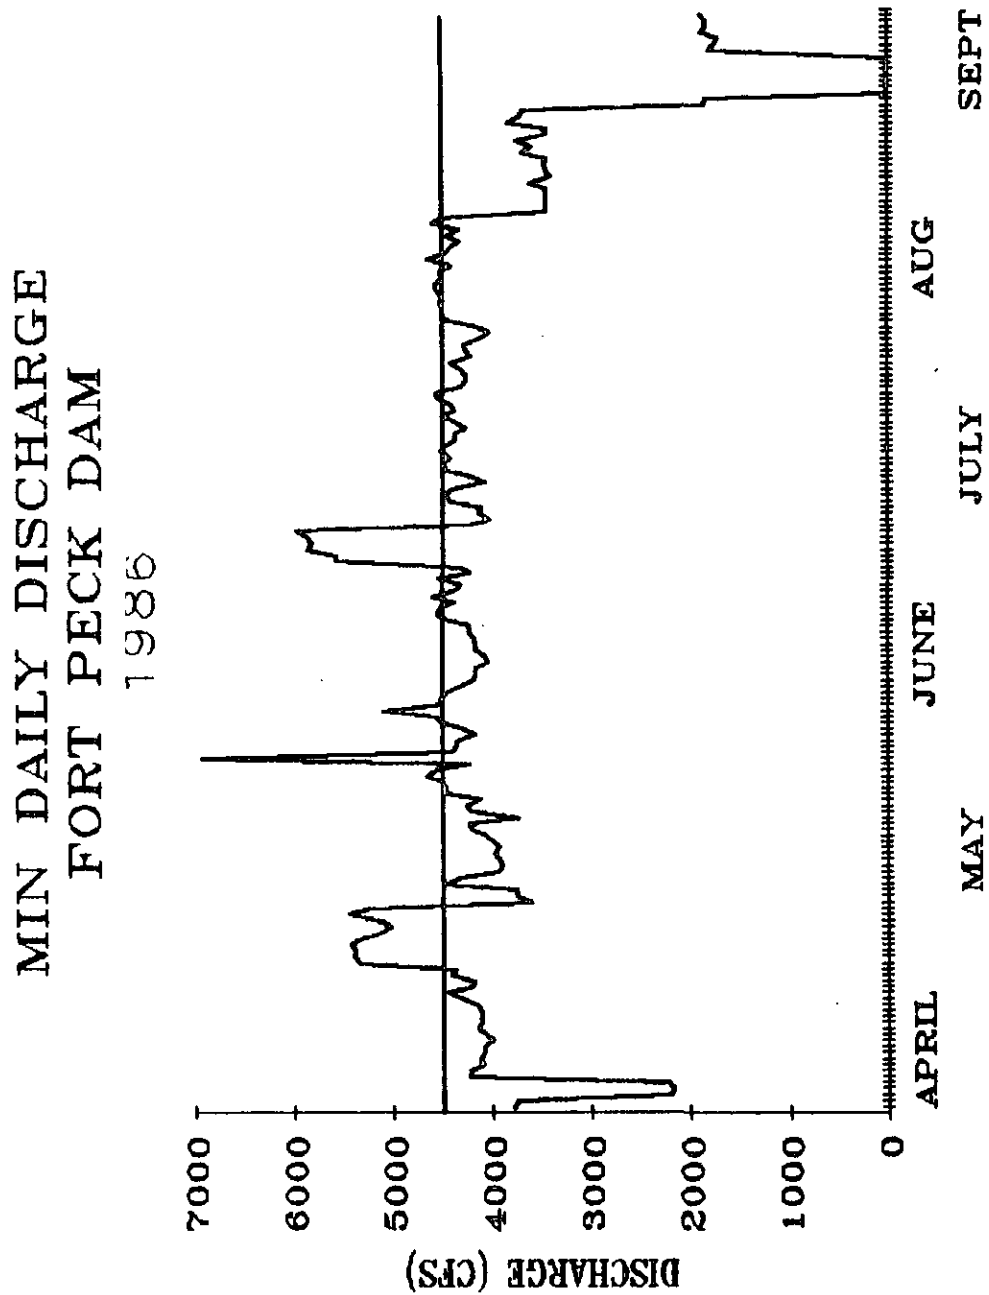
Figure 3. Minimum daily discharges from Fort Peck Dam, April 1 through September 15, 1936 compared to the recommended absolute minimum discharge of 4500 cfs,

Figure 3 is a graph of the minimum daily discharges at Fort Peck Dam during the recommended period in 1986. Although discharge levels were higher than those historically occurring during this time, they were not as high as the minimum recommended levels. On only one day during the 168-day recommendation period did the minimum daily discharge remain above 6,700 cfs. There were only 37 days when the minimum daily discharge remained above 4,500 cfs.

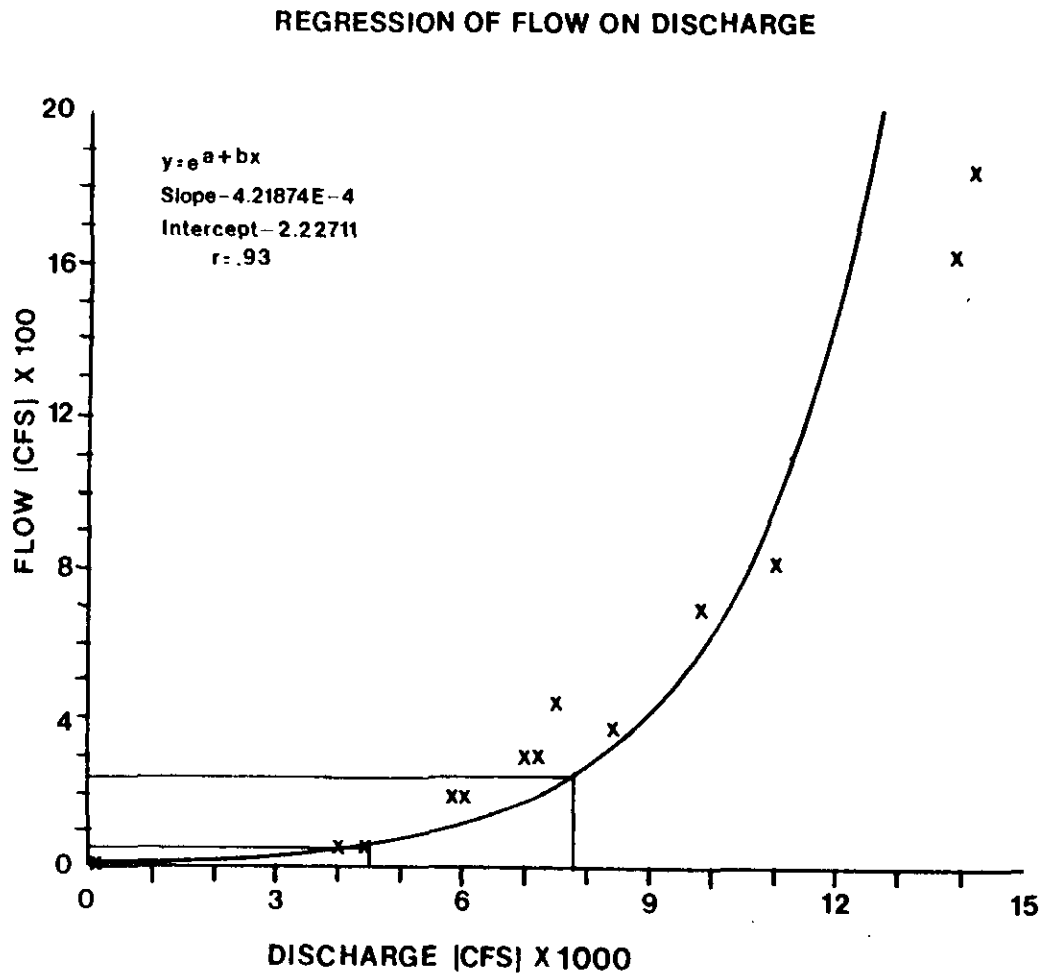
Figure 4. Regression curve of flow in the east side channel to discharge from Fort Peck Dam.

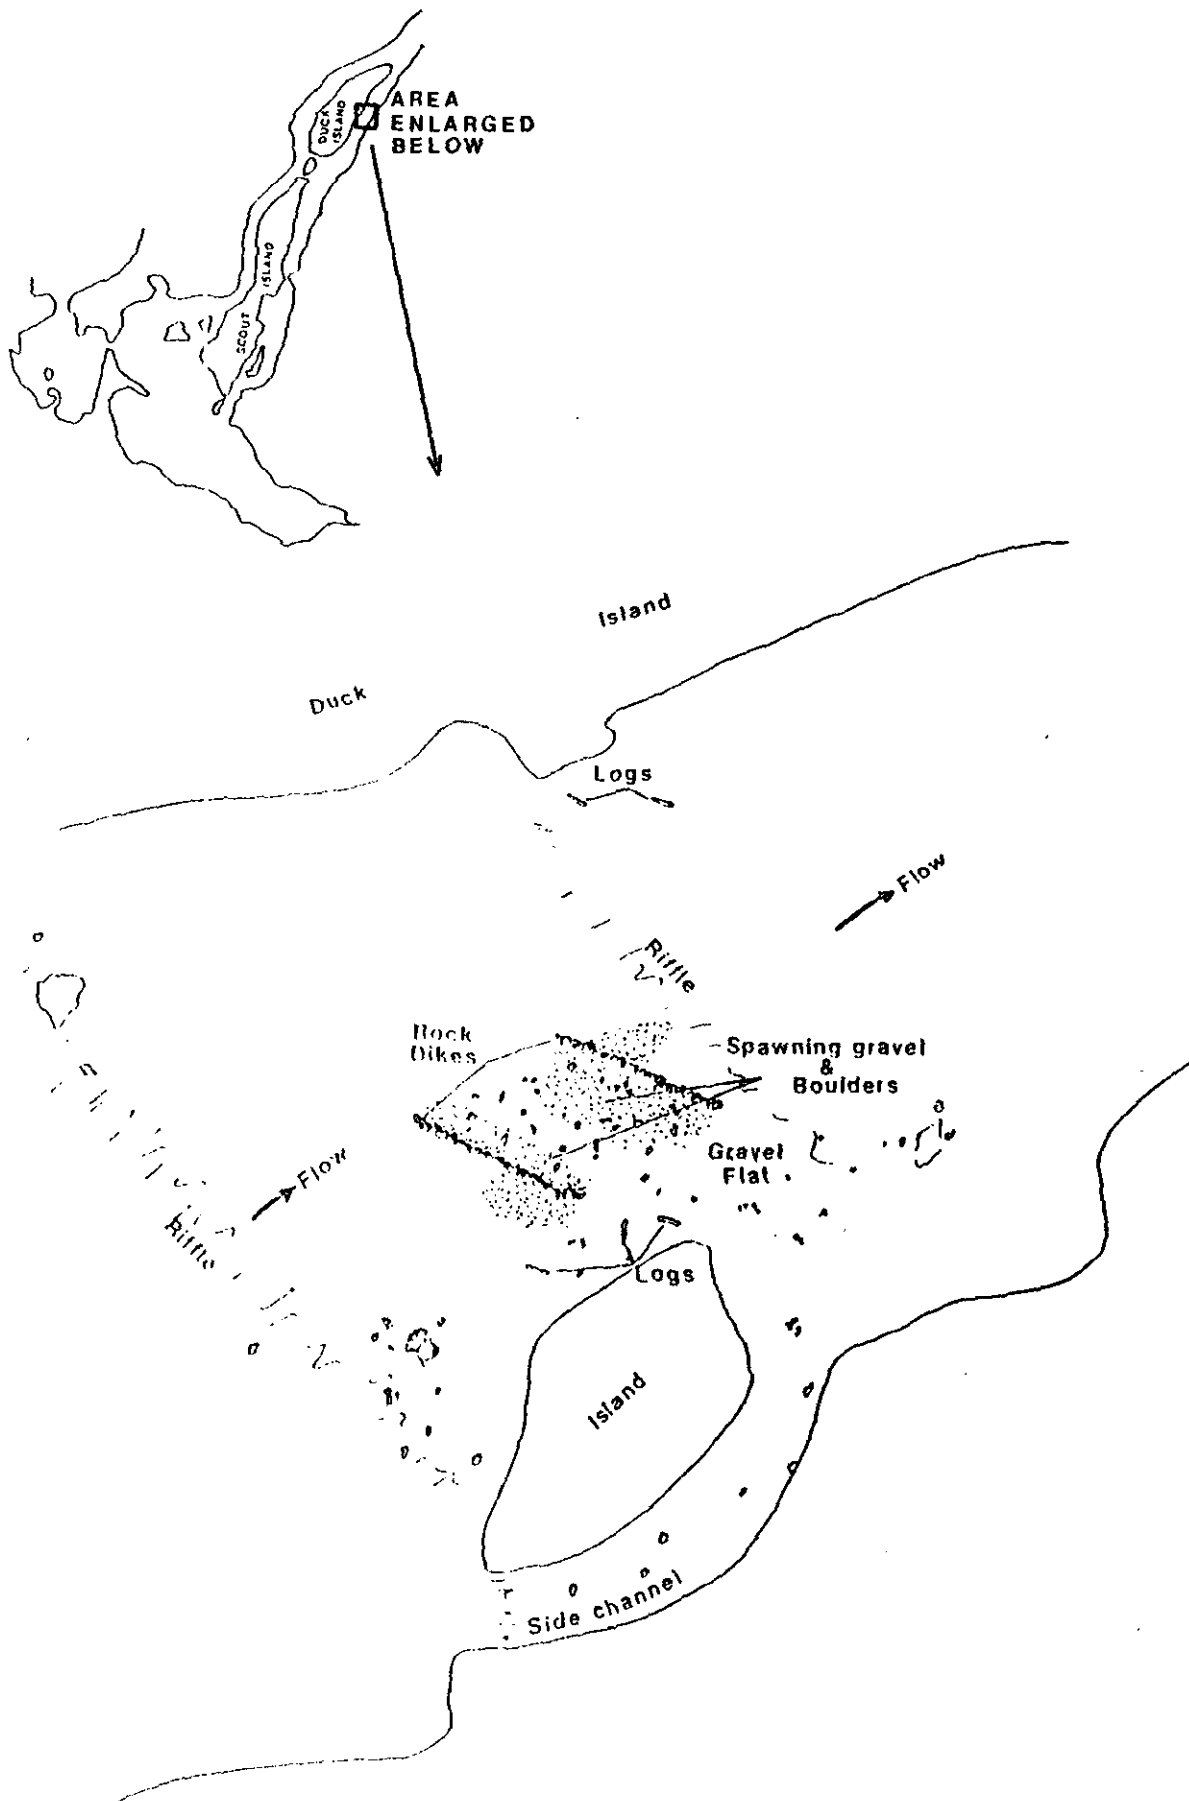
Figure 5. Location and diagrammatic sketch of habitat work completed in the east side channel in 1985.

The dikes were designed with several purposes in mind: 1) They were to act as partial dams to reduce current velocities in the center of the channel, thus allowing spawning gravel to deposit and remain in the channel and spawning fish to use the area during high flows. 2) They were to provide instream rearing cover that would remain watered at recommended low flows, and they were to provide a break in the current so that small fish could remain in the center of the channel during periods of high flow. 3) They were to provide good habitat for aquatic invertebrates, increasing the food supply available for rainbow rearing in the area. 4) They were to force deeper water over the large gravel flat at their downstream end (Figure 5). This area contained good natural spawning gravel, but the water was usually too shallow under normal flow conditions to be used by spawning fish. Many of the large boulders embedded in the gravel flat were dug up and placed on top of the gravel to help reduce bottom armoring and to provide additional rearing habitat.

Once the gravel was placed, boulders ranging from about 1 to 2 feet in diameter were arranged individually and in groups between the dikes. These were to provide additional cover for adult fish that moved into the area to spawn. Anderson et al. (1984) found that spawning fish avoided open gravel bars created by structures if hiding cover was insufficient. The boulders also were intended to provide additional rearing cover for YOY rainbow.

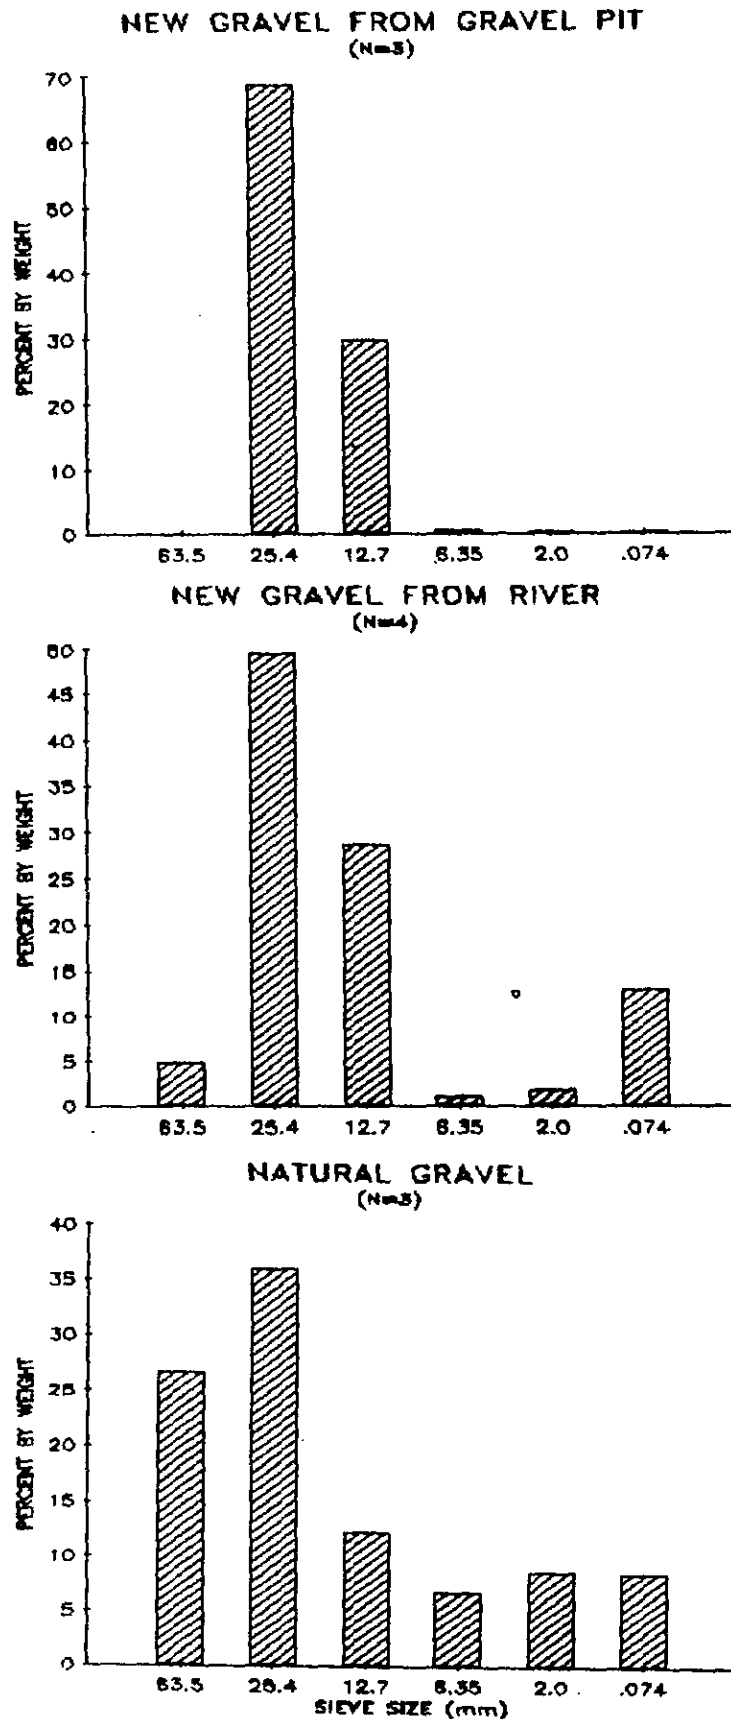
Figure 6. Composite substrate composition by day weight of new spawning gravel from the gravel pit and after being in the river one year and of natural gravel from spawning areas in the east side channel.

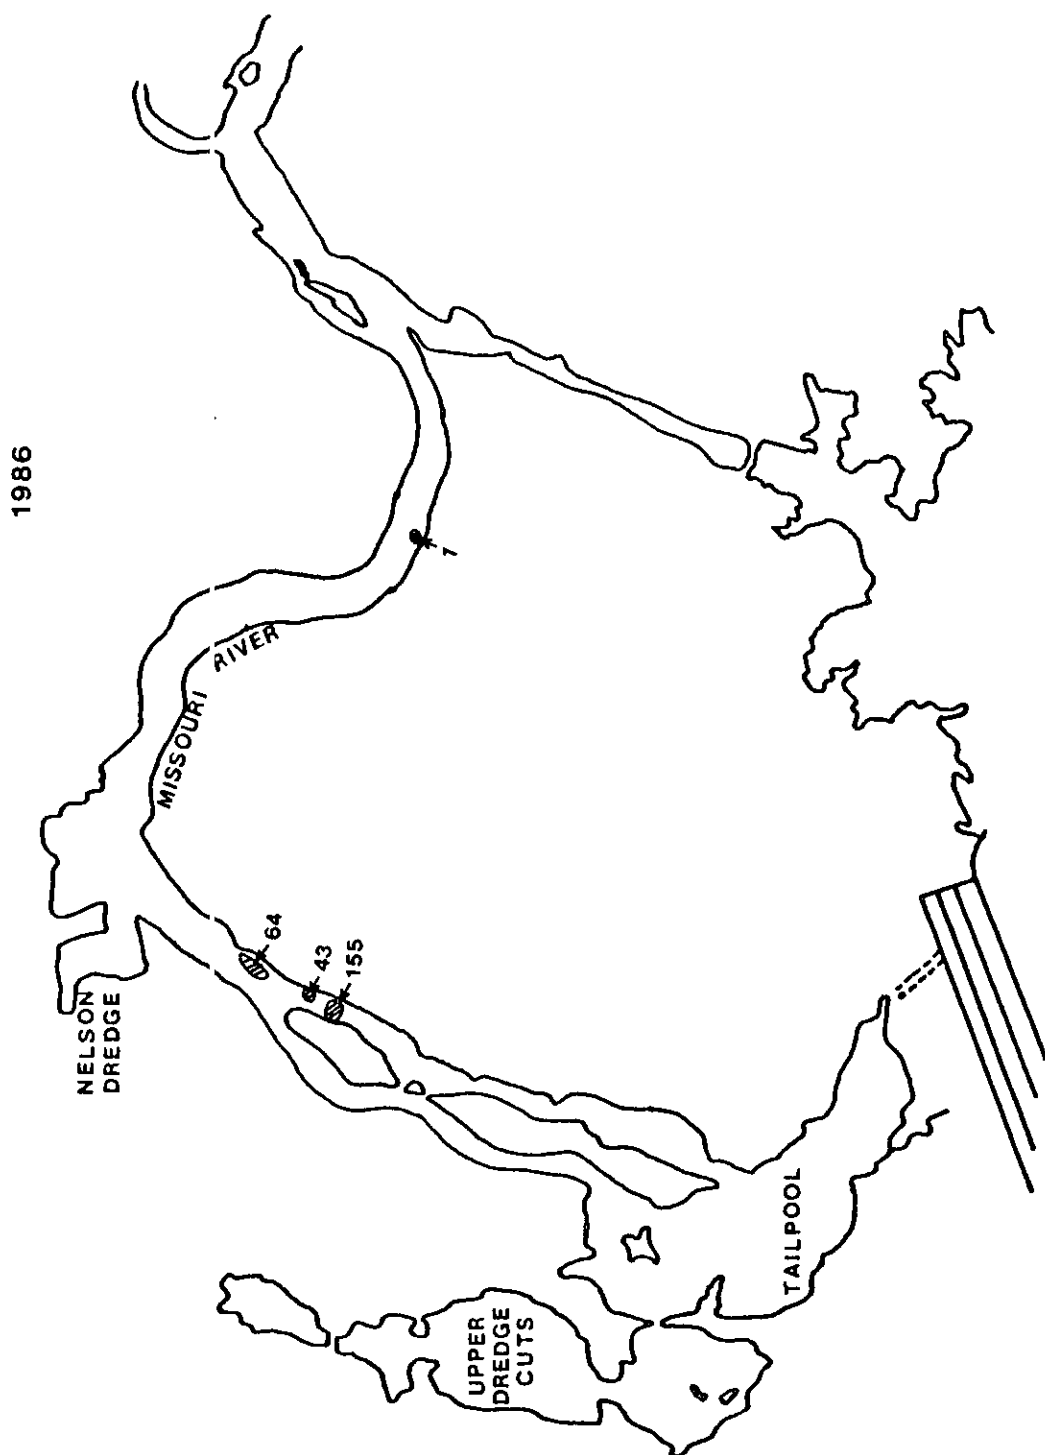
Figure 7. Numbers and distribution of rainbow redds counted in 1986.

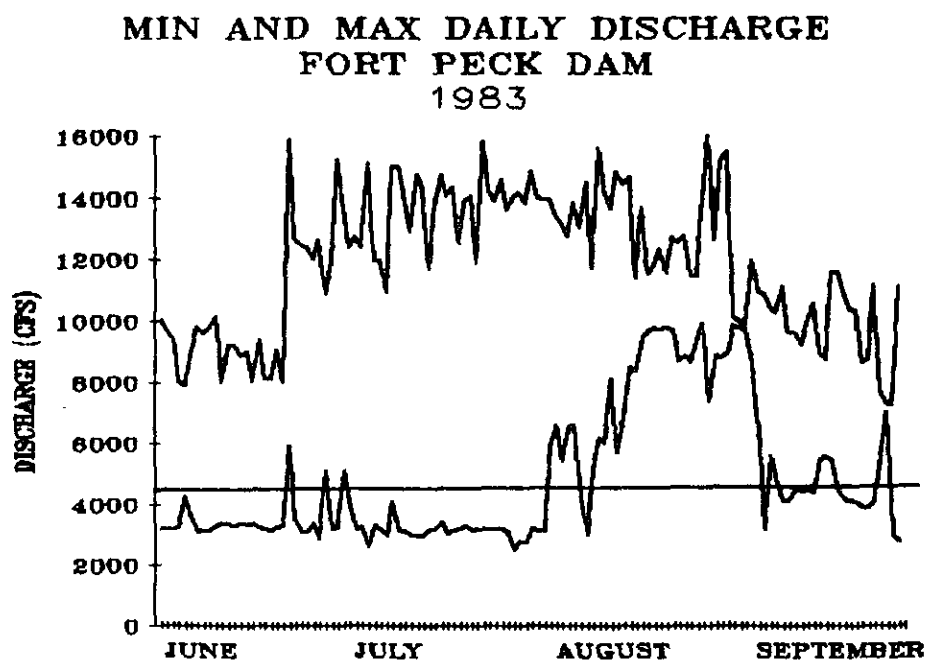
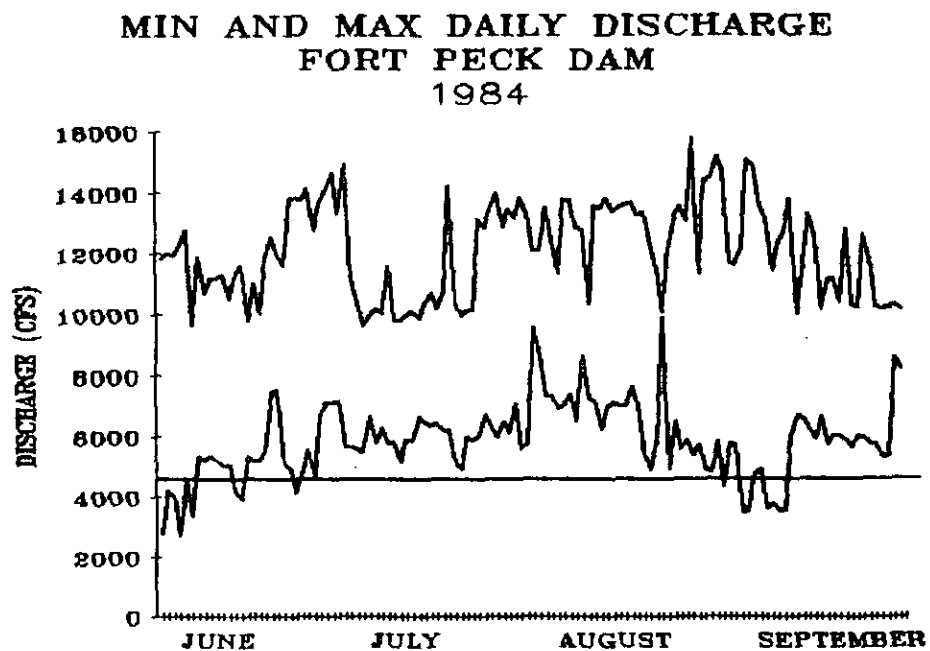
Figure 8. Minimum and maximum daily discharges from Fort Peck Dam during the 1983 and 1984 rainbow rearing period compared to the recommended absolute minimum level of 4500 cfs.

Discharges during the spring and early summer of 1983 were fairly representative of those historically occurring at Fort Peck. Minimum daily discharges averaged around 3,000 cfs from late March through July, and maximum discharge levels averaged over 10,000 cfs. Minimum daily discharges increased considerably in August and remained above 4,500 cfs through mid-September, but by this time low minimum daily discharges in July had eliminated filamentous algae from the east side channel. When electrofishing was conducted in late August, no natural rearing cover was available. Only 32 YOY rainbow were collected from the entire lower side channel and the main river channel west of Duck Island.

Minimum daily discharges were maintained well above 4,500 cfs throughout the rearing period in 1984, because the COE was working on downstream projects and had to increase power production at Fort Peck. The higher flows had a major impact on available rearing cover, and thick mats of filamentous algae remained in the east side channel throughout the summer, even along the shorelines. When the lower side channel was electrofished in late August, 140 YOY rainbow were sampled, four times as many as in 1983 even though less area was actually sampled. More rainbow were probably present but not seen due to the algae. Almost any algae cover in and around riffle areas held YOY rainbow. Shocking was conducted as water levels were rising; most rainbow were collected from shallow shoreline areas in algae that had just recently been flooded. This indicated that the fish were moving in with rising water levels.

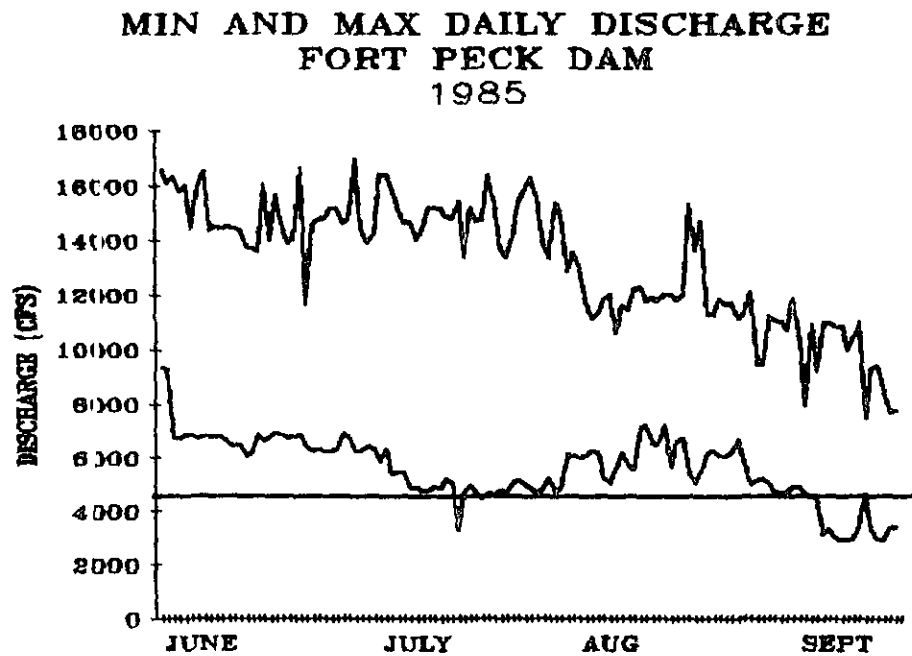
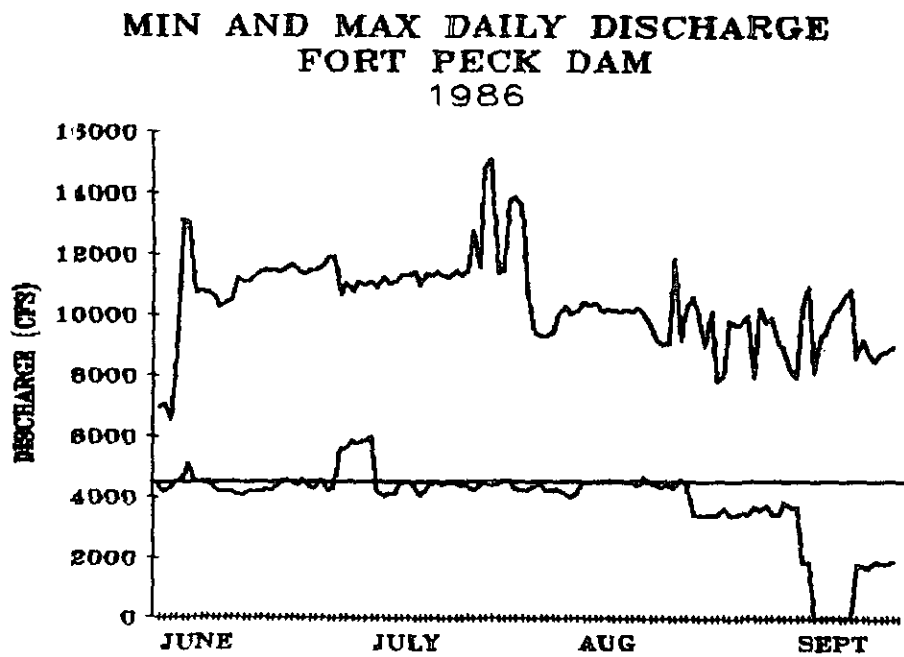
Figure 9. Minimum and maximum daily discharges from Fort Peck Dam during the 1985 and 1986 rainbow rearing period compared to the recommended absolute minimum level of 4500 cfs.

1985 was the first year the DFWP made specific minimum discharge recommendations to the COE for the fishery below Fort Peck. The COE made a sincere effort to follow these recommendations, and with the exception of a couple of days in July, minimum daily discharges were maintained above 4,500 cfs through the entire spawning and rearing period. When sampling was conducted in late August, algae conditions were similar to those in 1984. Several log structures were also placed in the side channel in 1985 to provide additional instream rearing habitat (Frazer 1986). The number of YOY rainbow sampled in 1985 was up 75 % from 1984.

In 1986 the DFWP made the same discharge recommendations to the COE. As mentioned earlier, minimum daily discharge levels were maintained higher than historic levels, but they were maintained above the recommended absolute minimum level of 4,500 cfs on only 22% of the days from April 1 to September 15. As a result, flow conditions in 1986 were not quite as good as they had been in 1984 and 1985, but the additional spawning and rearing habitat put out in the fall of 1985 more than made up for these deficiencies.

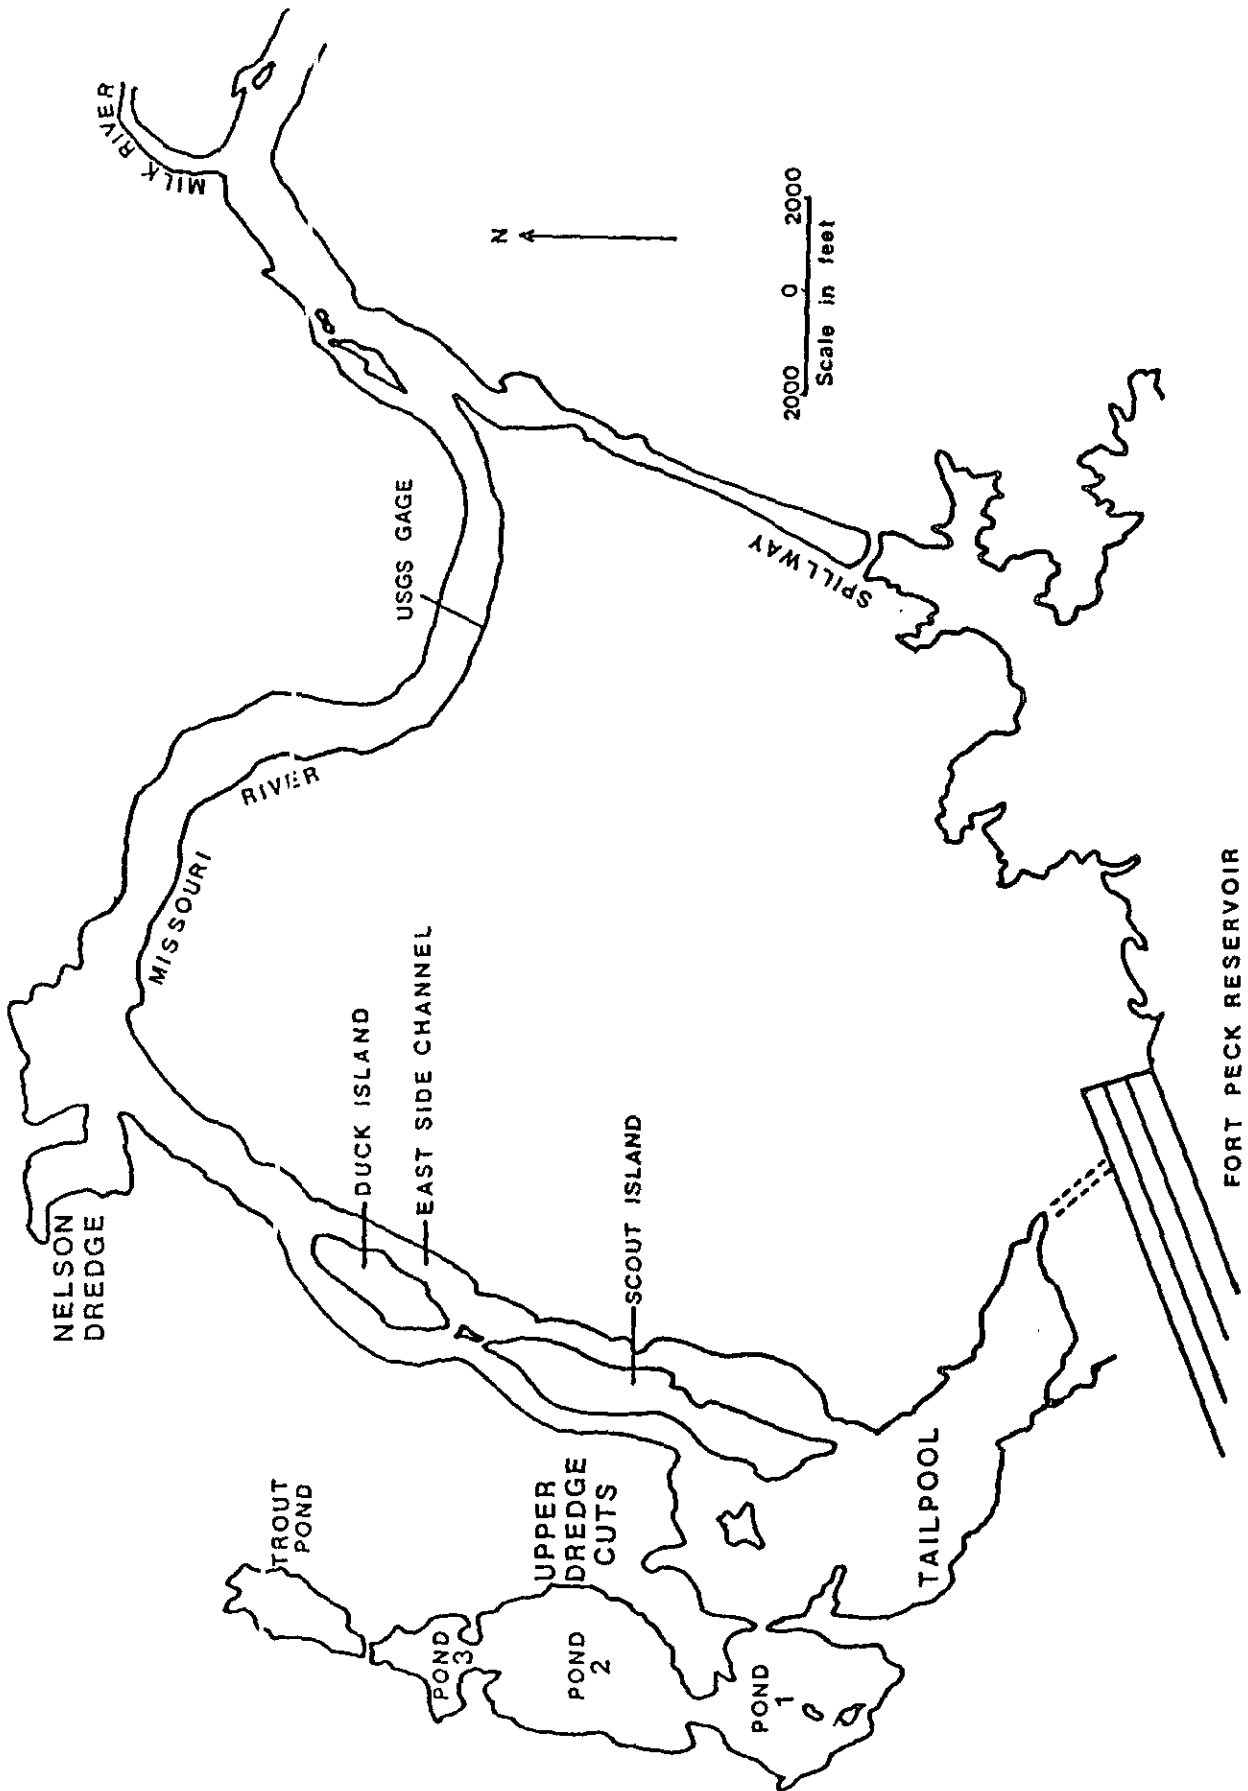
Figure 1. Study Area

There are two dredge cut areas. The upper one, 1.6 miles downstream from the dam, consists of three interconnected ponds with a single connection to the river (Figure 1). The ponds have a total surface area of approximately 650 acres and a maximum depth of approximately 31 feet. Their average depth is 15 to 20 feet. The banks and bottom of the ponds are composed of sand and silt. The banks are steep and very unstable with little shoreline cover. Two gravel points provide potential spawning habitat for walleye and sauger.

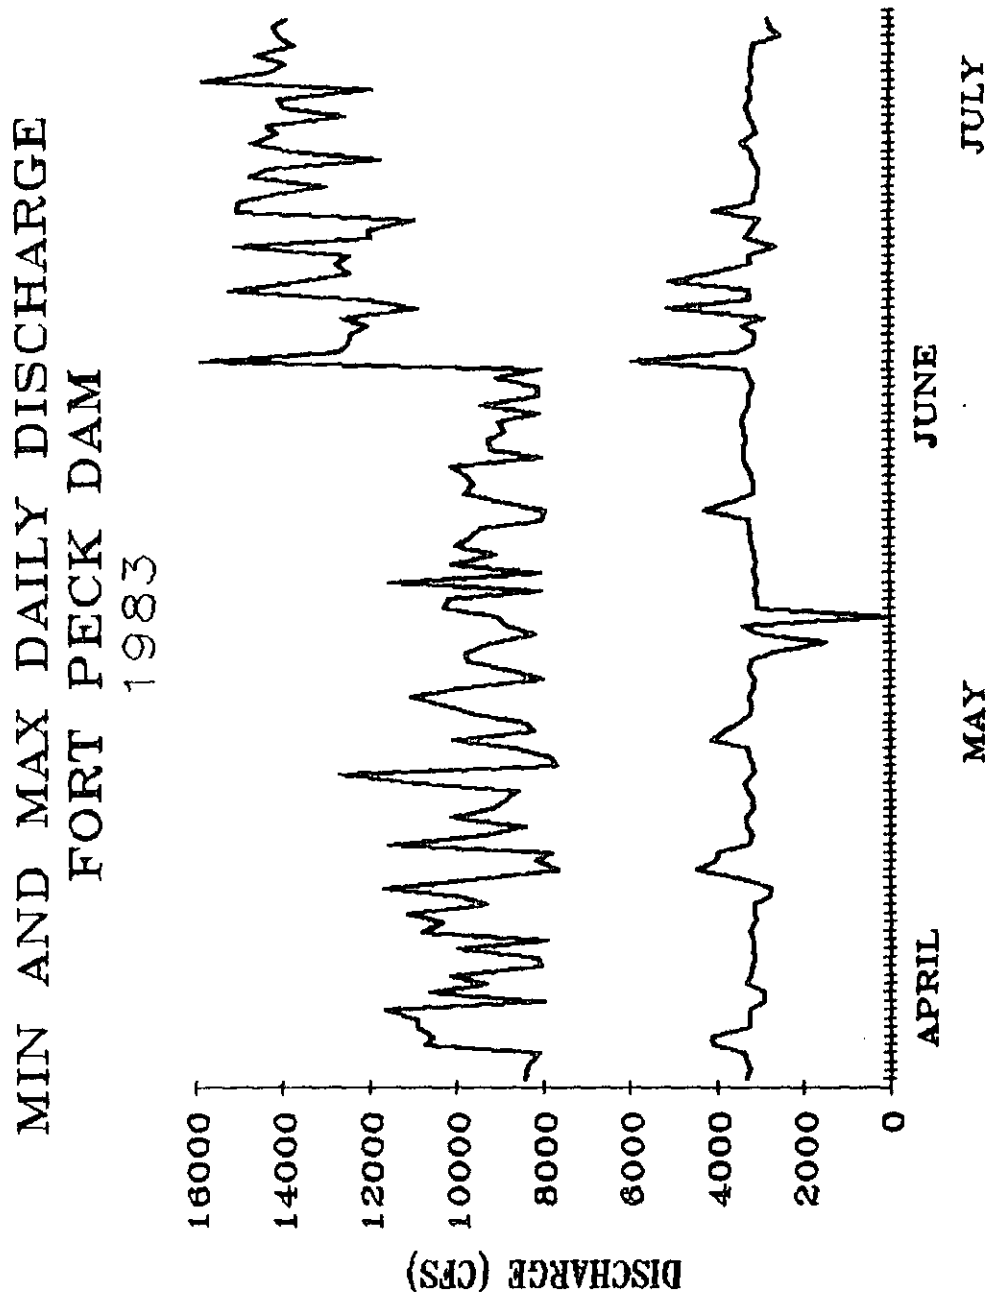
Figure 2. Minimum and maximum daily discharges from Fort Peck Dam during the spring and early summer, 1983.

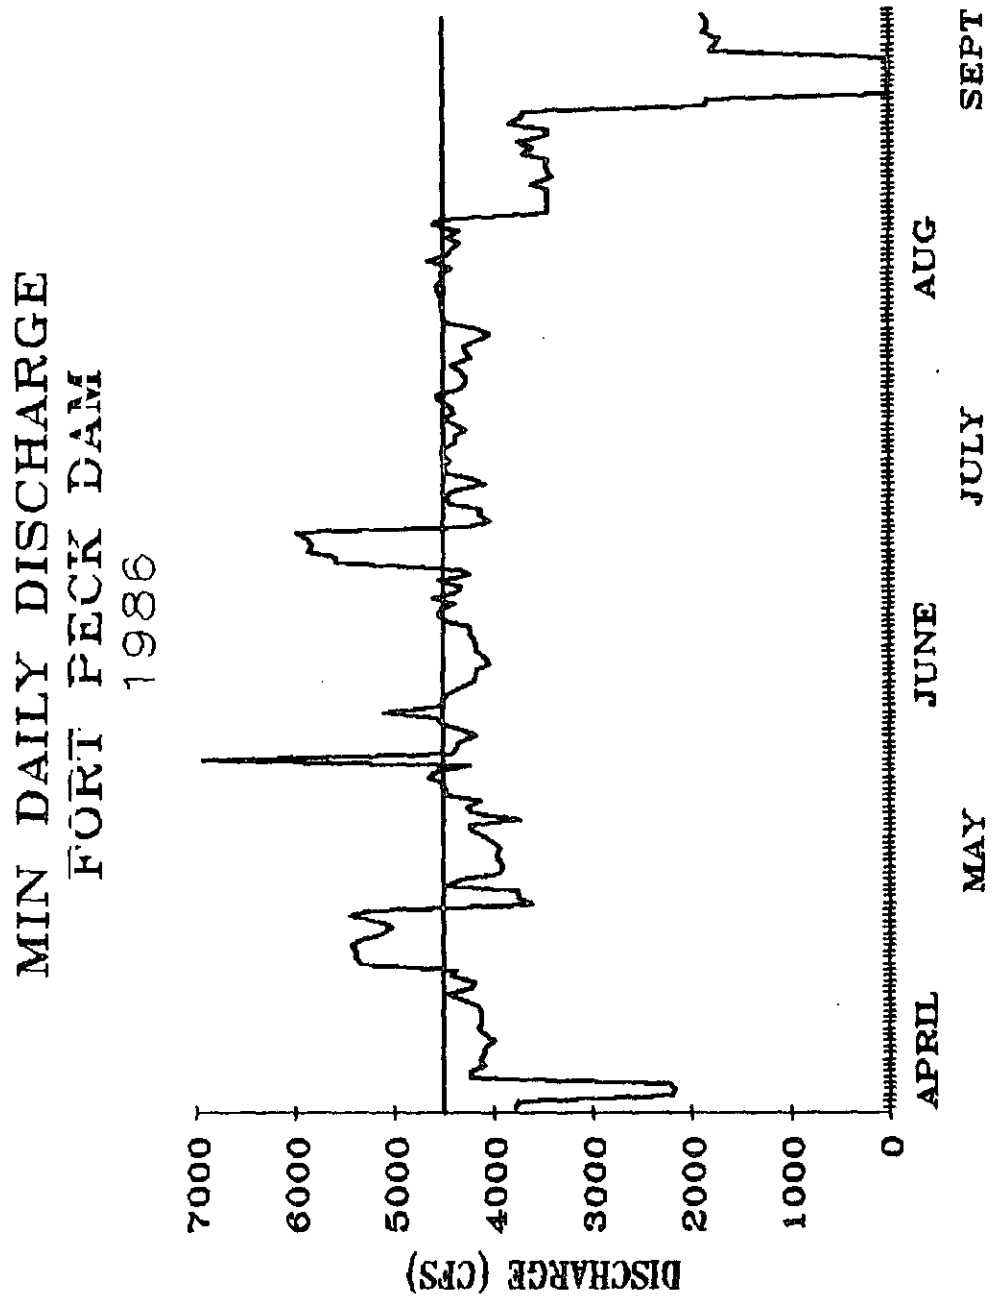
Figure 3. Minimum daily discharges from Fort Peck Dam, April 1 through September 15, 1986 compared to the recommended absolute minimum discharge of 4500 cfs,

Figure 3 is a graph of the minimum daily discharges at Fort Peck Dam during the recommended period in 1986. Although discharge levels were higher than those historically occurring during this time, they were not as high as the minimum recommended levels. On only one day during the 168-day recommendation period did the minimum daily discharge remain above 6,700 cfs. There were only 37 days when the minimum daily discharge remained above 4,500 cfs.

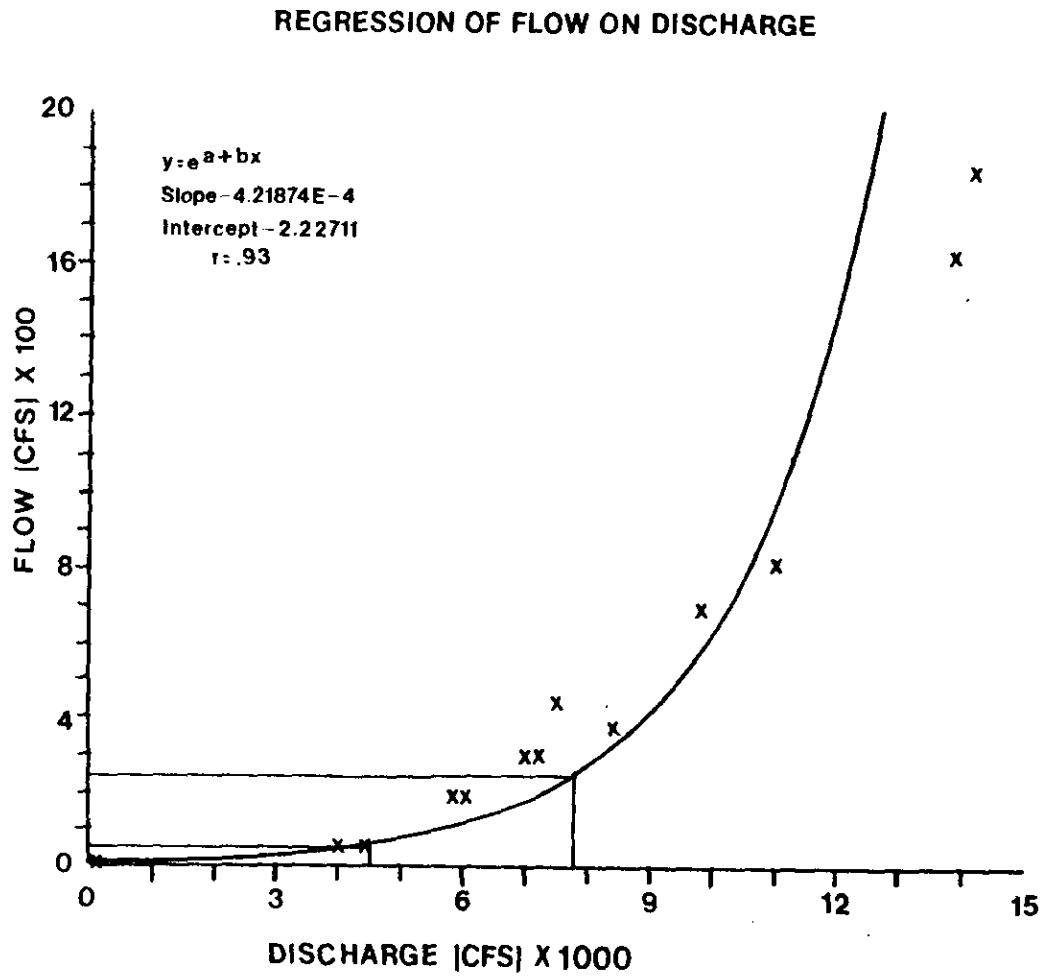
Figure 4. Regression curve of flow in the east side channel to discharge from Fort Peck Dam.
