**FORT PECK FISHERY HABITAT EVALUATION
AND IMPROVEMENT STUDY**

Annual Milestone

Montana Department of Fish, Wildlife and Parks
1987

Funding Provided By:
U.S. Army Corps of Engineers
Missouri River Division

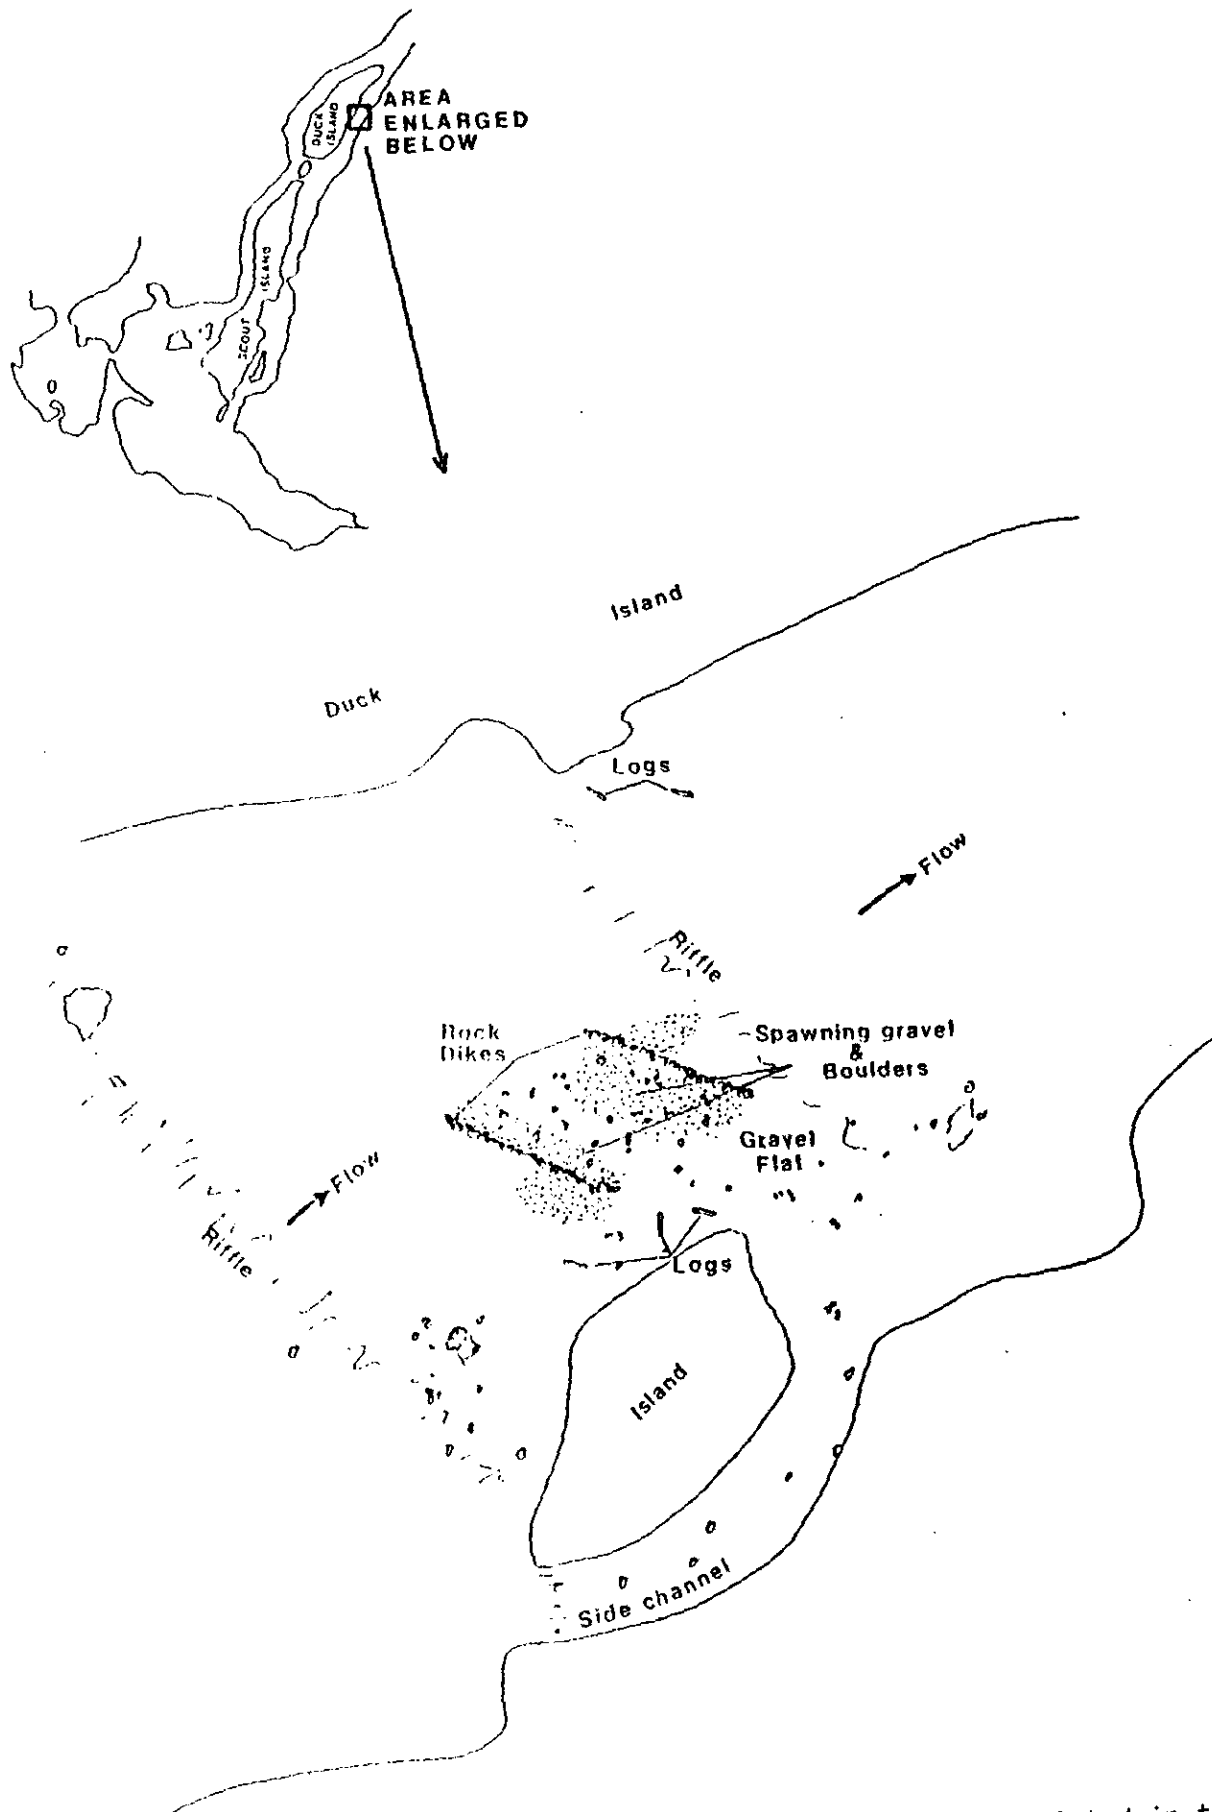
Figure 5. Location and diagrammatic sketch of habitat work completed in the east side channel in 1985.

The dikes were designed with several purposes in mind: 1) They were to act as partial dams to reduce current velocities in the center of the channel, thus allowing spawning gravel to deposit and remain in the channel and spawning fish to use the area during high flows. 2) They were to provide instream rearing cover that would remain watered at recommended low flows, and they were to provide a break in the current so that small fish could remain in the center of the channel during periods of high flow. 3) They were to provide good habitat for aquatic invertebrates, increasing the food supply available for rainbow rearing in the area. 4) They were to force deeper water over the large gravel flat at their downstream end (Figure 5). This area contained good natural spawning gravel, but the water was usually too shallow under normal flow conditions to be used by spawning fish. Many of the large boulders embedded in the gravel flat were dug up and placed on top of the gravel to help reduce bottom armoring and to provide additional rearing habitat.

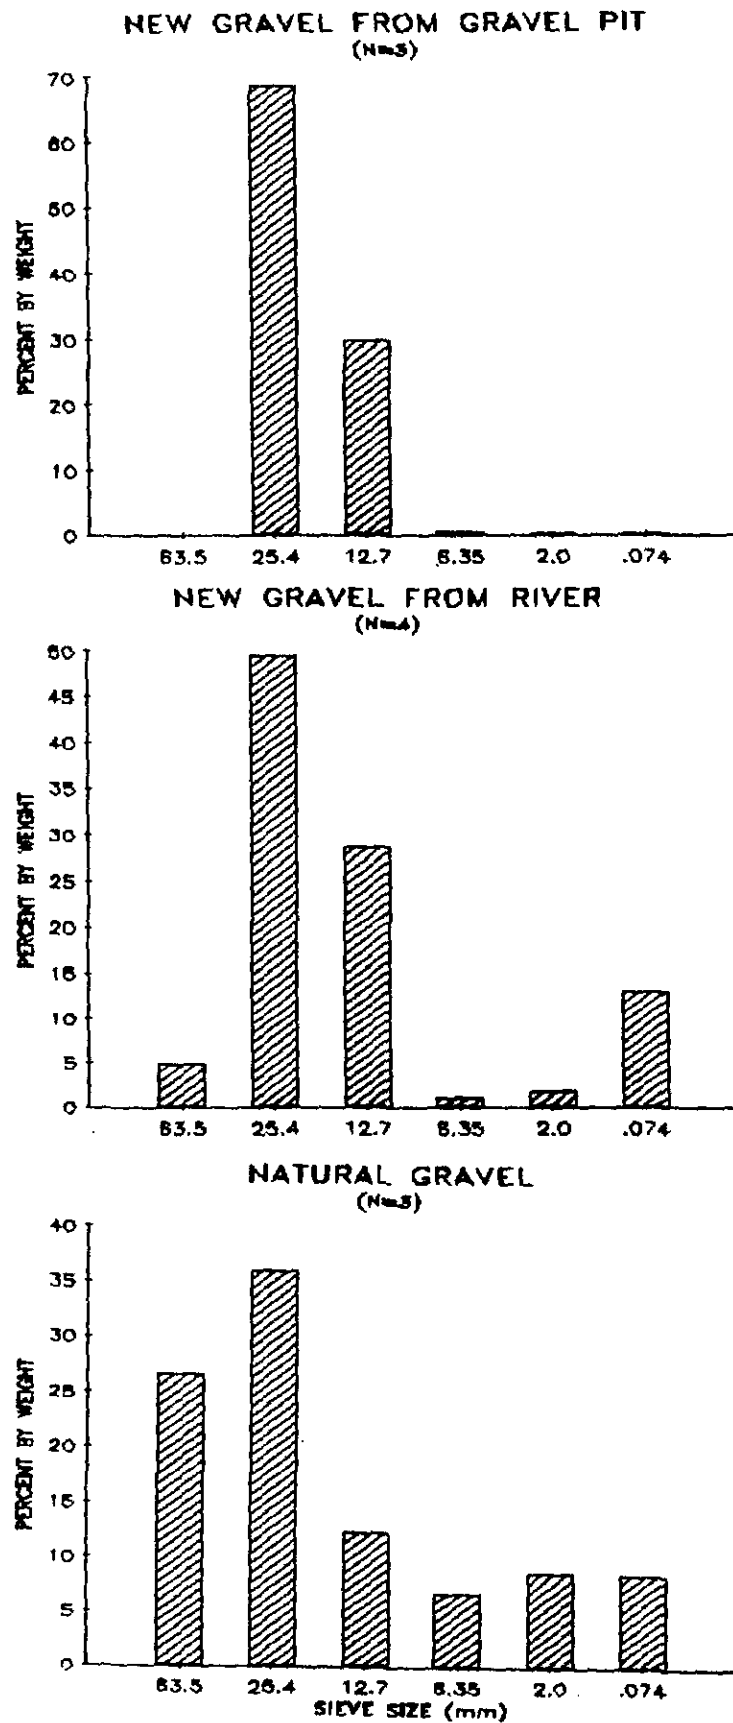
Figure 6. Composite substrate composition by day weight of new spawning gravel from the gravel pit and after being in the river one year and of natural gravel from spawning areas in the east side channel.

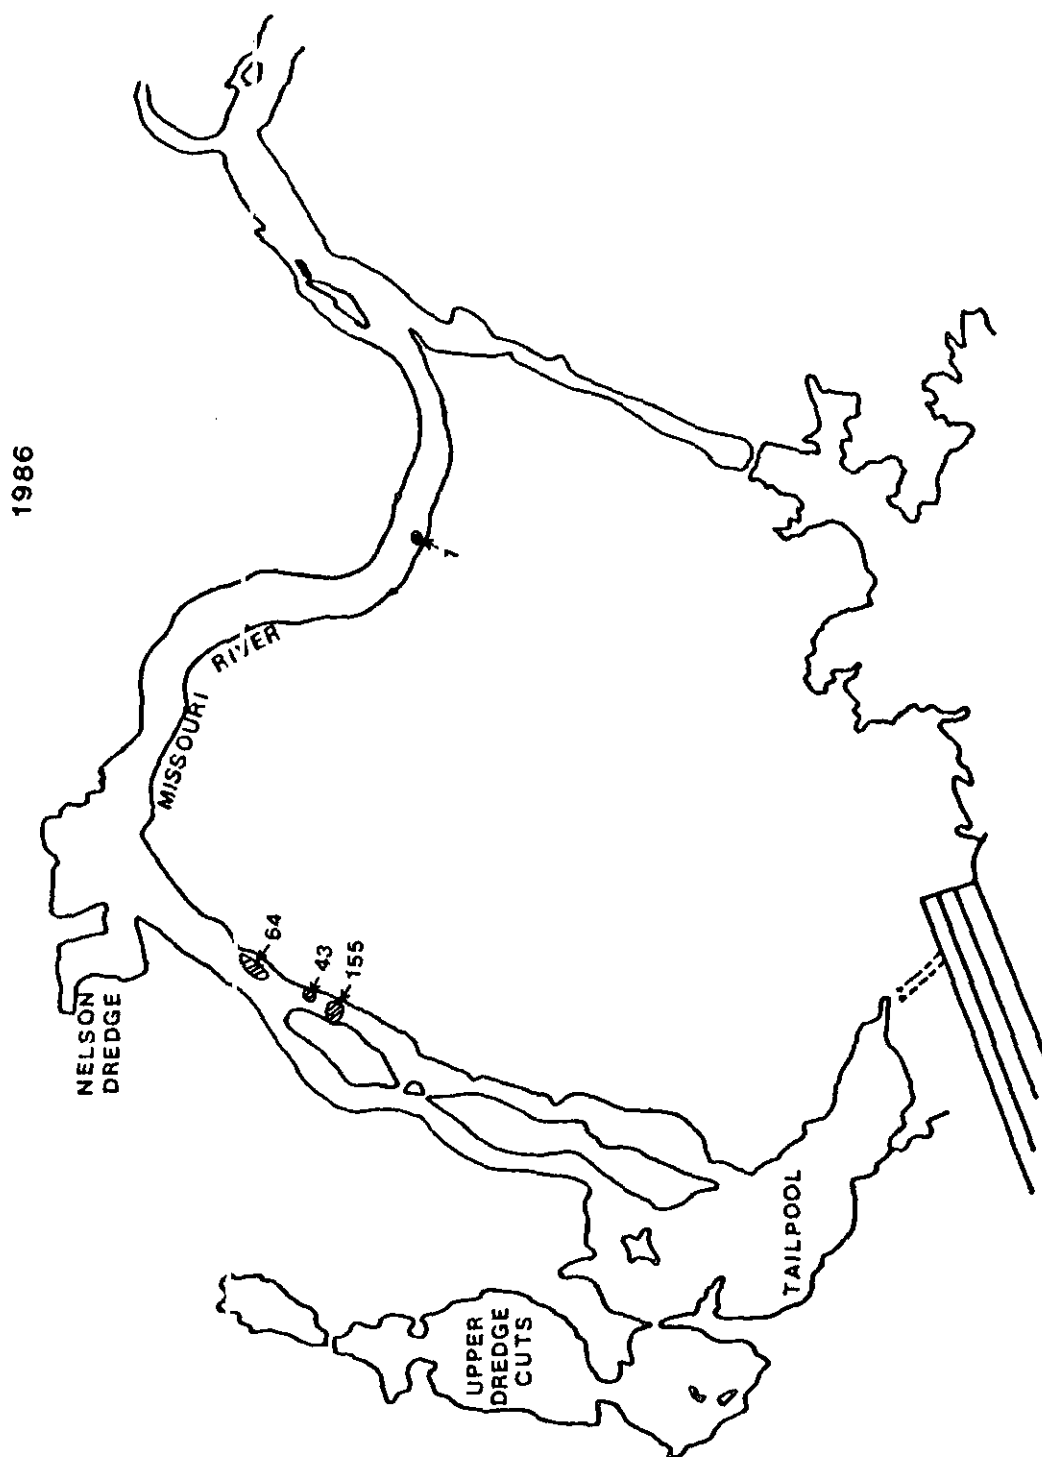
Figure 7. Numbers and distribution of rainbow redds counted in 1986.

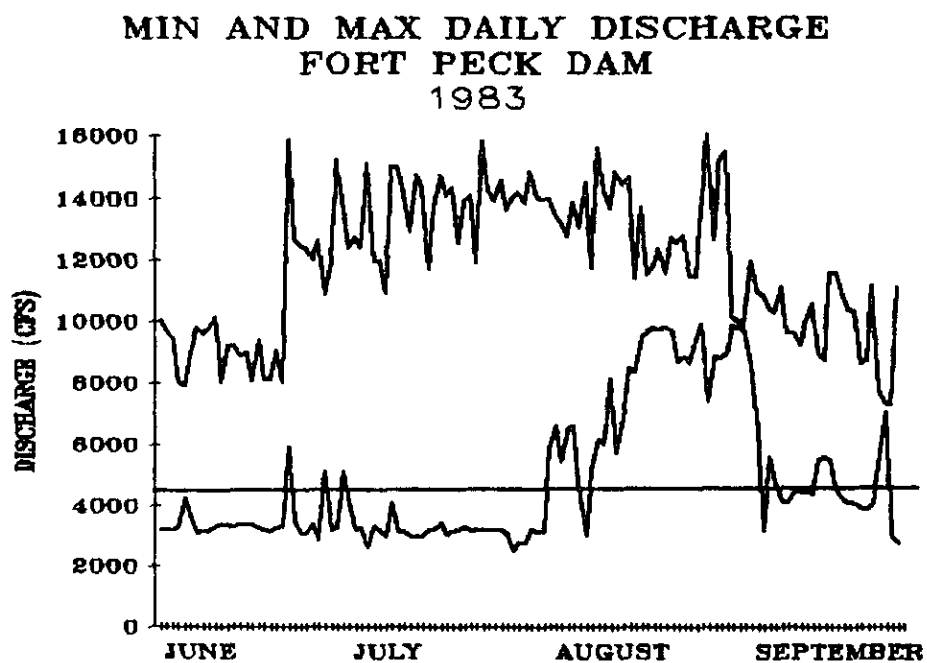
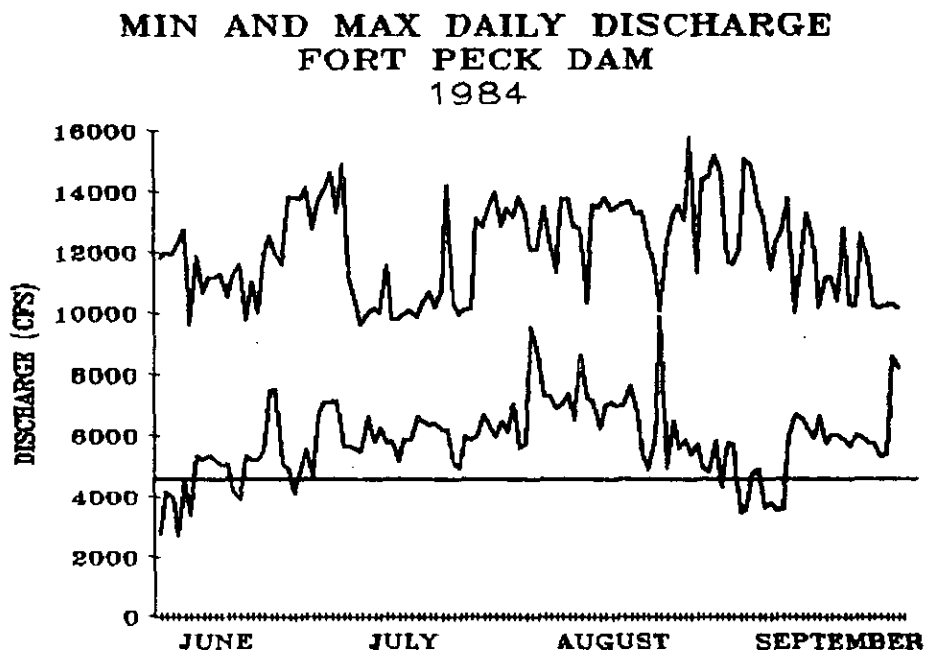
Figure 8. Minimum and maximum daily discharges from Fort Peck Dam during the 1983 and 1984 rainbow rearing period compared to the recommended absolute minimum level of 4500 cfs.

Discharges during the spring and early summer of 1983 were fairly representative of those historically occurring at Fort Peck. Minimum daily discharges averaged around 3,000 cfs from late March through July, and maximum discharge levels averaged over 10,000 cfs. Minimum daily discharges increased considerably in August and remained above 4,500 cfs through mid-September, but by this time low minimum daily discharges in July had eliminated filamentous algae from the east side channel. When electrofishing was conducted in late August, no natural rearing cover was available. Only 32 YOY rainbow were collected from the entire lower side channel and the main river channel west of Duck Island.

Minimum daily discharges were maintained well above 4,500 cfs throughout the rearing period in 1984, because the COE was working on downstream projects and had to increase power production at Fort Peck. The higher flows had a major impact on available rearing cover, and thick mats of filamentous algae remained in the east side channel throughout the summer, even along the shorelines. When the lower side channel was electrofished in late August, 140 YOY rainbow were sampled, four times as many as in 1983 even though less area was actually sampled. More rainbow were probably present but not seen due to the algae. Almost any algae cover in and around riffle areas held YOY rainbow. Shocking was conducted as water levels were rising; most rainbow were collected from shallow shoreline areas in algae that had just recently been flooded. This indicated that the fish were moving in with rising water levels.

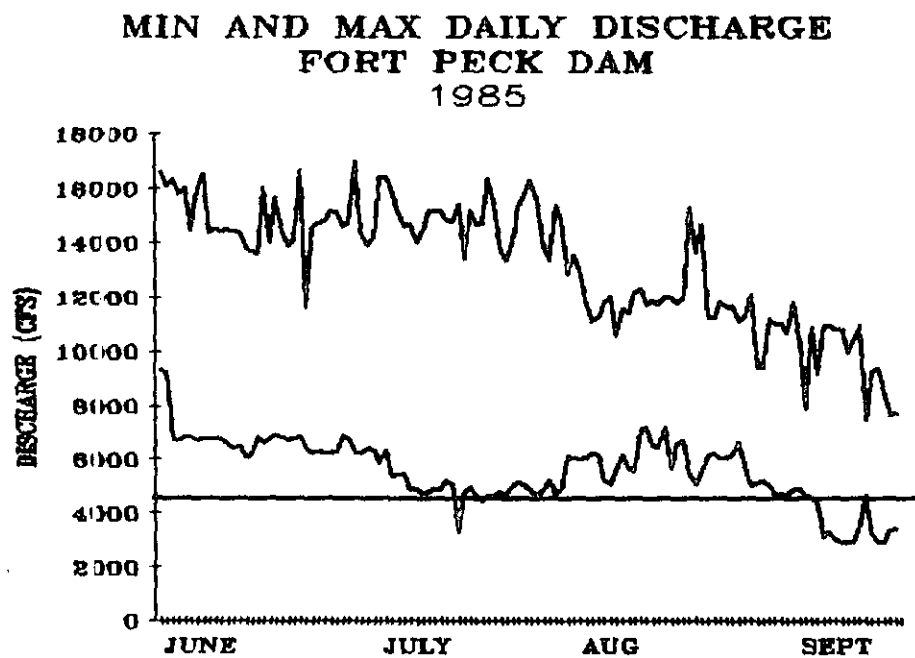
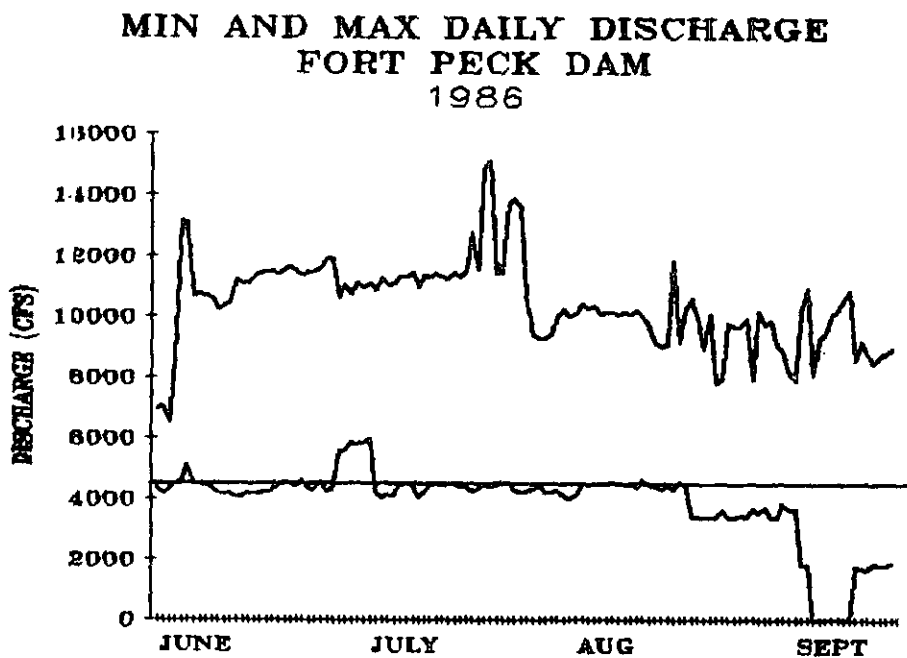
Figure 9. Minimum and maximum daily discharges from Fort Peck Dam during the 1985 and 1986 rainbow rearing period compared to the recommended absolute minimum level of 4500 cfs.
