MODIFICATIONS OF A TURBULENT FOUNTAIN FOR USE AS A FISH SCREEN IN SMALL HIGH-GRADIENT STREAMS

INTERMOUNTAIN JOURNAL OF SCIENCES

Vol. 9, No. 4: 101-106

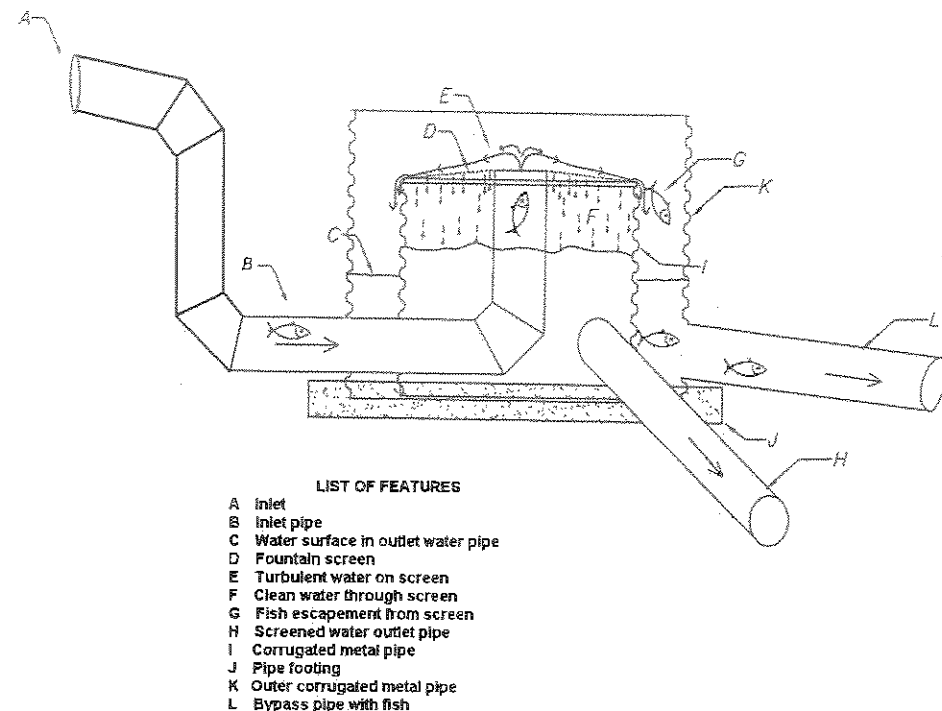
Figure 1. Conceptual design of a turbulent fountain fish screen with bypass to stream.

In addition to hydraulic design criteria defined by Bondurant and Kemper (1985), our prototype "fish screen" design incorporated a circular outer wall with an attached fish bypass pipe (Fig. 1), along with inflow and outflow capacity designed to maintain constant flow through the bypass pipe. The screen was designed for a maximum inflow of 0.14 m³/sec, of which a

During this impingement evaluation of our initial fish screen design, we identified two construction flaws that appeared to contribute to unnecessary impingement: 1) the close proximity of inner chamber to a portion of outer wall of the structure, and 2) a lower screen angle than specified in our prototype design (Fig. 2). Due to the first construction flaw, the fountain was unable to completely wash debris from the edge of the screen. At this location, fish were unable to wash free of the screen and were impinged on the screen against the debris. Based on this observation, we modified our original screen by adding a flow deflector shield to the fountain riser in order to direct water, debris and fish away from this area of screen. We also modified the shape of the screen from a low-angle flat screen to a rounded cone-shaped screen with a mean 1-percent slope (Fig. 1).

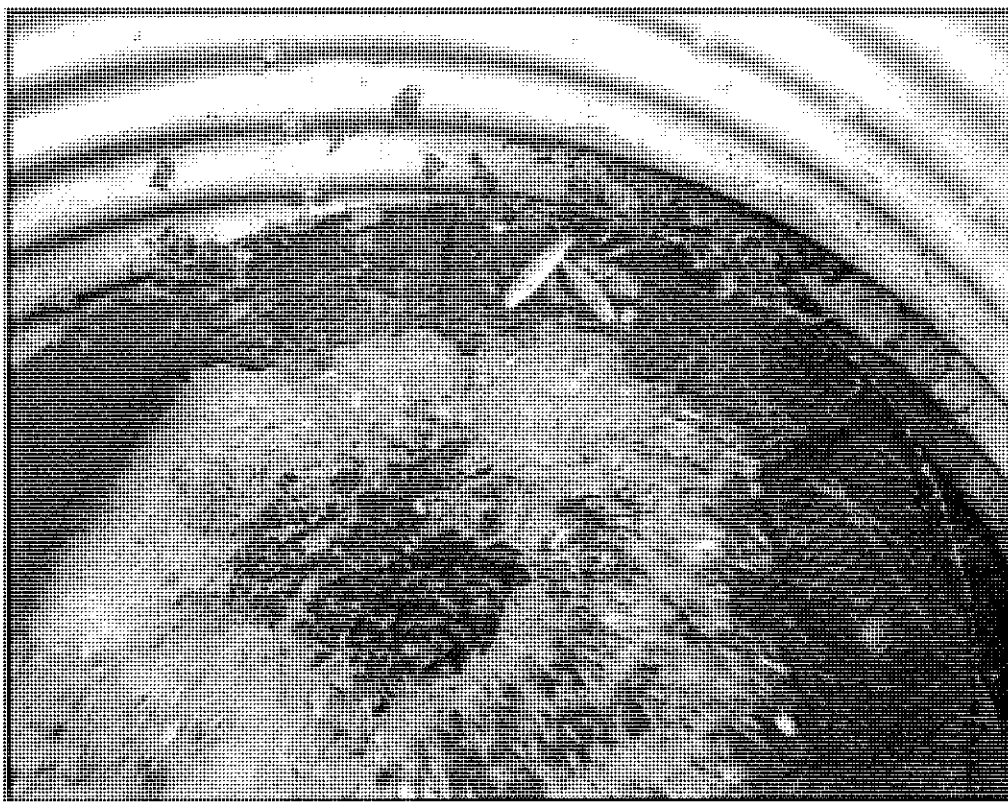
Figure 2. Fish impinged on the outer portion of the screen against the screen in area of debris collects.

Following screen modifications, all but four (6%) of the 66 fish immediately passed through the fountain and screen with no impingement (< 2 seconds). Of the four impinged fish, all washed over the screen within four seconds (median = 2, range = 2-3 sec). For these four fish, all impingement occurred in a localized boundary area between the main flow and the shielded portion of the screen.
