4 Appendix: Completed Field Forms and Associated Photos

4.1 Bad Canyon Creek barrier repair (003-2005)

FFIP 2016 Field Monitoring Appendix
Field Forms and Geo-referenced Photos
Yellowstone River Watershed

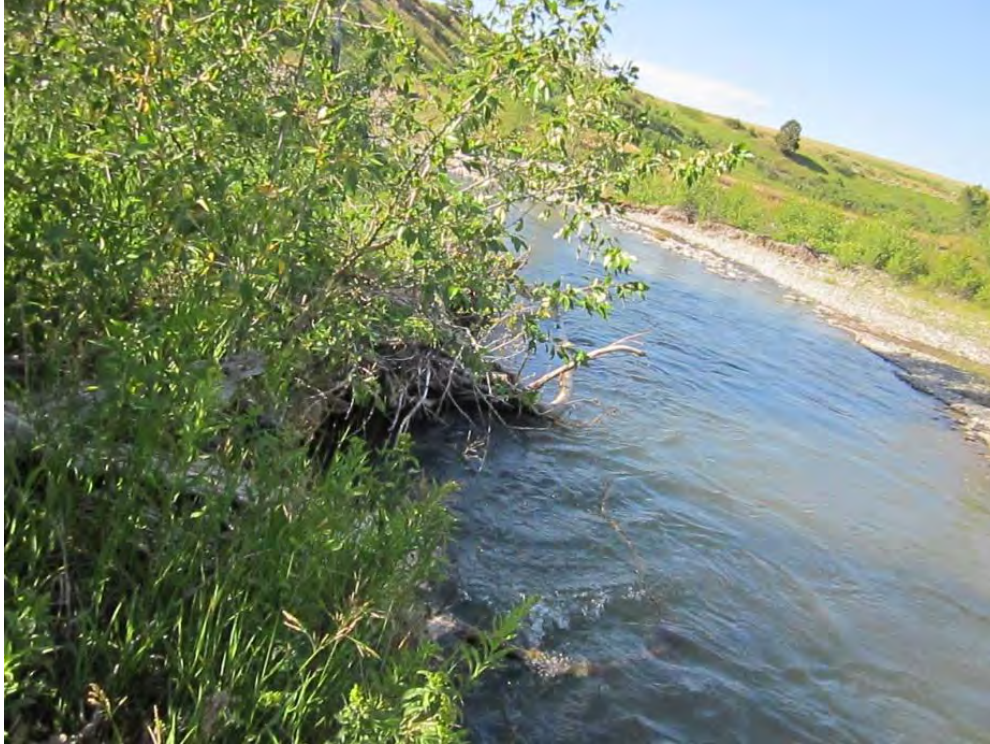
Photo 4. Created pool with overhanging willow.

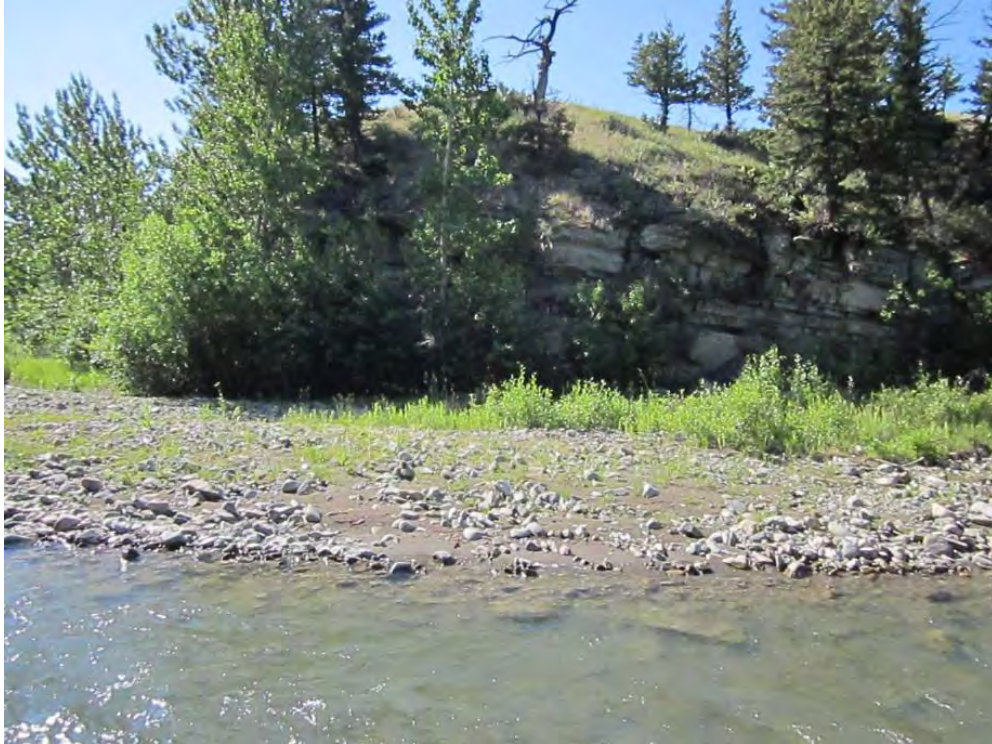
Photo 6. Vegetation recruiting on new point bar.

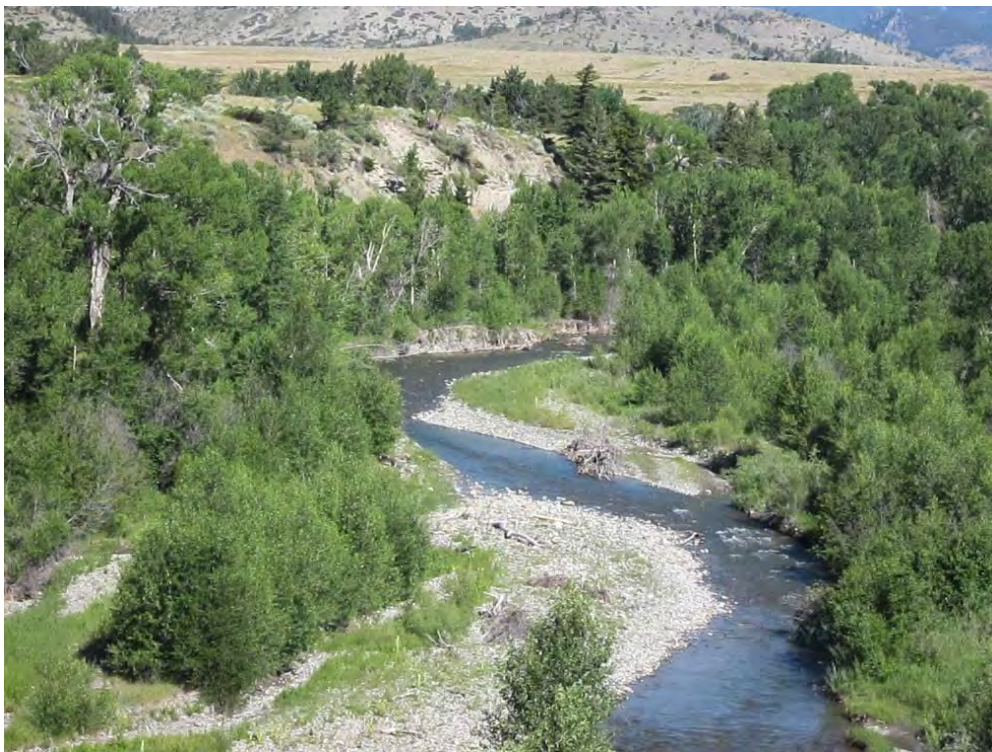
Photo 9. Overview of project from end.

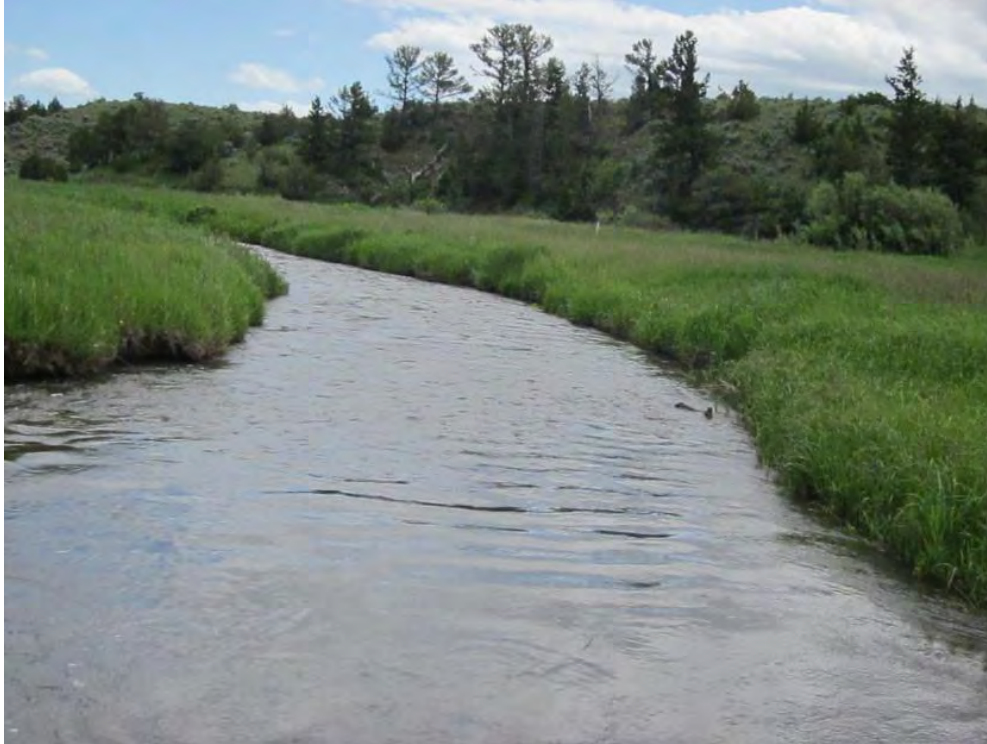
Photo 3. Stable constructed bank with willow recruitment.

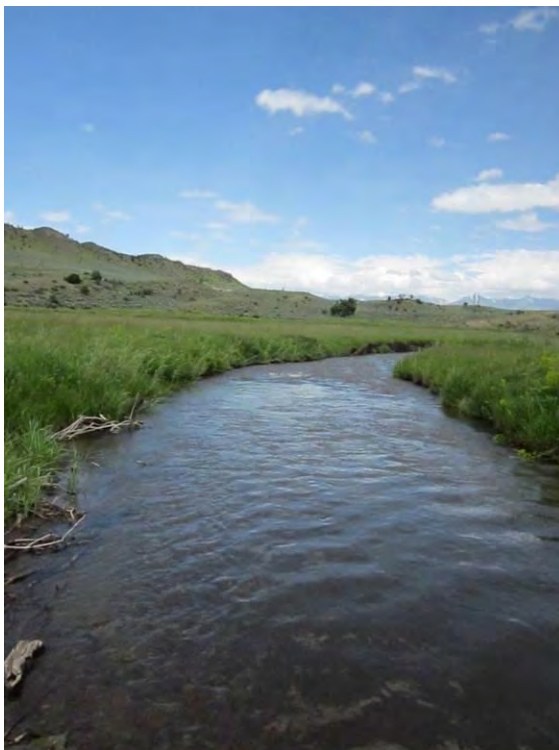
Photo 5. Stable bank with willow recruitment.

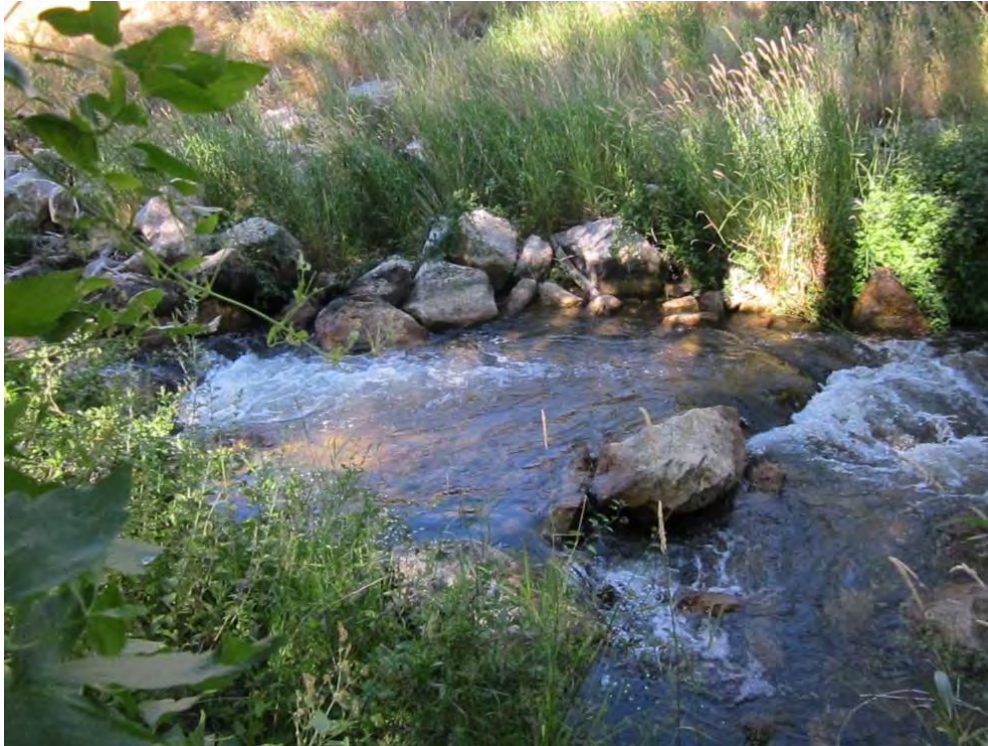
Photo 4. Close up of step-pools in project area.

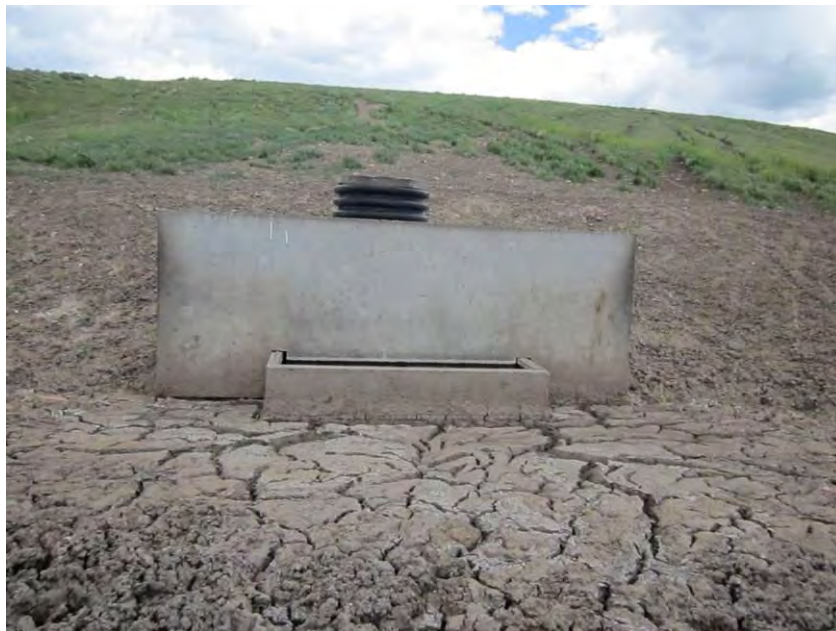
Photo 1. Off-channel watering source #1.

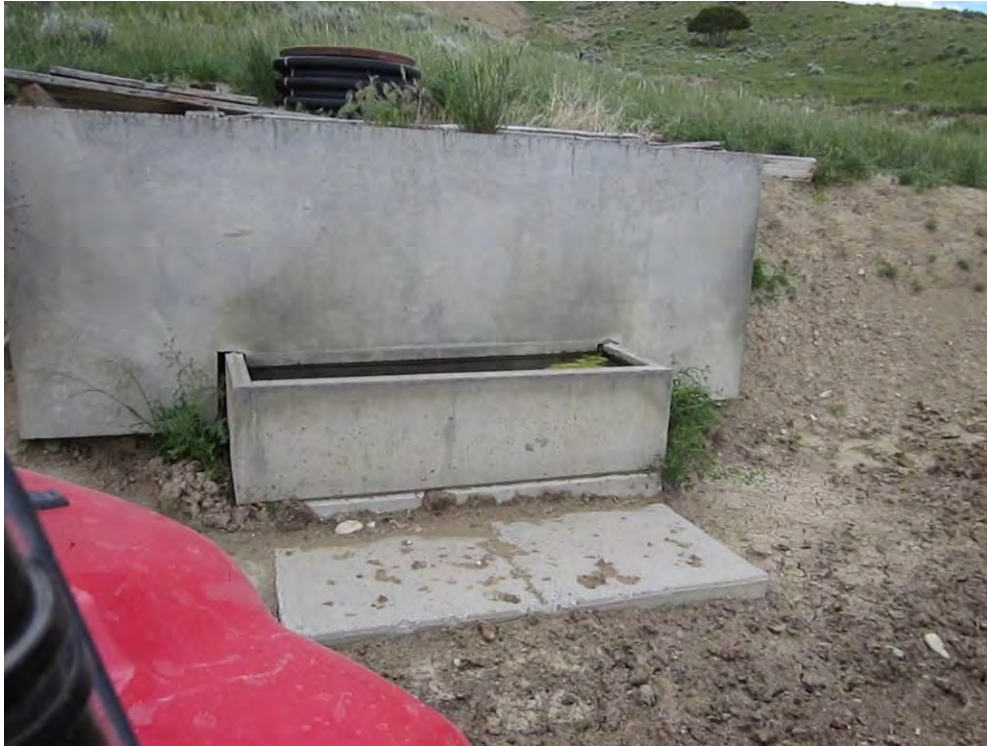
Photo2. Off-channel water source #2.

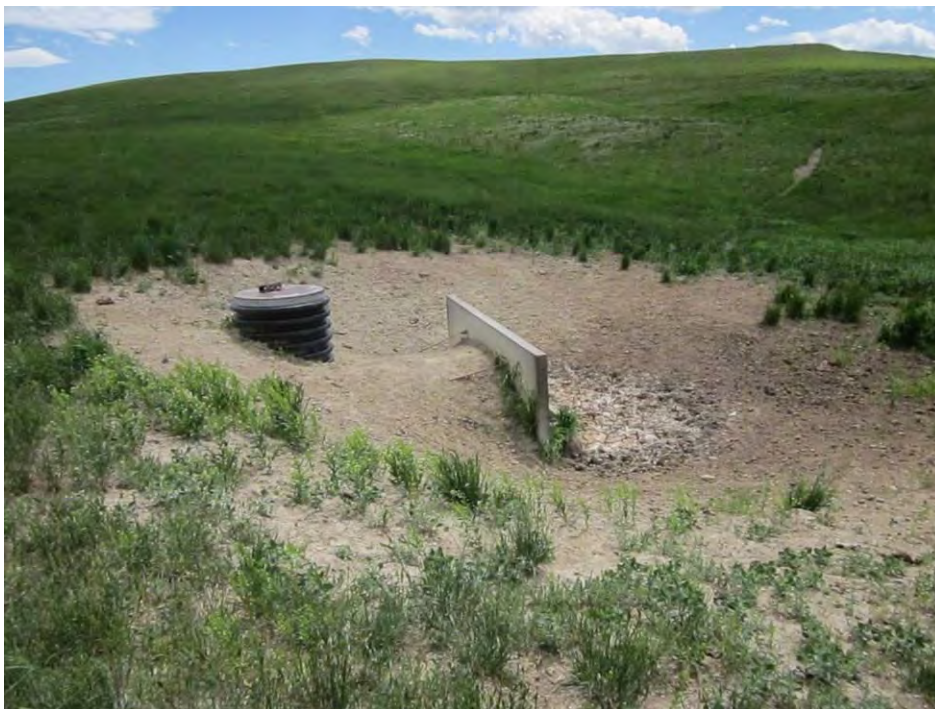
Photo5. Off-channel watering source #3.

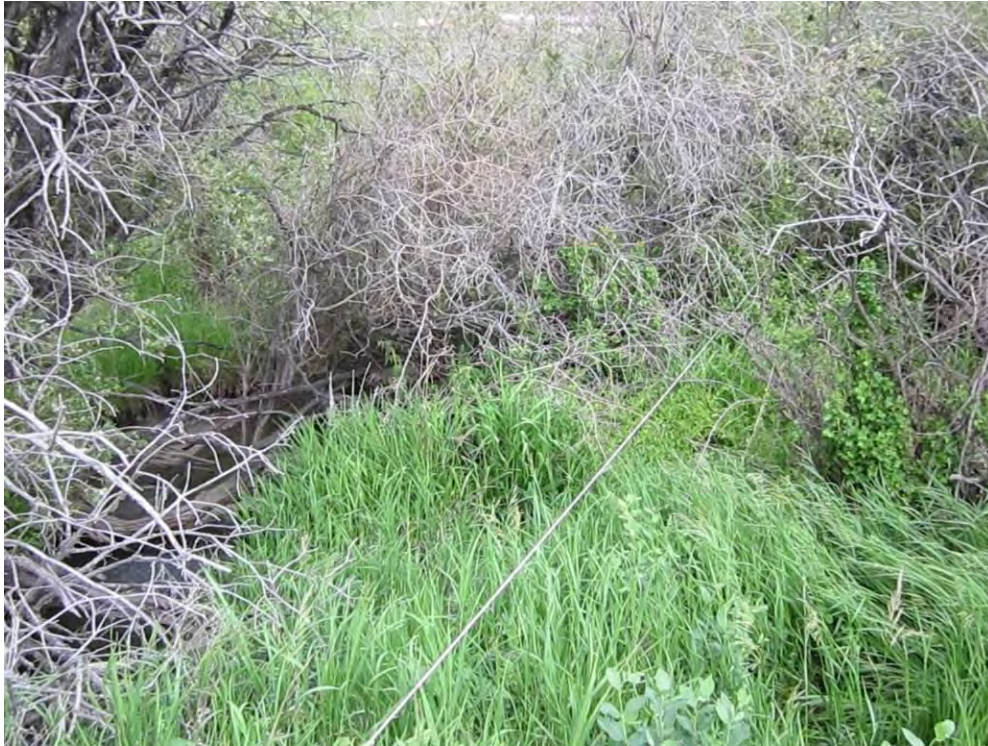
Photo 6. End of electric fence.

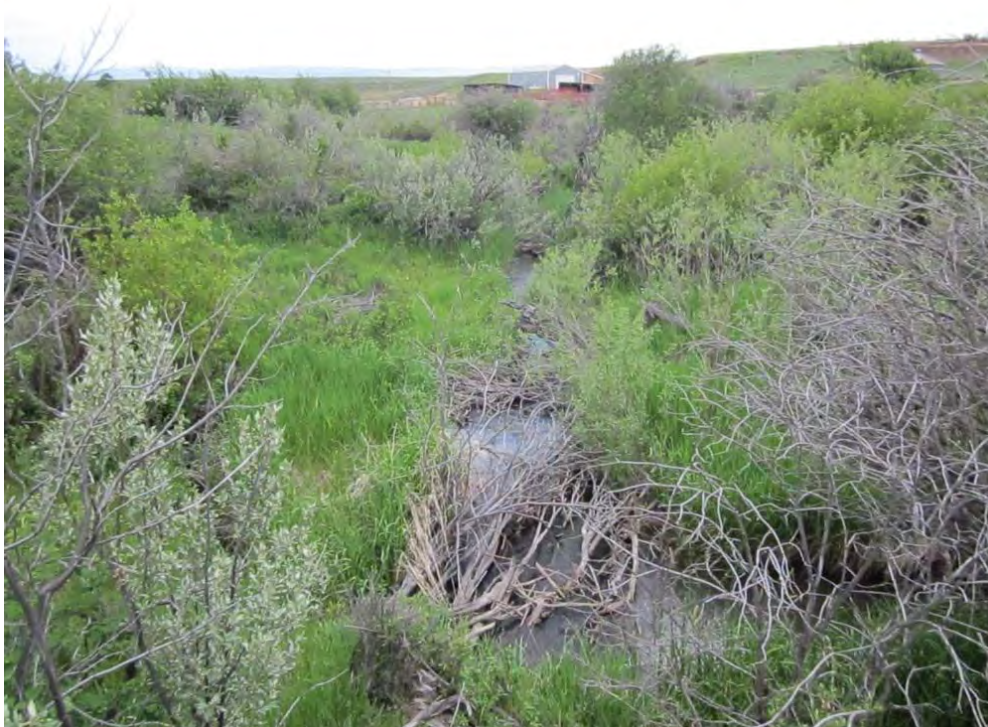
Photo 9. Overview of a stream segment within the fenced area

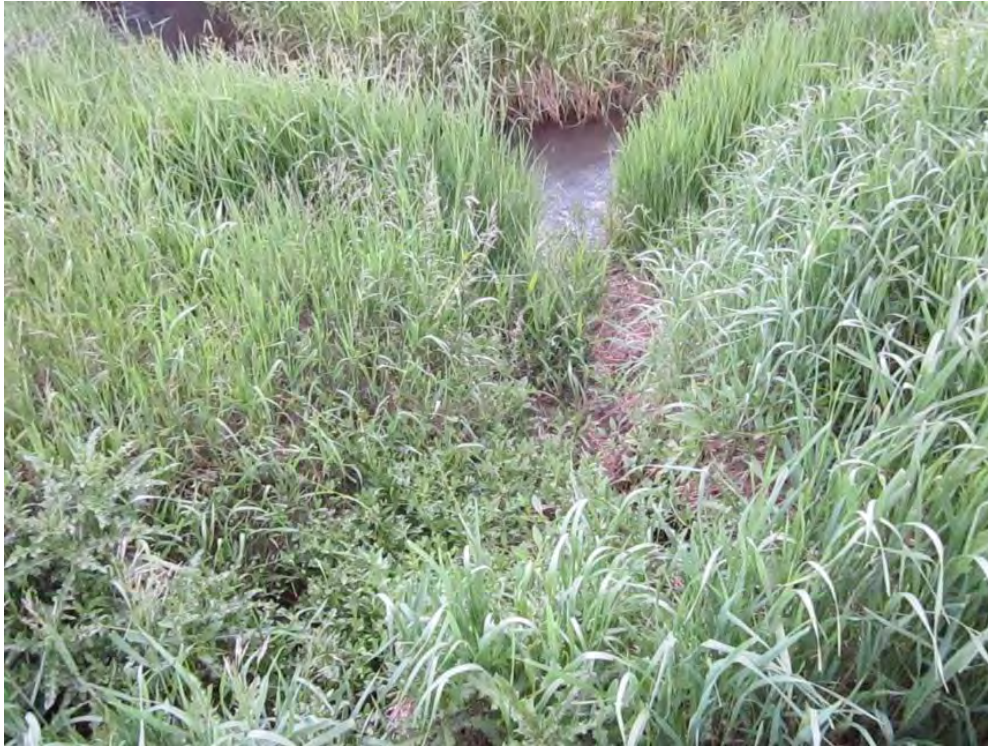
Photo 10. Old cattle/game trail healing

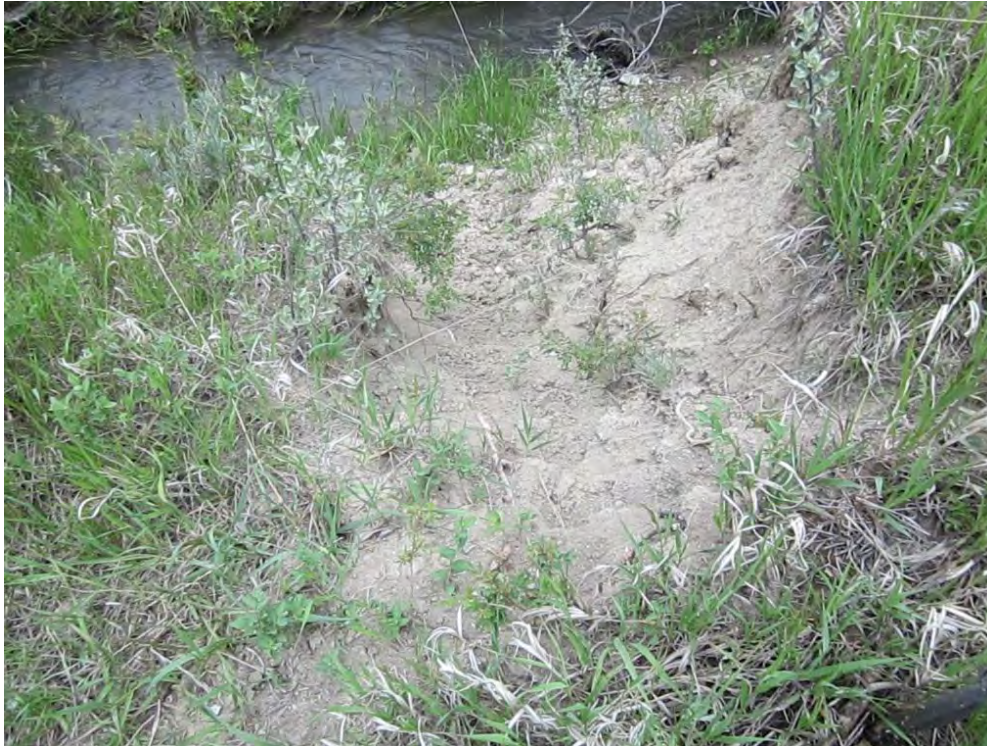
Photo 12. Newer cattle/game trail

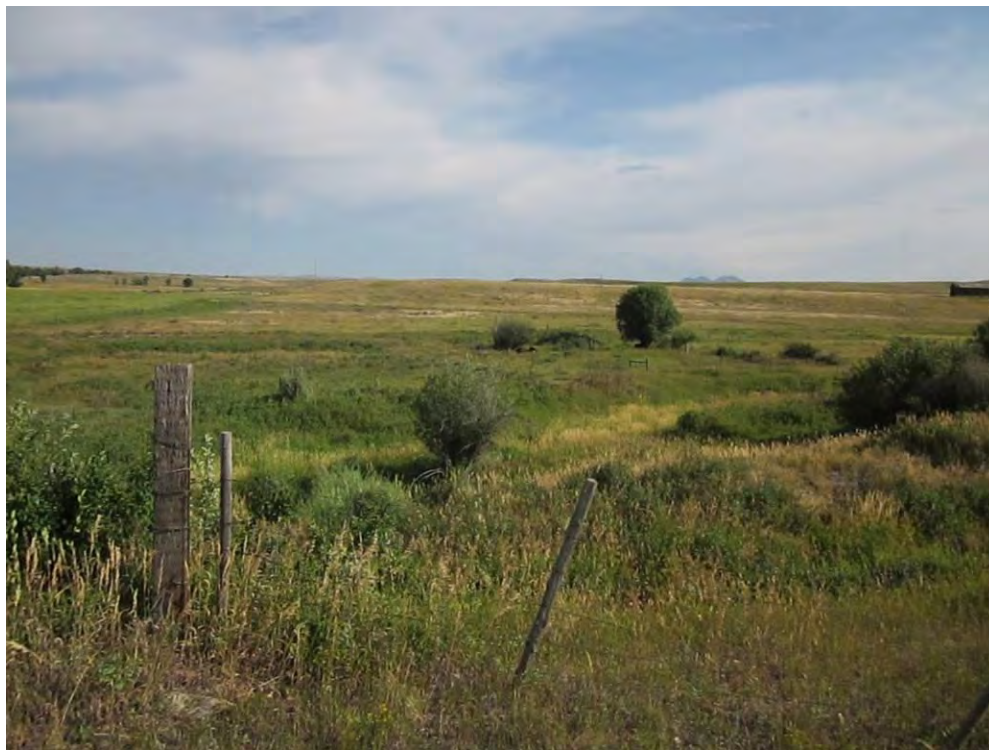
Photo 1: Daisy Dean Creek

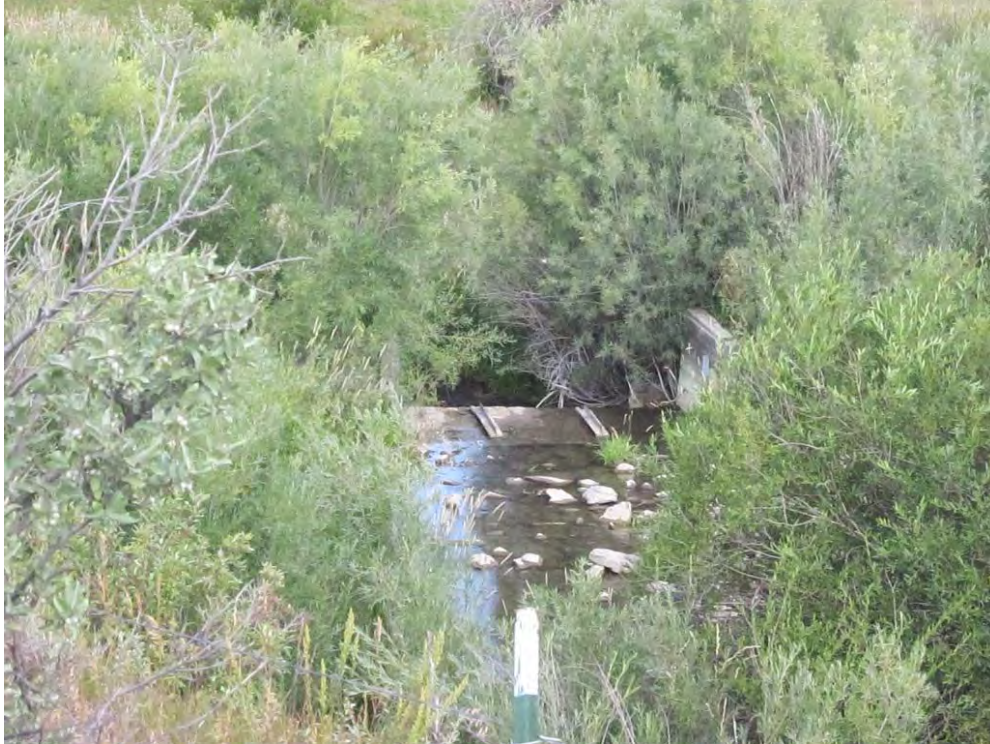
photo 11 Lat. 46.02502, Long. -110.63593 2011 flood demolished part of bank, but most is holding
 Photo 12 Lat. 46.02382, Long. -110.63500 Off site stock water
 Head gate on Daisy Dean is starting to become undercut. Landowner stated that he was going to try and get in touch with Scott Opitz about more rock.
 Riparian has come back strong since the grazing plan has been in use.
 Some banks that are vertical have not migrated according to landowner.
 Light grazing during non growing season is being implemented.
 Canada thistle, hounds tongue
 Landowners have issues with off channel stock water; pipes and well freeze during early winter, and has to chip ice on the outer portion frequently until cattle drink enough to keep it thawed.

Photo 2: Head gate on Daisy Dean Creek

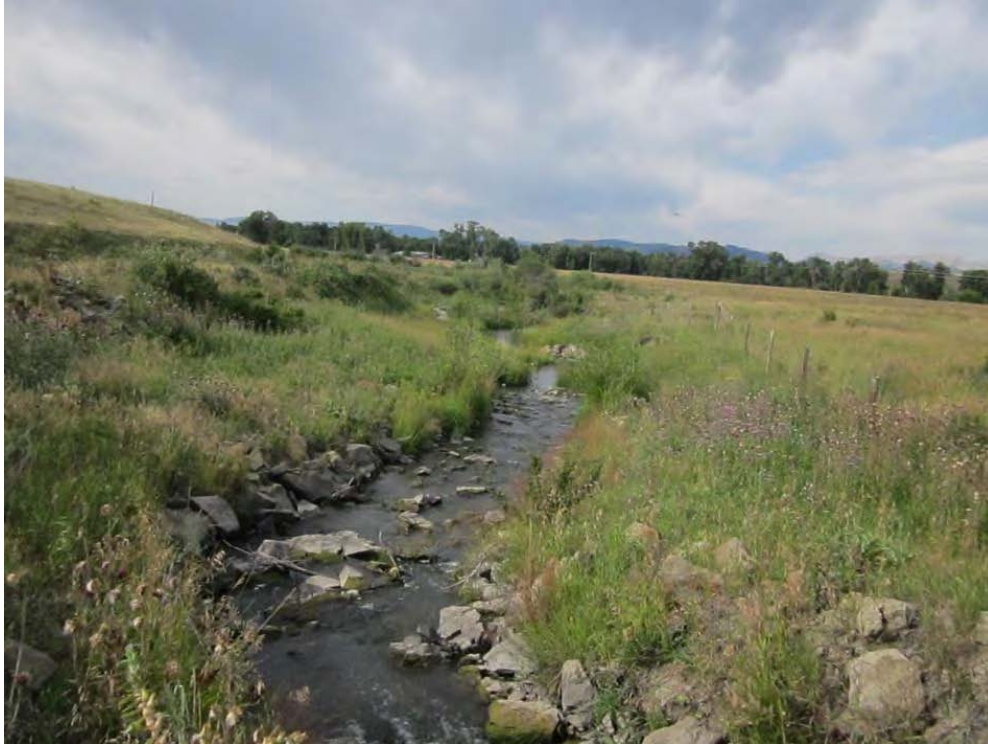
Photo 3a: Start of project different angle.

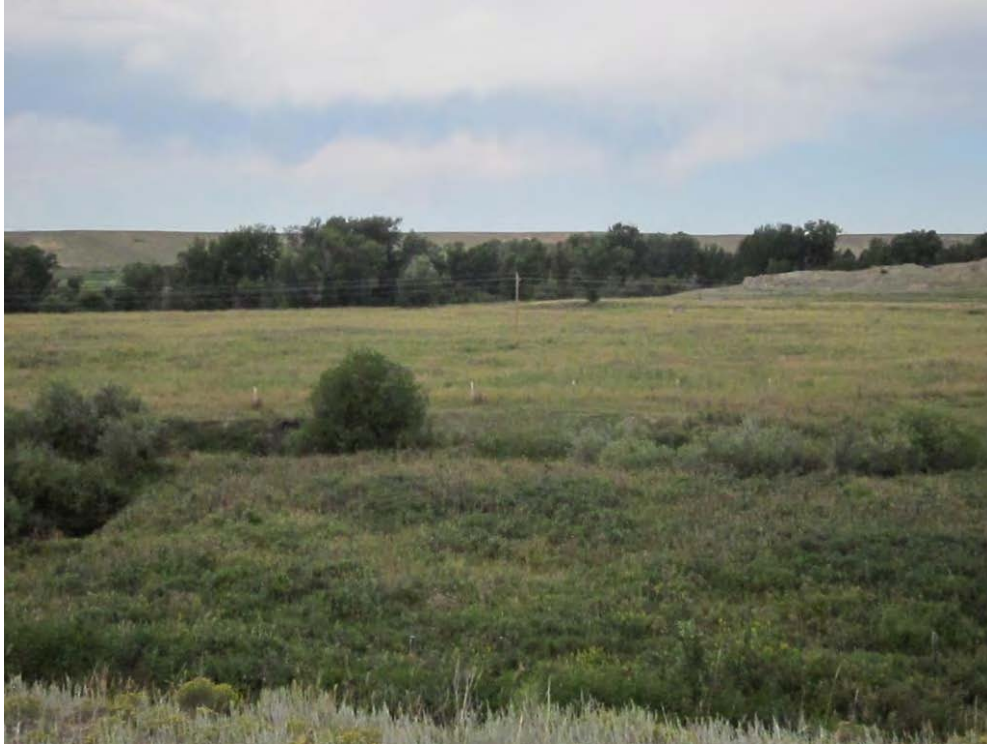
Photo 6: Bank stabilization

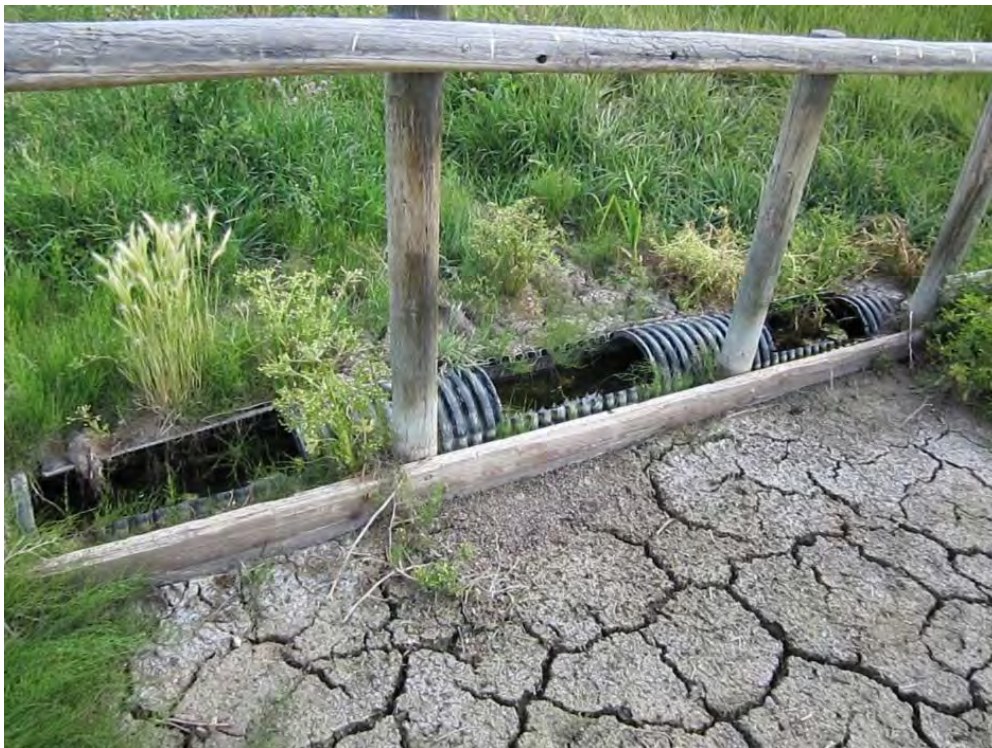
Photo 7: Spring stock water

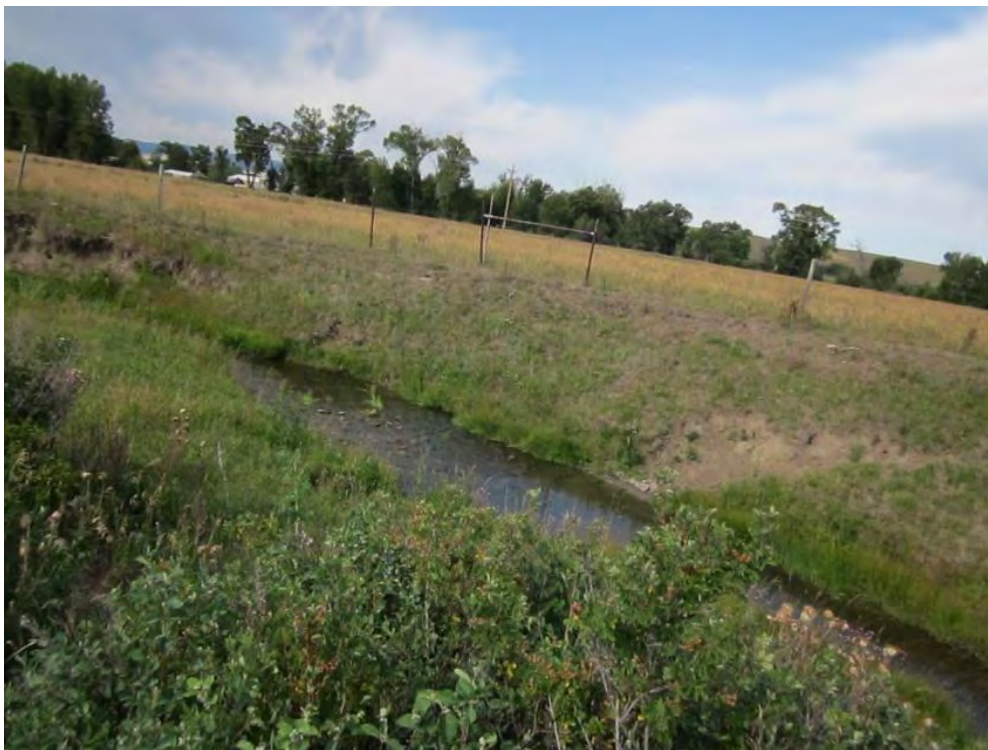
Photo 9: Re-sloped bank

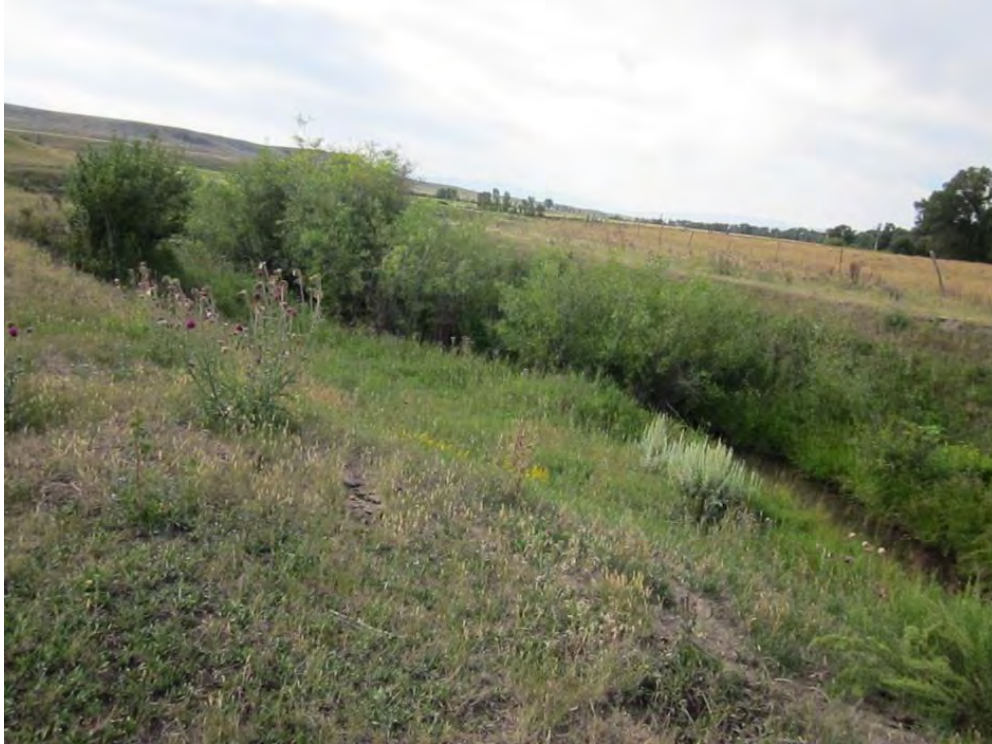
Photo 10: Willow recruitment.

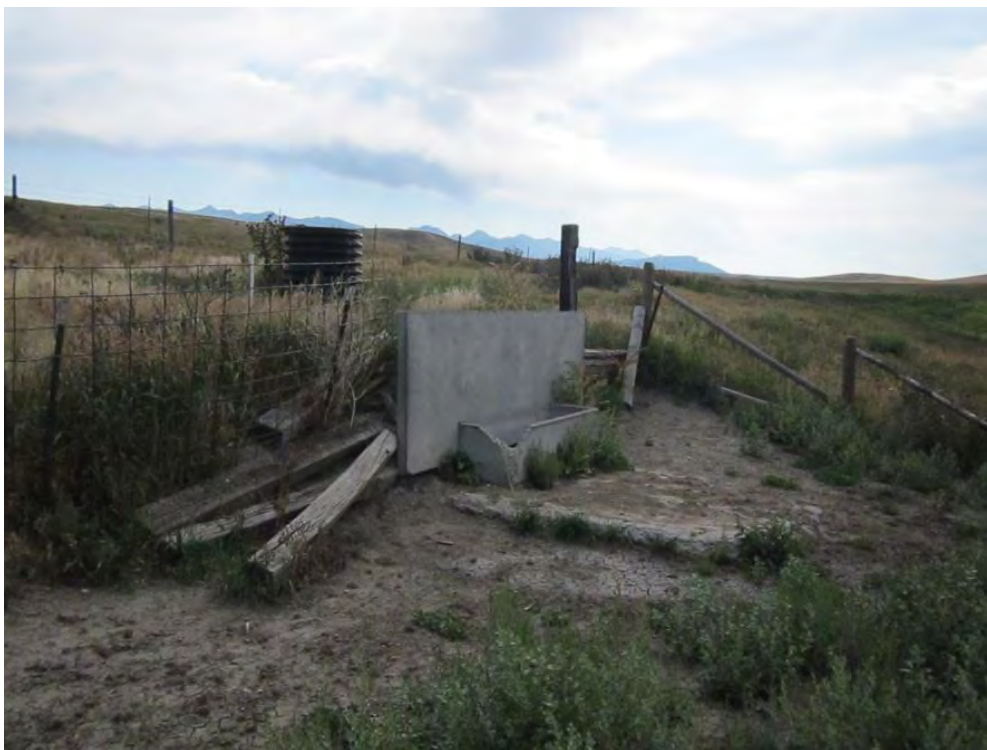
Photo 13: offsite stock water.

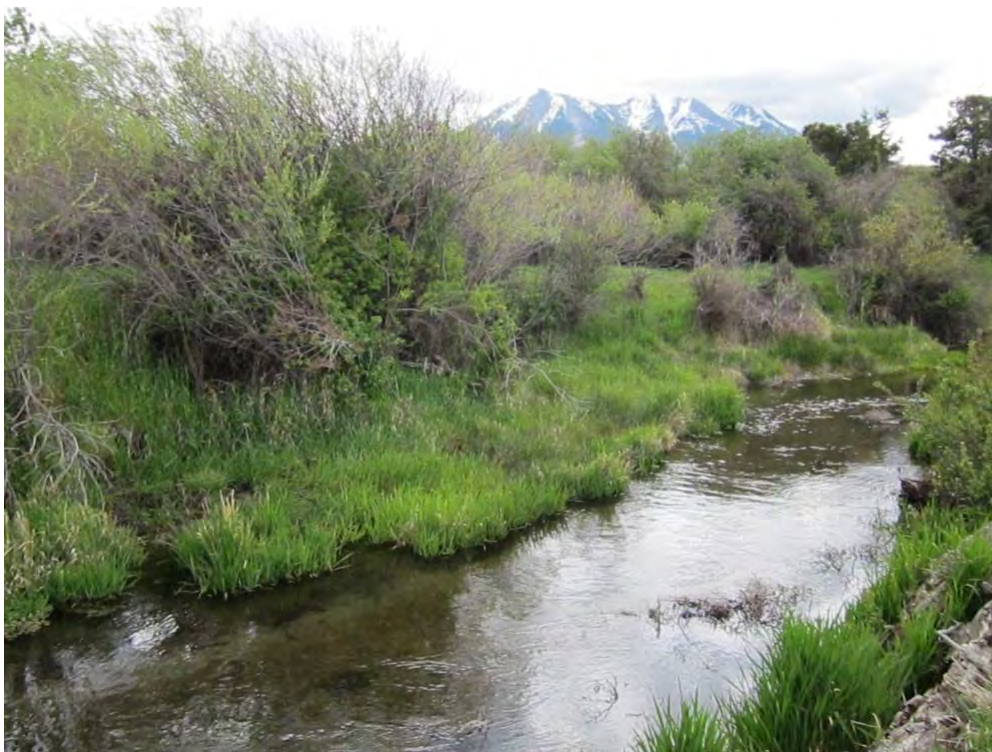
Photo 3: Vegetation on point bar, woody plants above bank full.

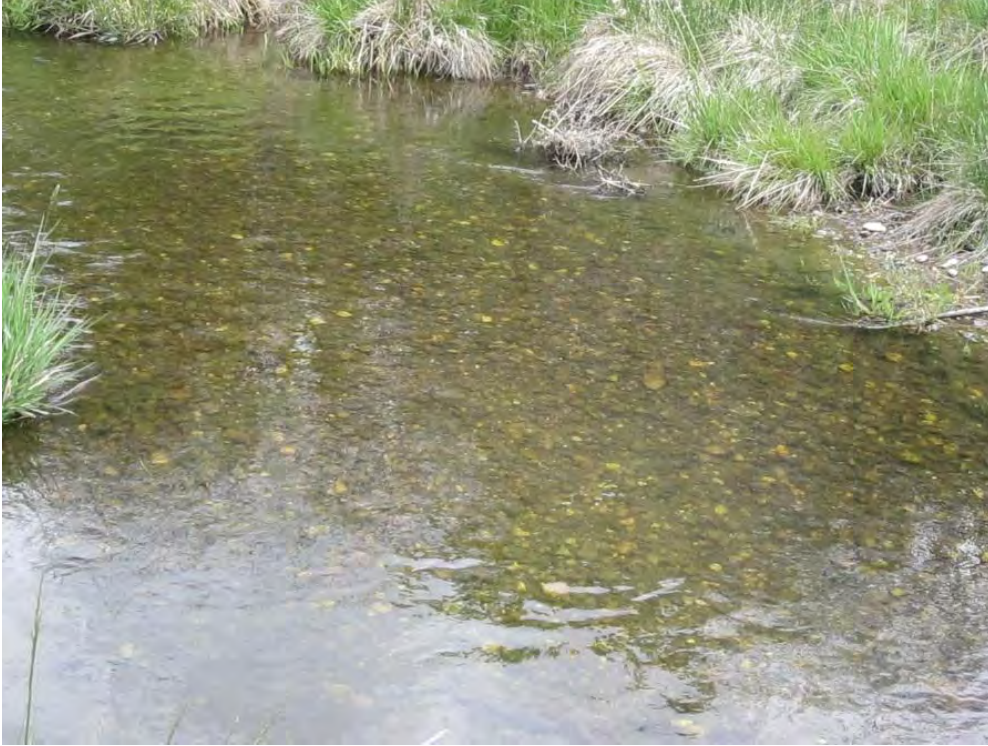
Photo 4: Good spawning gravel.

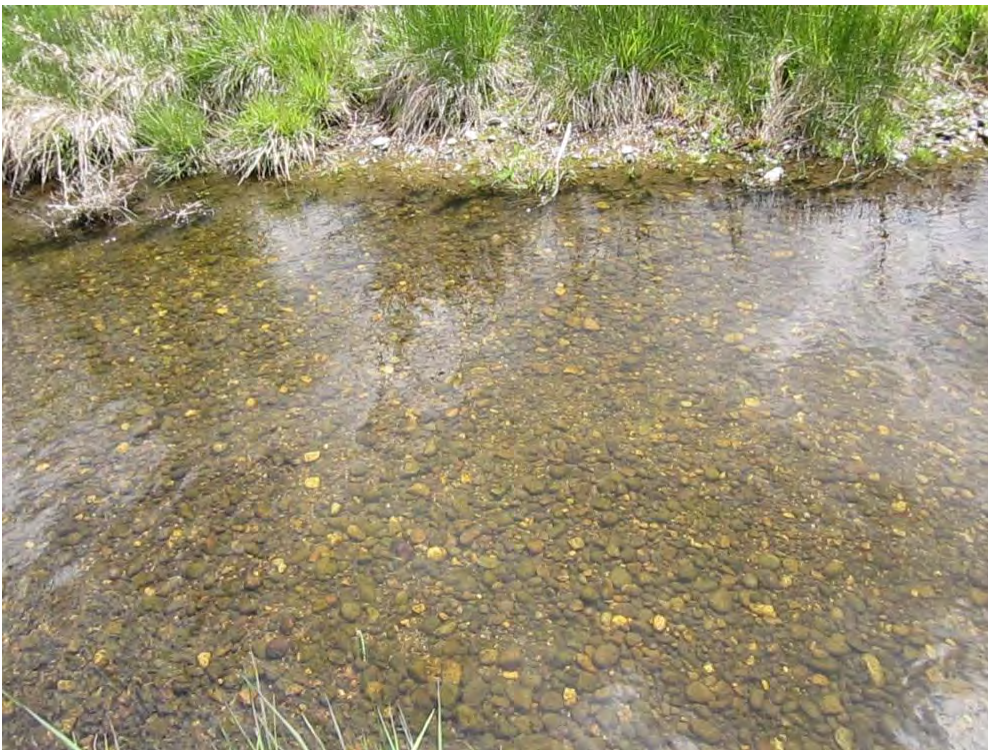
Photo 5: Good spawning gravel.

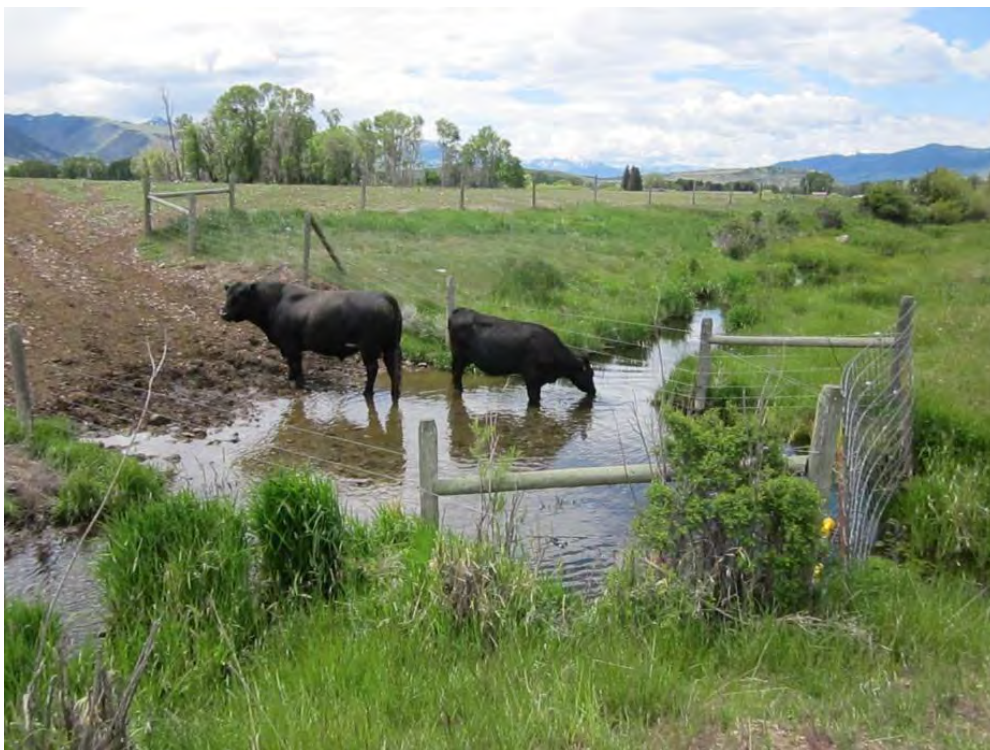
Photo 7: Stock water.

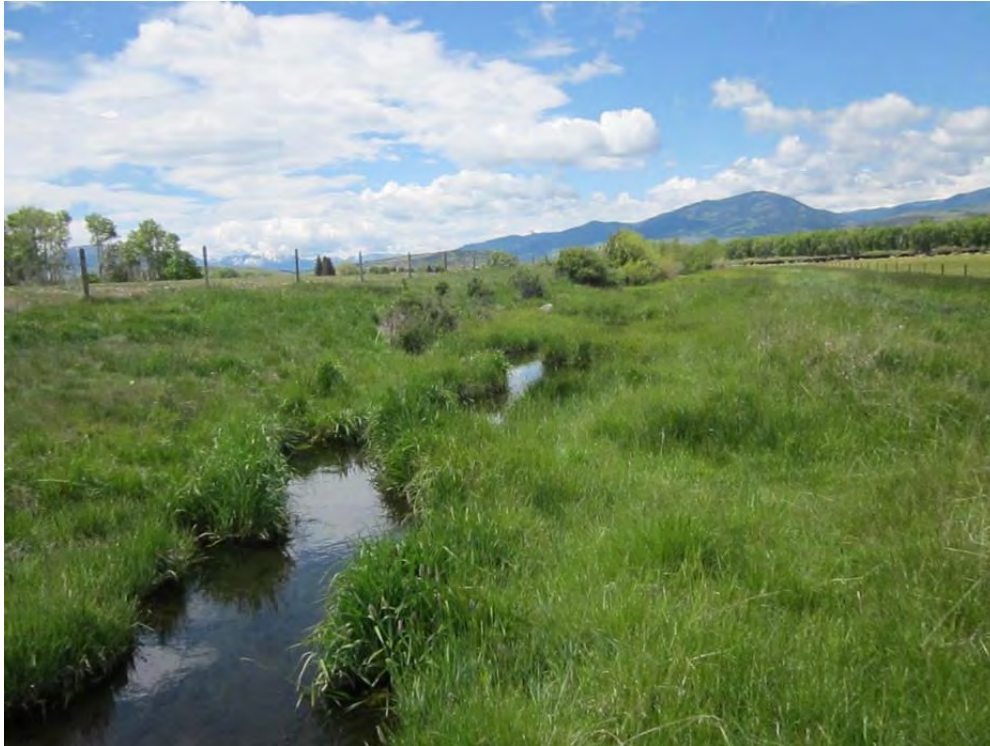
Photo 8: Start of meander.

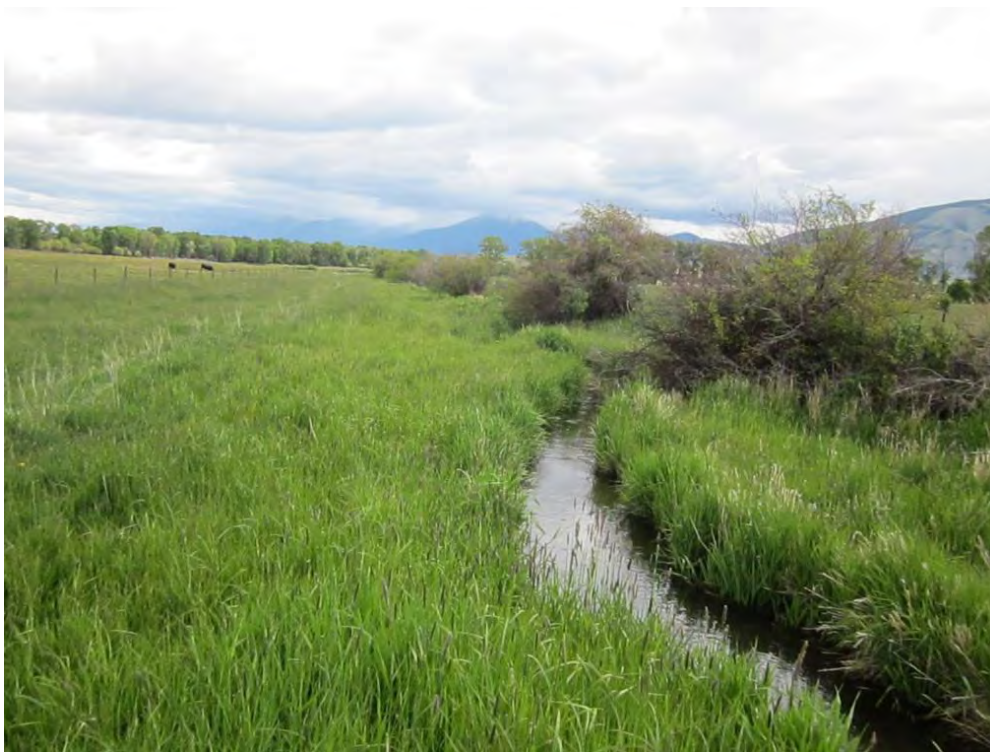
Photo 9: End of channel restoration. (Downstream view)

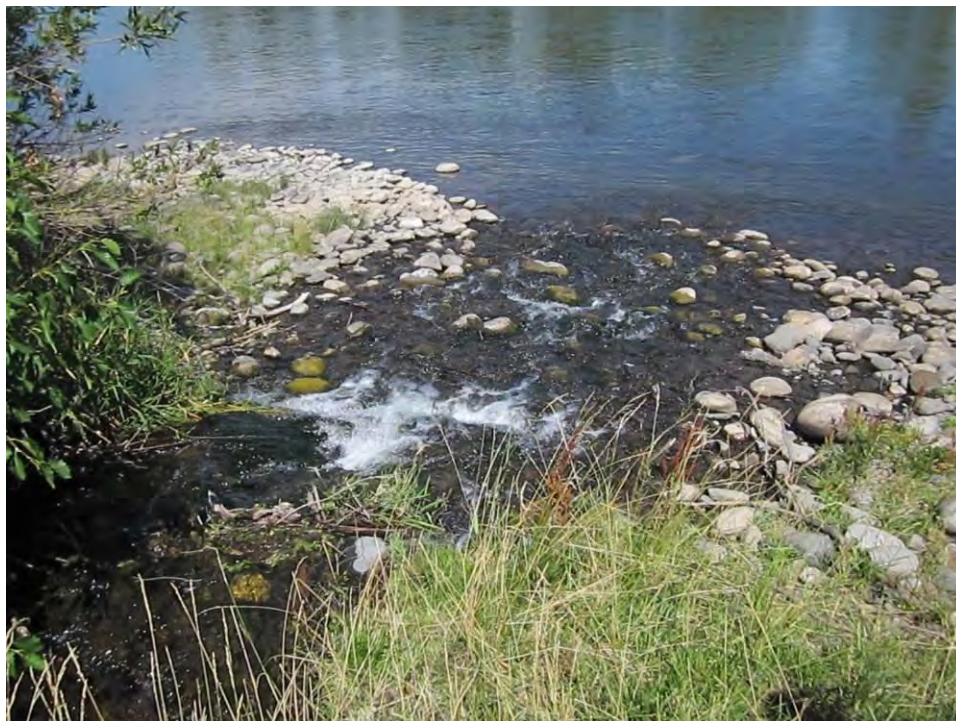
Photo 1: Start of project.

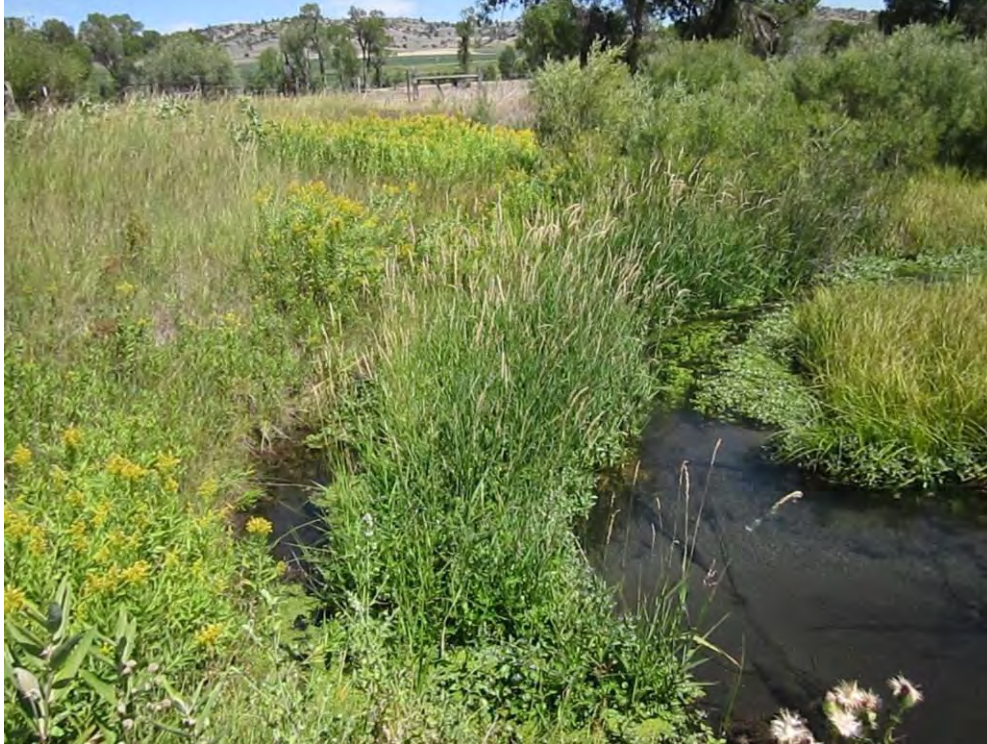
Photo 4: possible stream movement, or sedges growing within a designed pool.

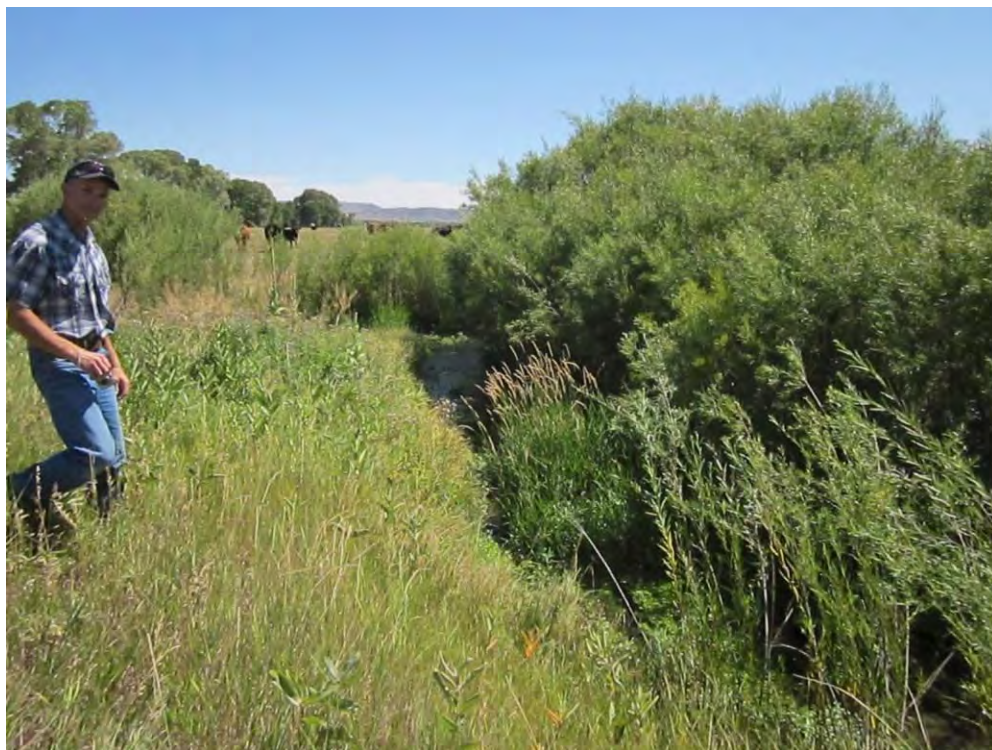
Photo 5: Willow recruitment. (with Chuck Roloff, NRCS district conservationist)

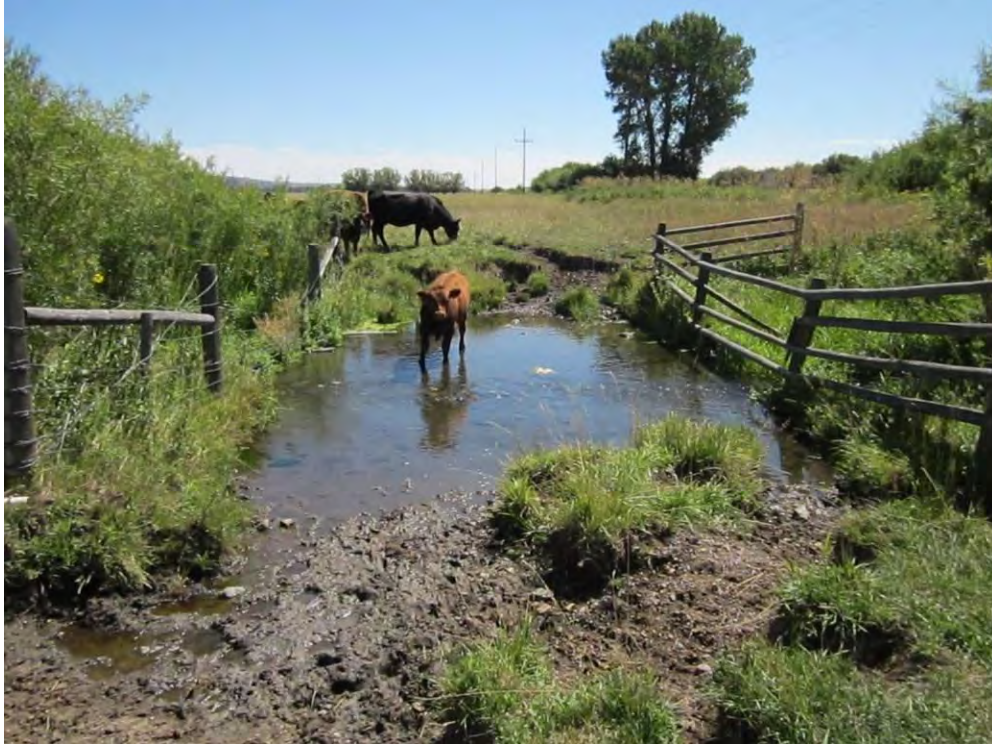
Photo 6: Cattle water gap.
