4 Appendix: Completed Field Forms and Associated Photos

4.1 Bad Canyon Creek barrier repair (003-2005)

FFIP 2016 Field Monitoring Appendix
Field Forms and Geo-referenced Photos
Yellowstone River Watershed

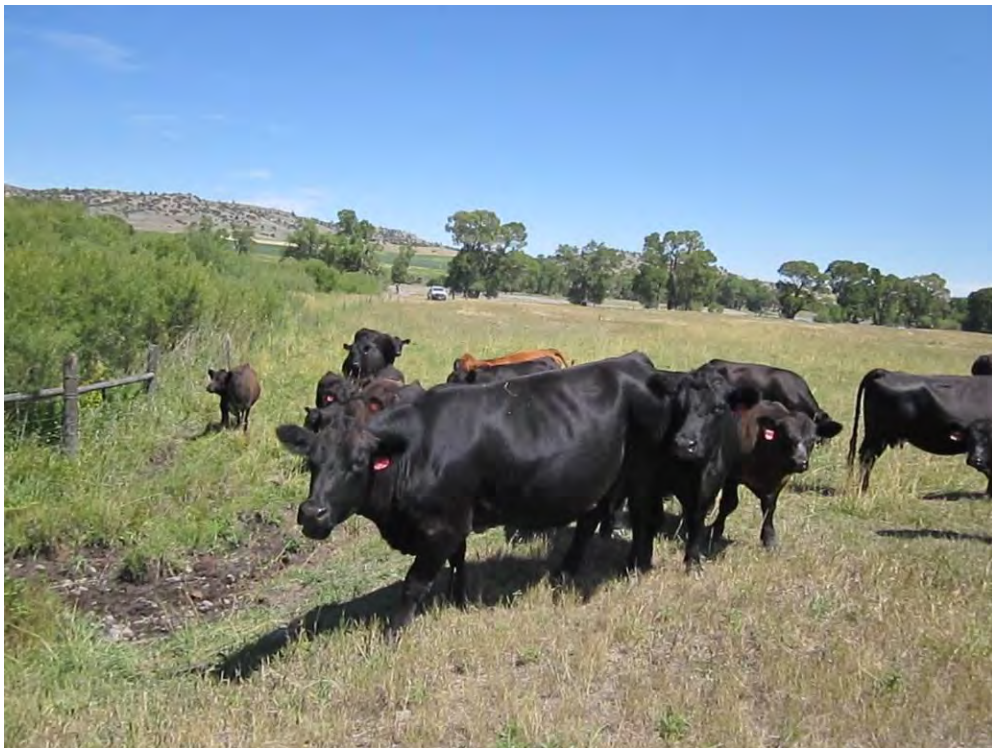
Photo 6a: Next in line for water.

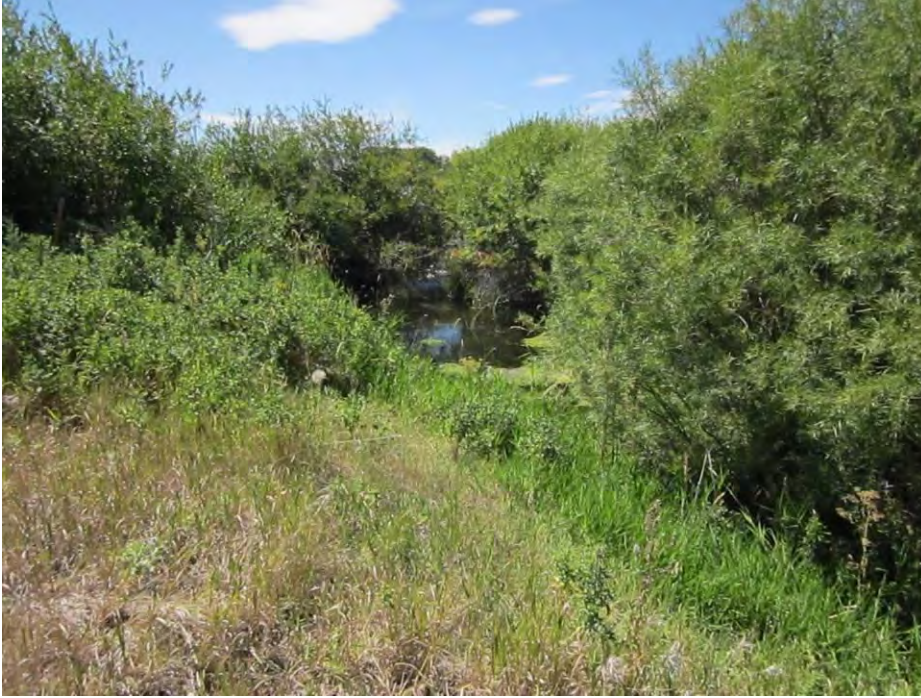
Photo 7: End.

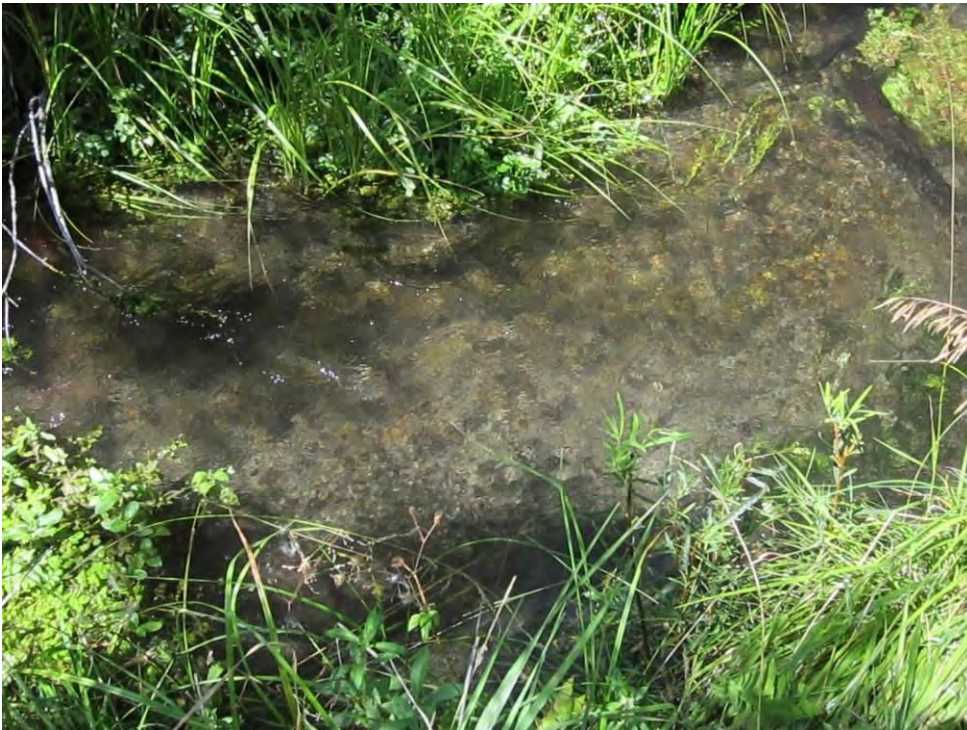
Extra photo: spawning gravel.

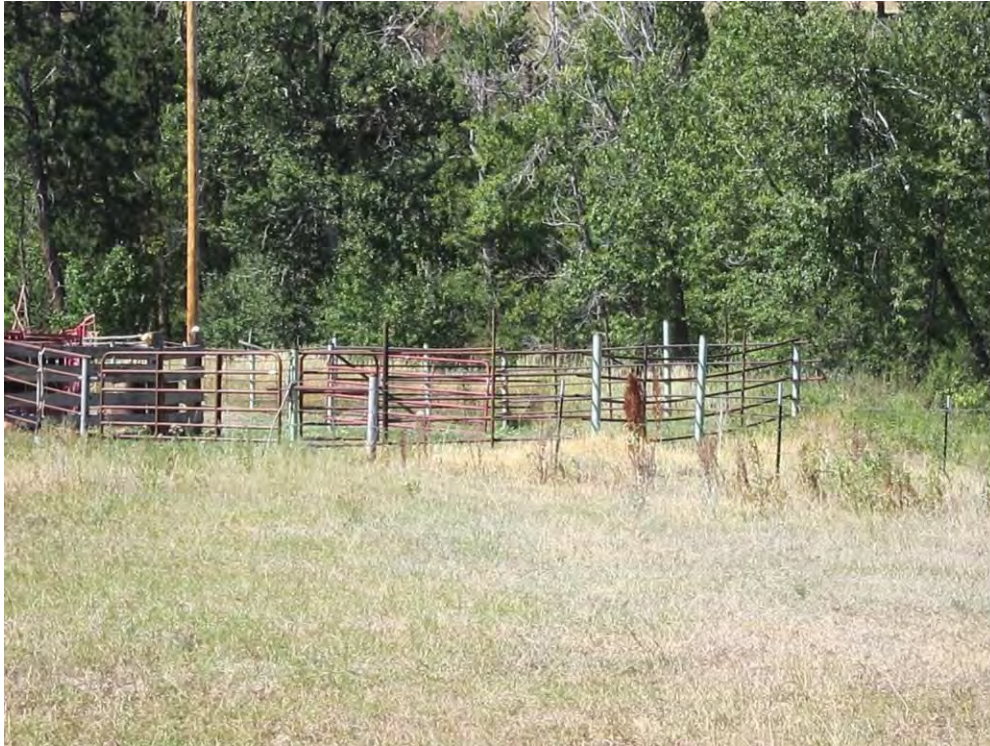
Photo 2: Corrals landowner built on his own time.

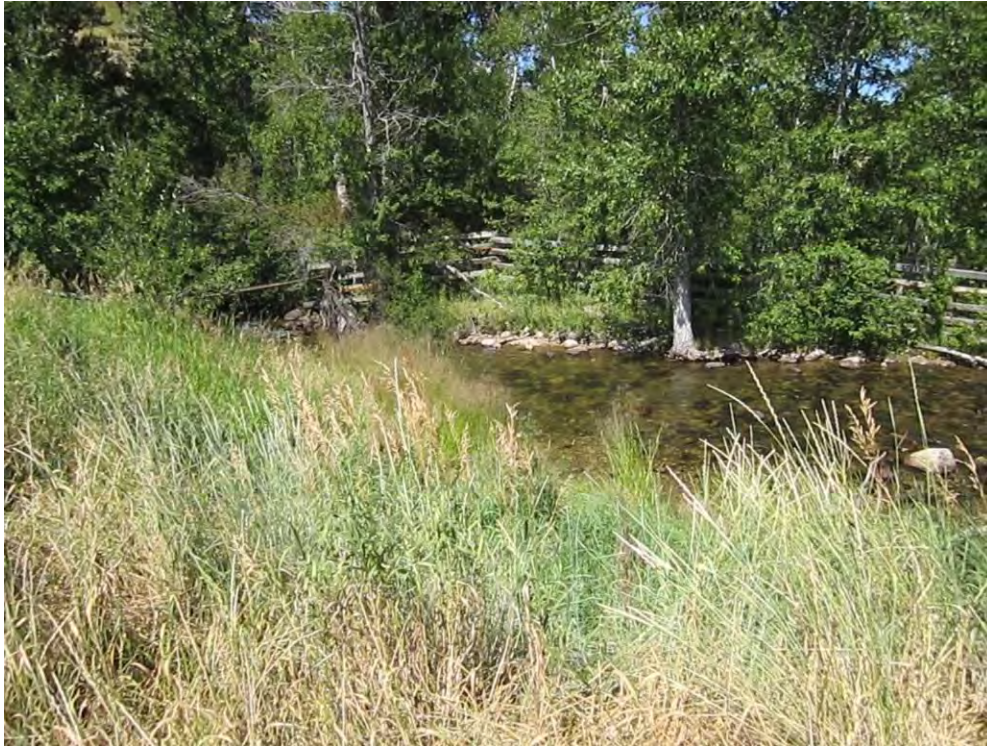
Photo 4: Old fence and recovering riparian area.

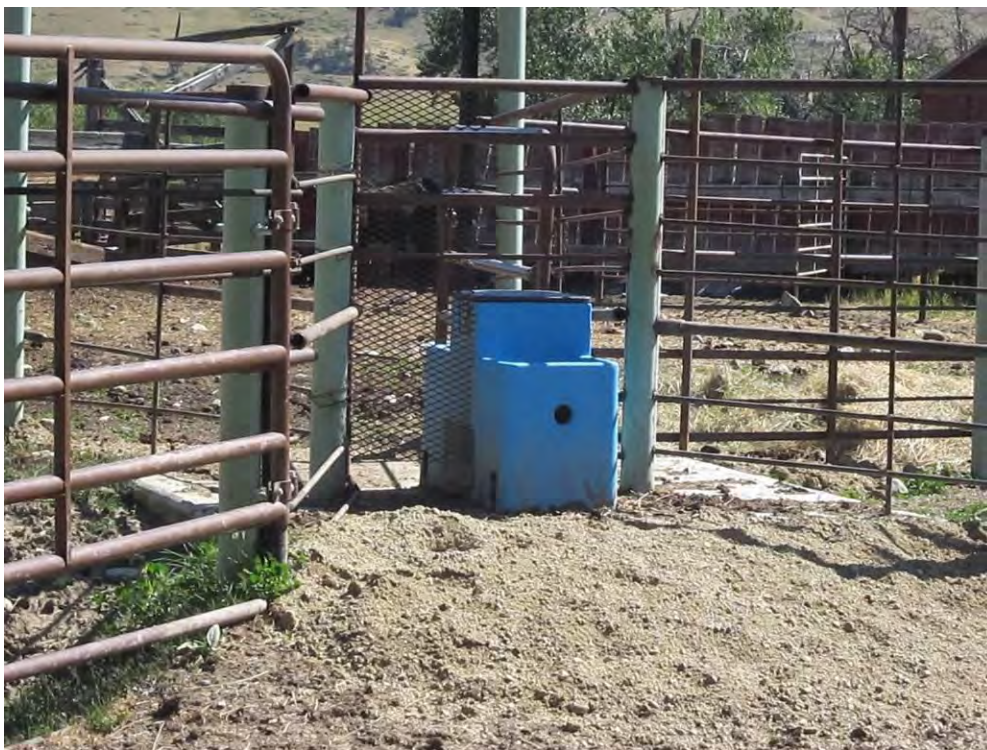
Photo 5: Offsite water with in corrals.

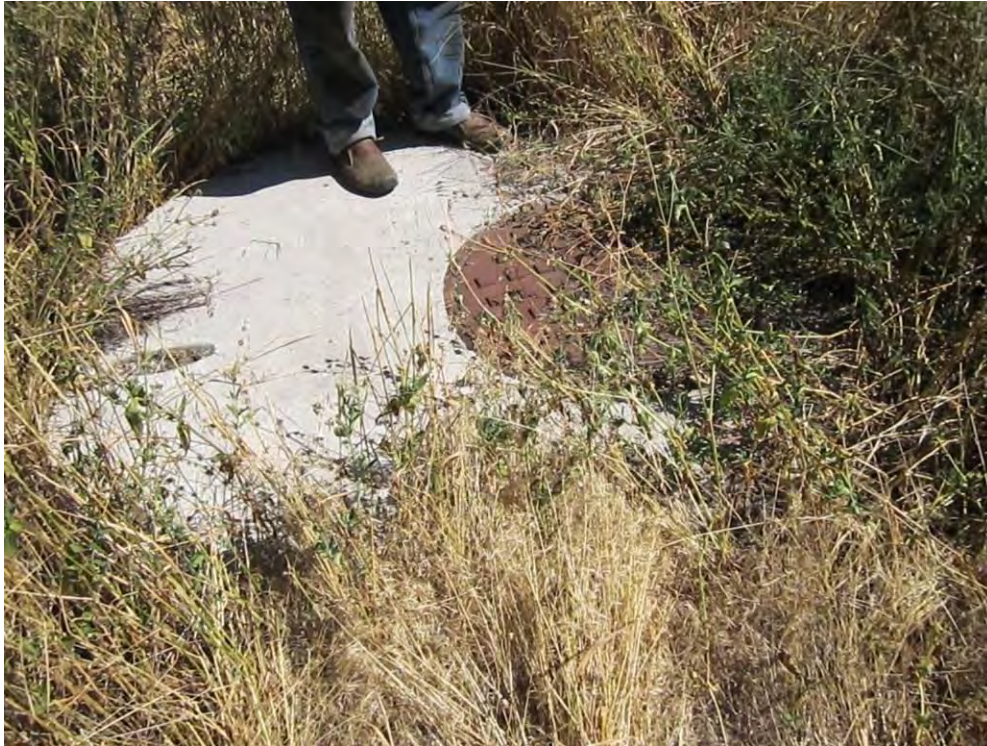
Photo 6: Pressure pump.

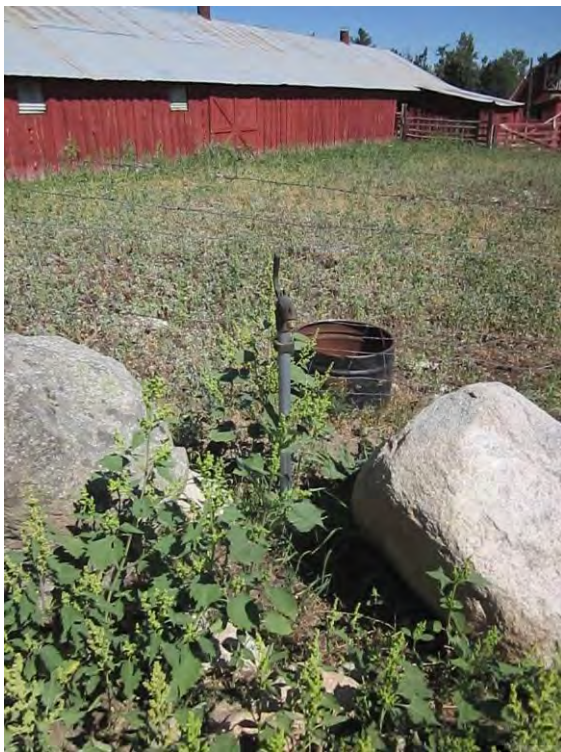
Photo 7: Frost free spikit. (one of several)

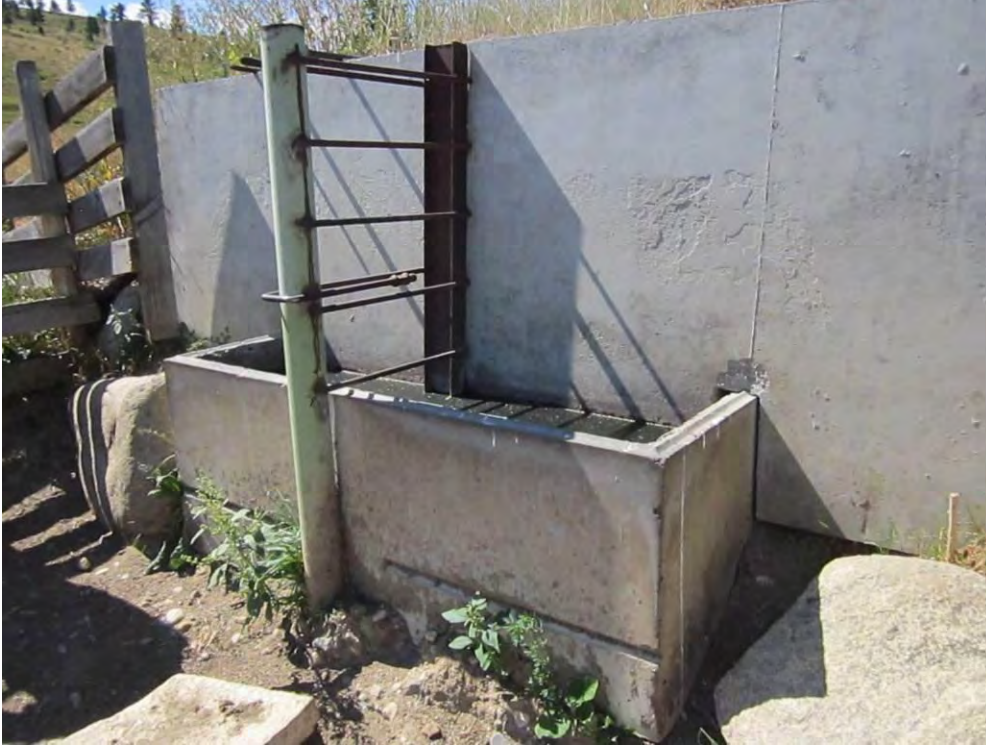
Photo 8: Offsite water.

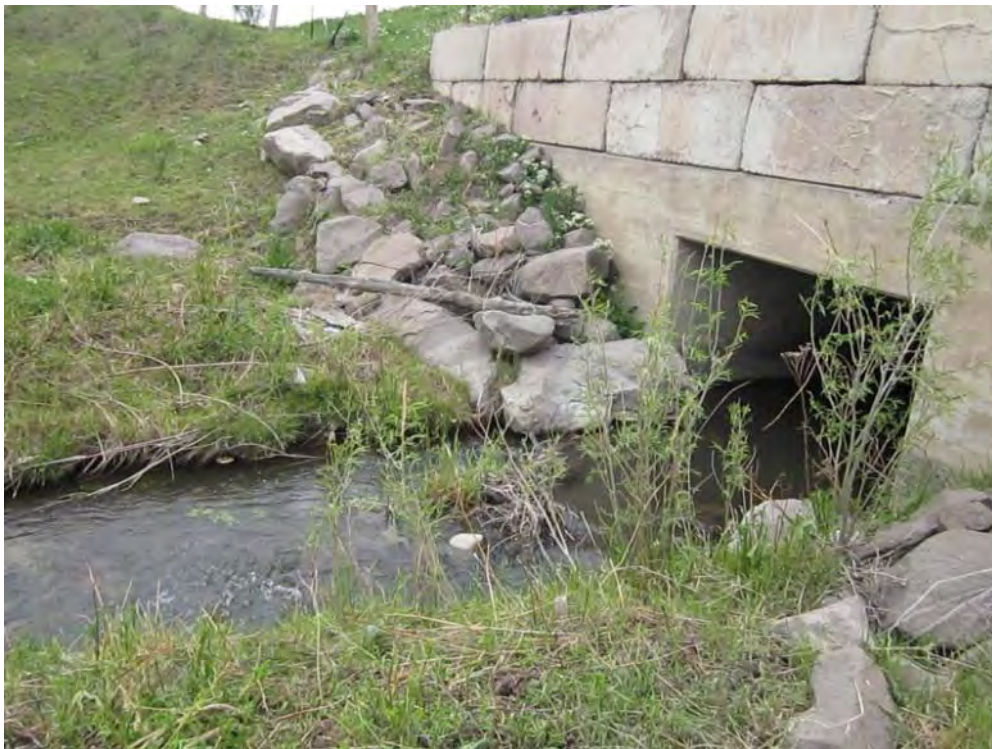
Photo 1: Start of project.

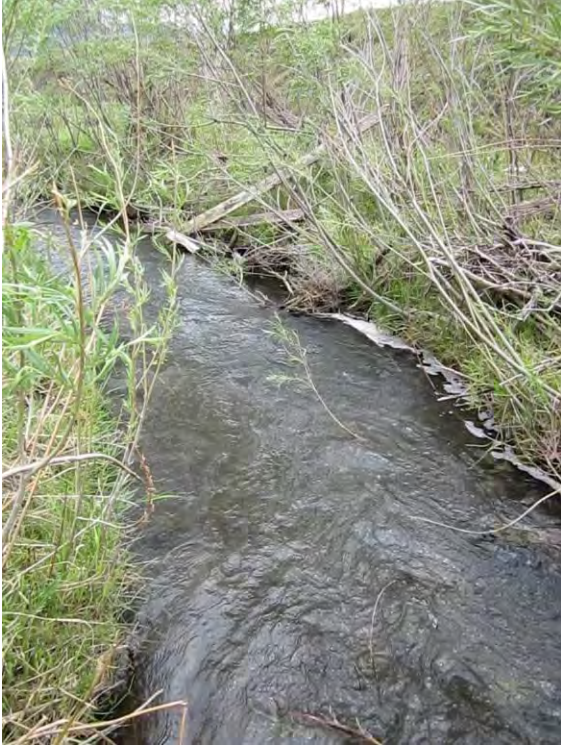
Photo 2: Undercut bank, willow survival high.

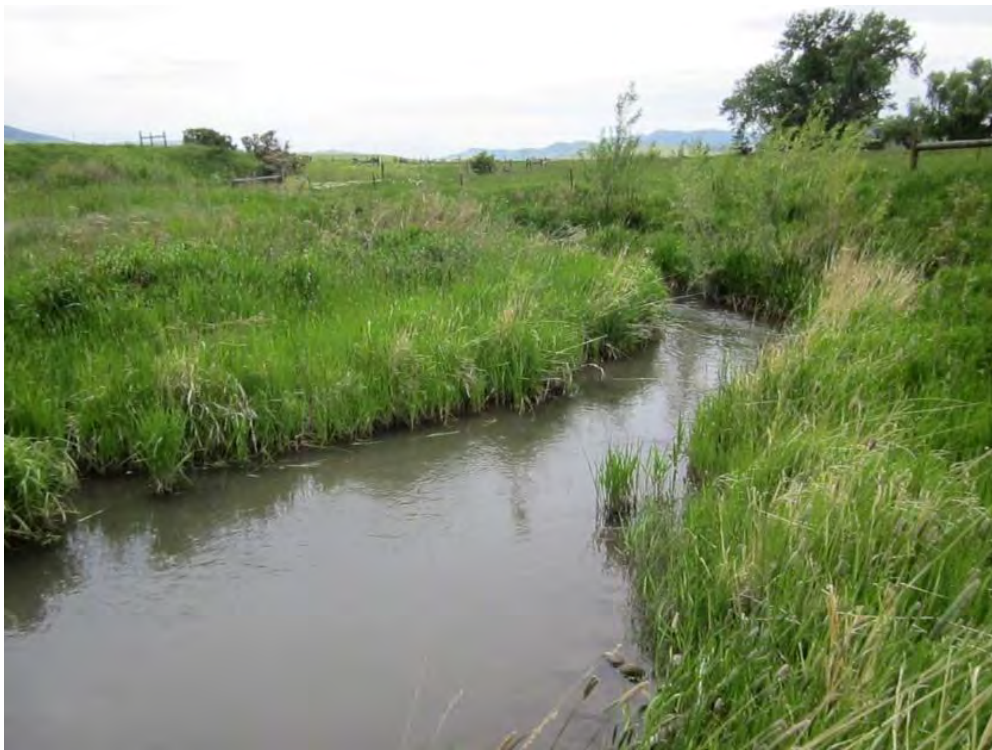
Photo 11: End of project.

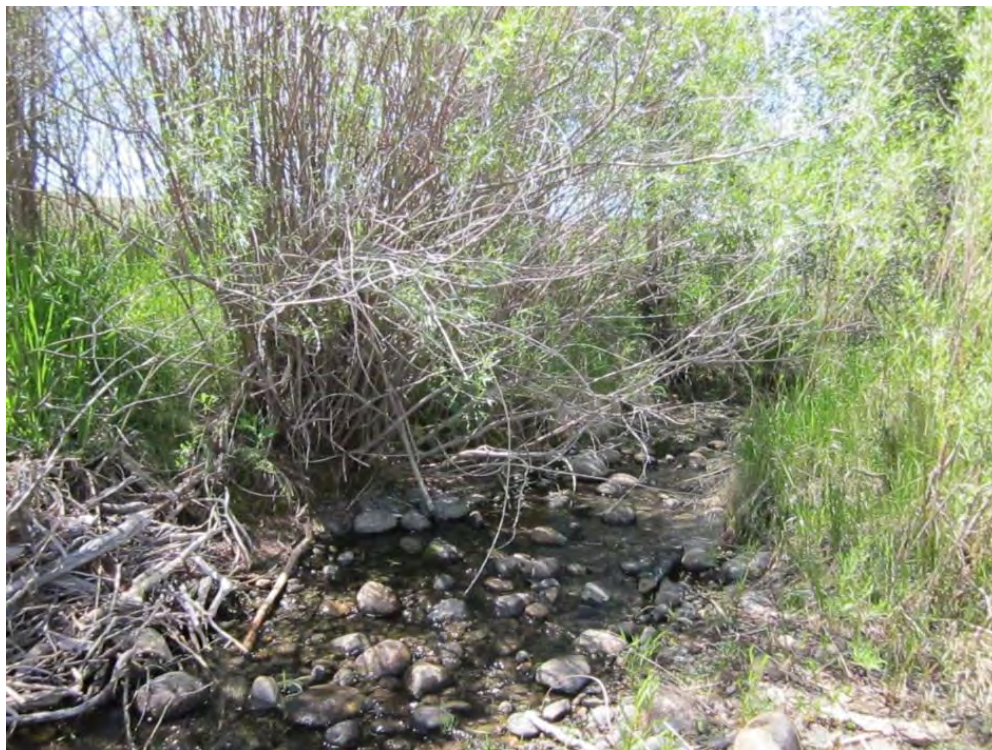
Photo 1: Mouth of spring creek.

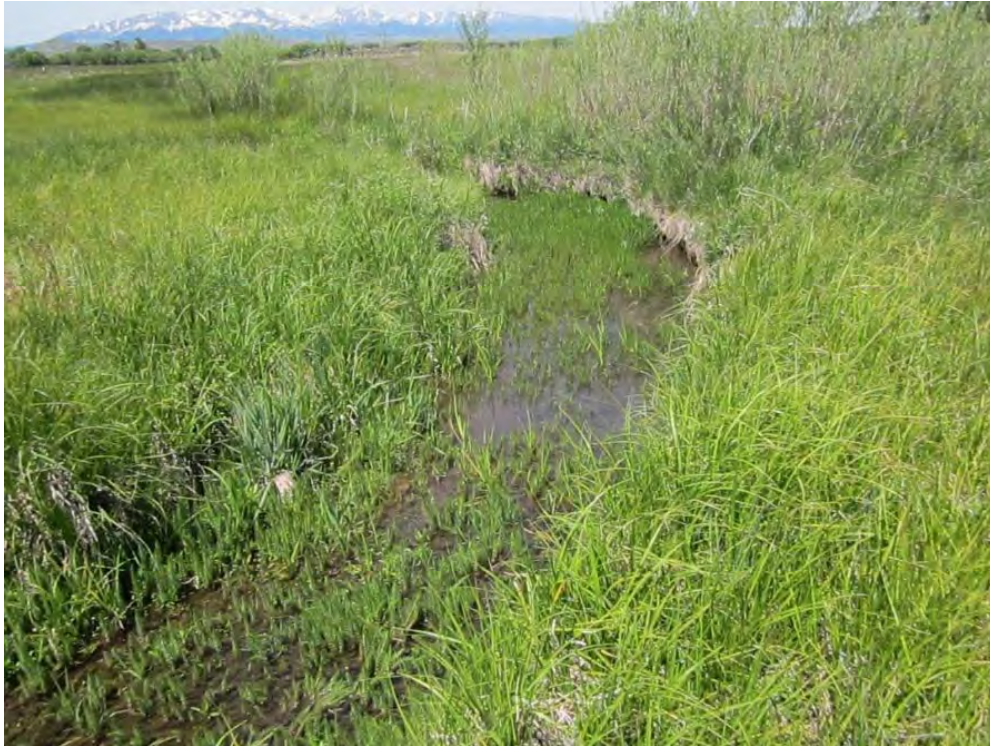
Photo 4: Plants in stream with evidence of willow recruitment.

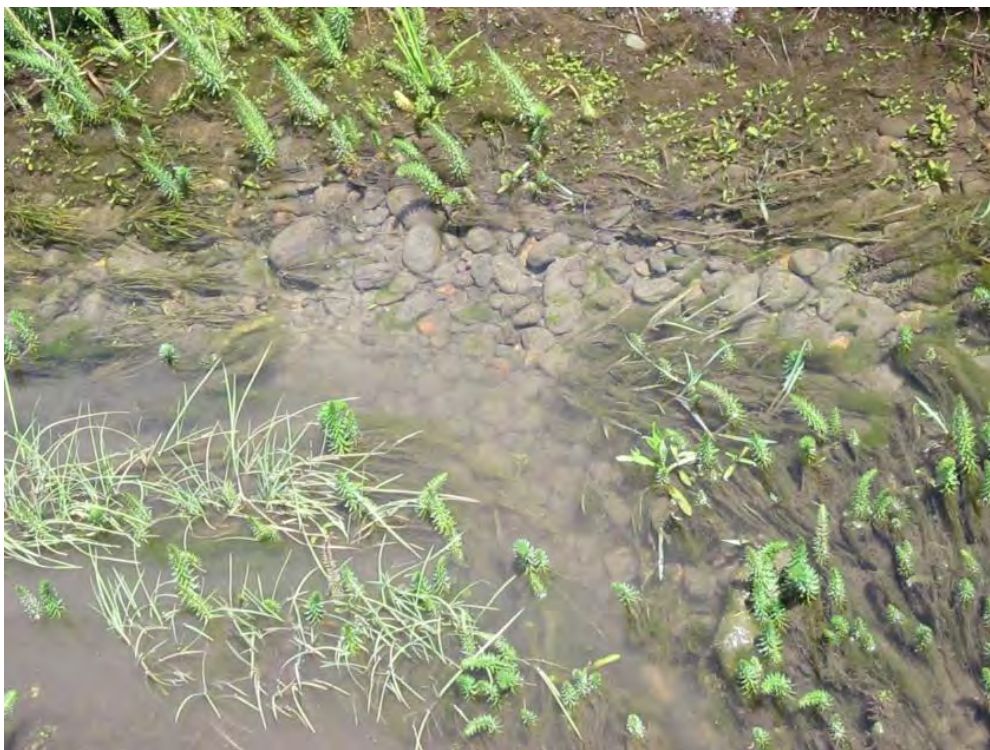
Photo 5: Exposed gravel.

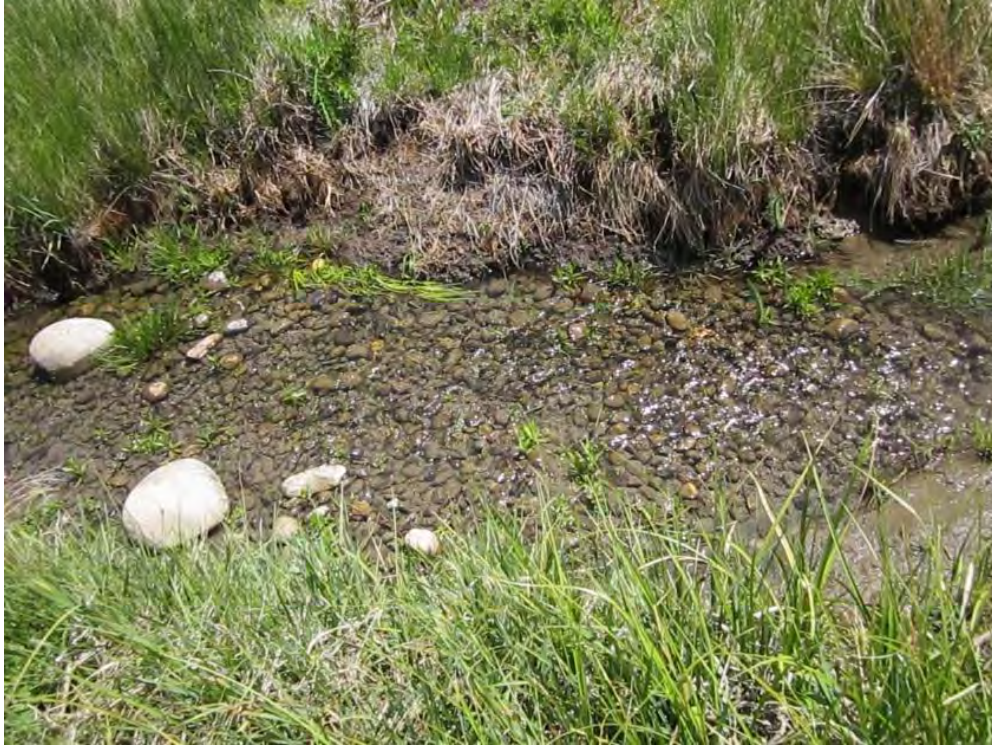
Photo 6: Possible spawning gravel.

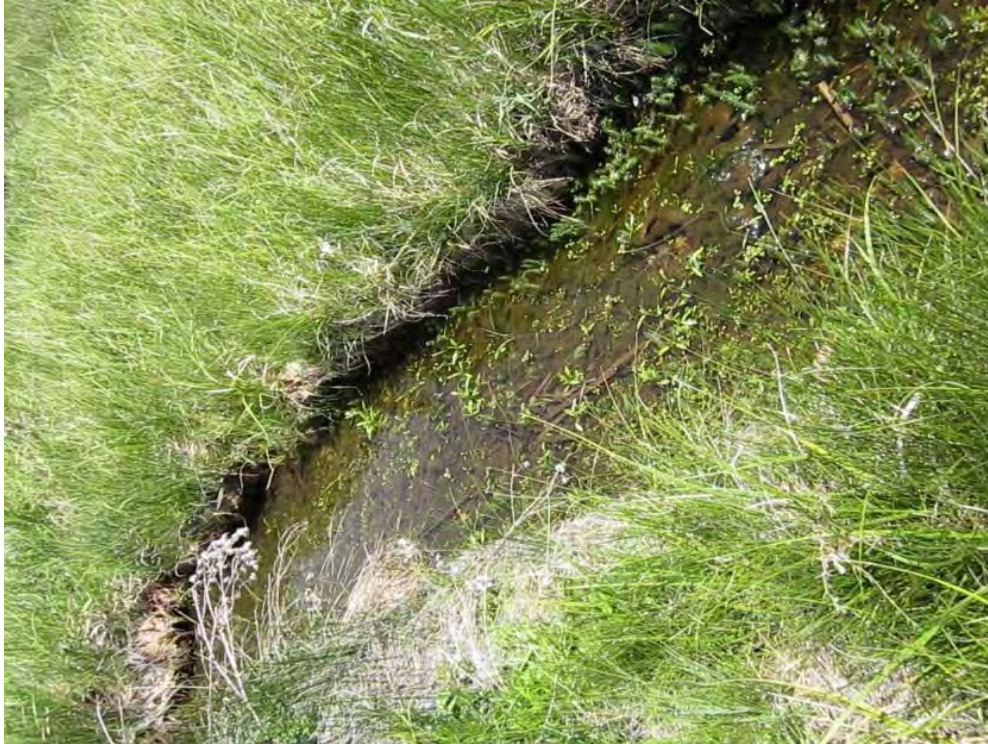
Photo 8: Ideal channel, width/depth ratio.

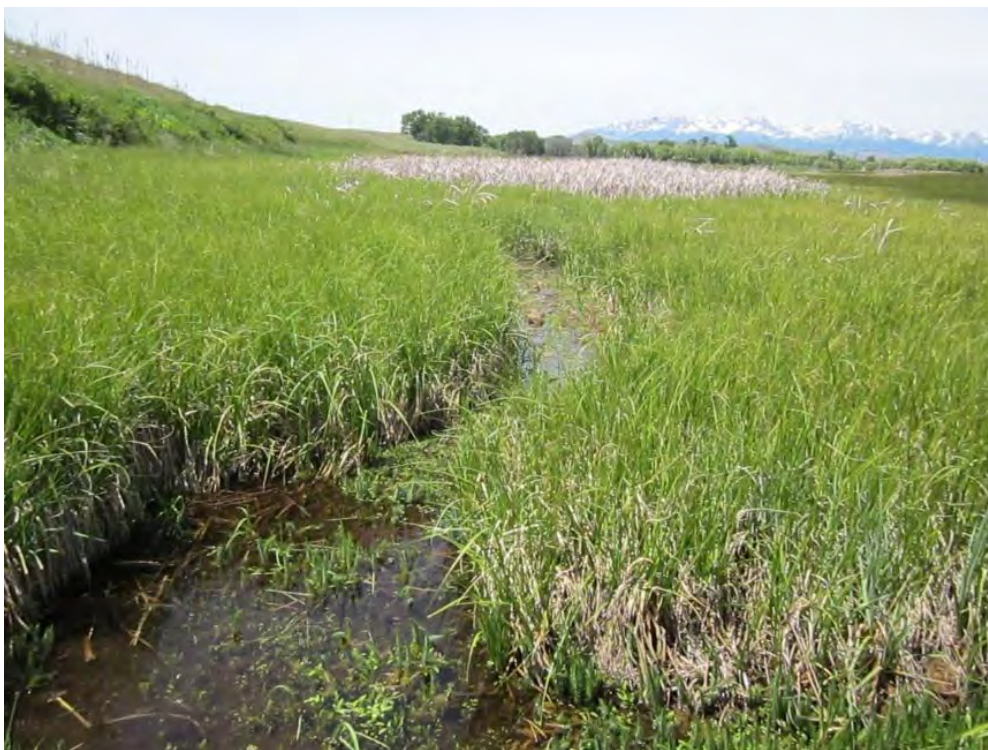
Photo 9: End of project.
